26 Plummers Point West

Tauranga Harbour Coastal Erosion Assessment
 Erosion Hazard Overview
 Site 26: Plummers Point West

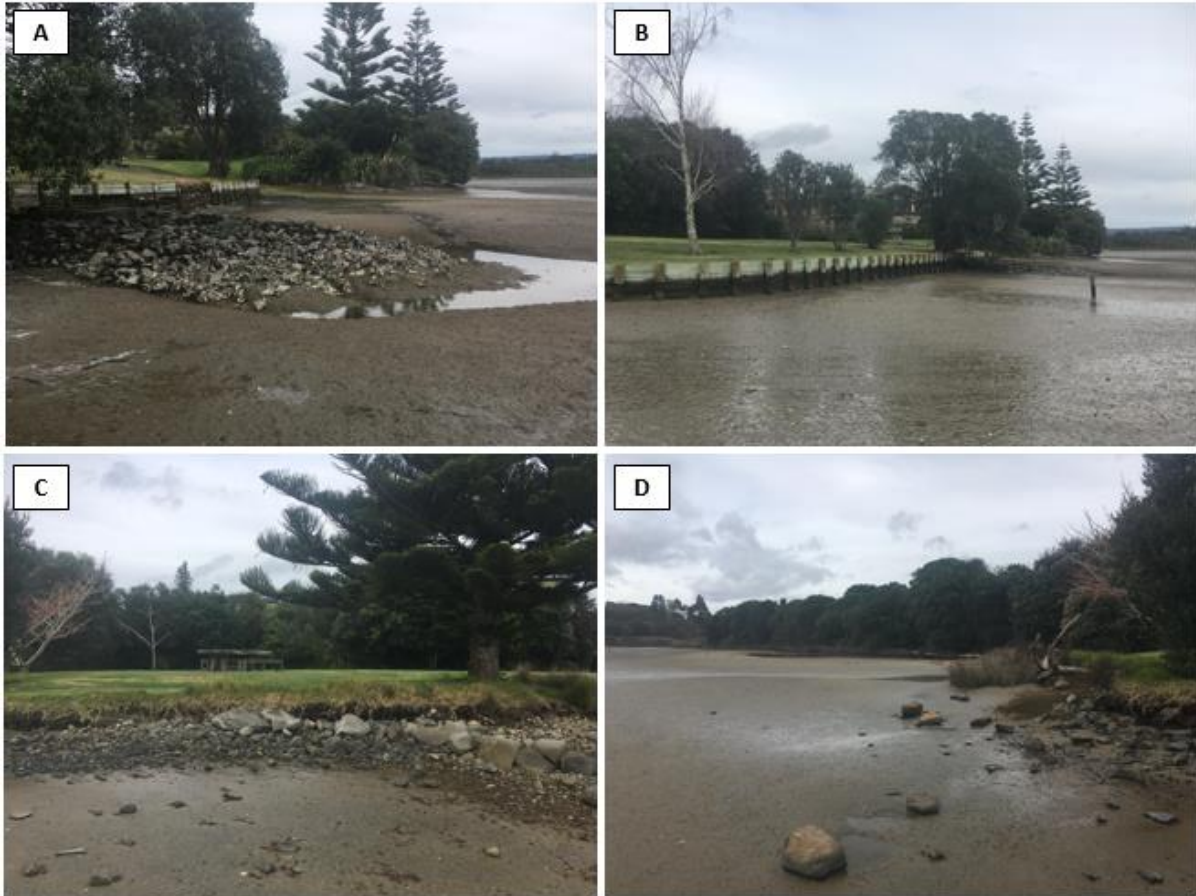
The shoreline within Cell 26D is characterised by a low grass bank, which is partially protected by a timber seawall and rock rip rap. The bank is northwest-facing and ranges in elevation from RL 1 to 2 m. There is evidence of some undercutting along the unprotected sections of the bank. The grass bank continues to wrap around to a north-facing orientation with small patches of salt marsh along the toe of the bank (Cell 26E).

Figure 26-2 Site photos for Plummers Point West. (A) Rock around drain outfall (Cell 26D), (B) timber seawall (Cell 26D), (C) consolidated bank (Cell 26D), (D) low grass bank with patches of salt marsh (Cell 26E).

There is approximately 50 m of timber seawall along the grass bank within Cell 26D (Figure 26-2B). There is also a drain outfall within Cell 26D which is surrounded with rock rip rap (Figure 26-2A).

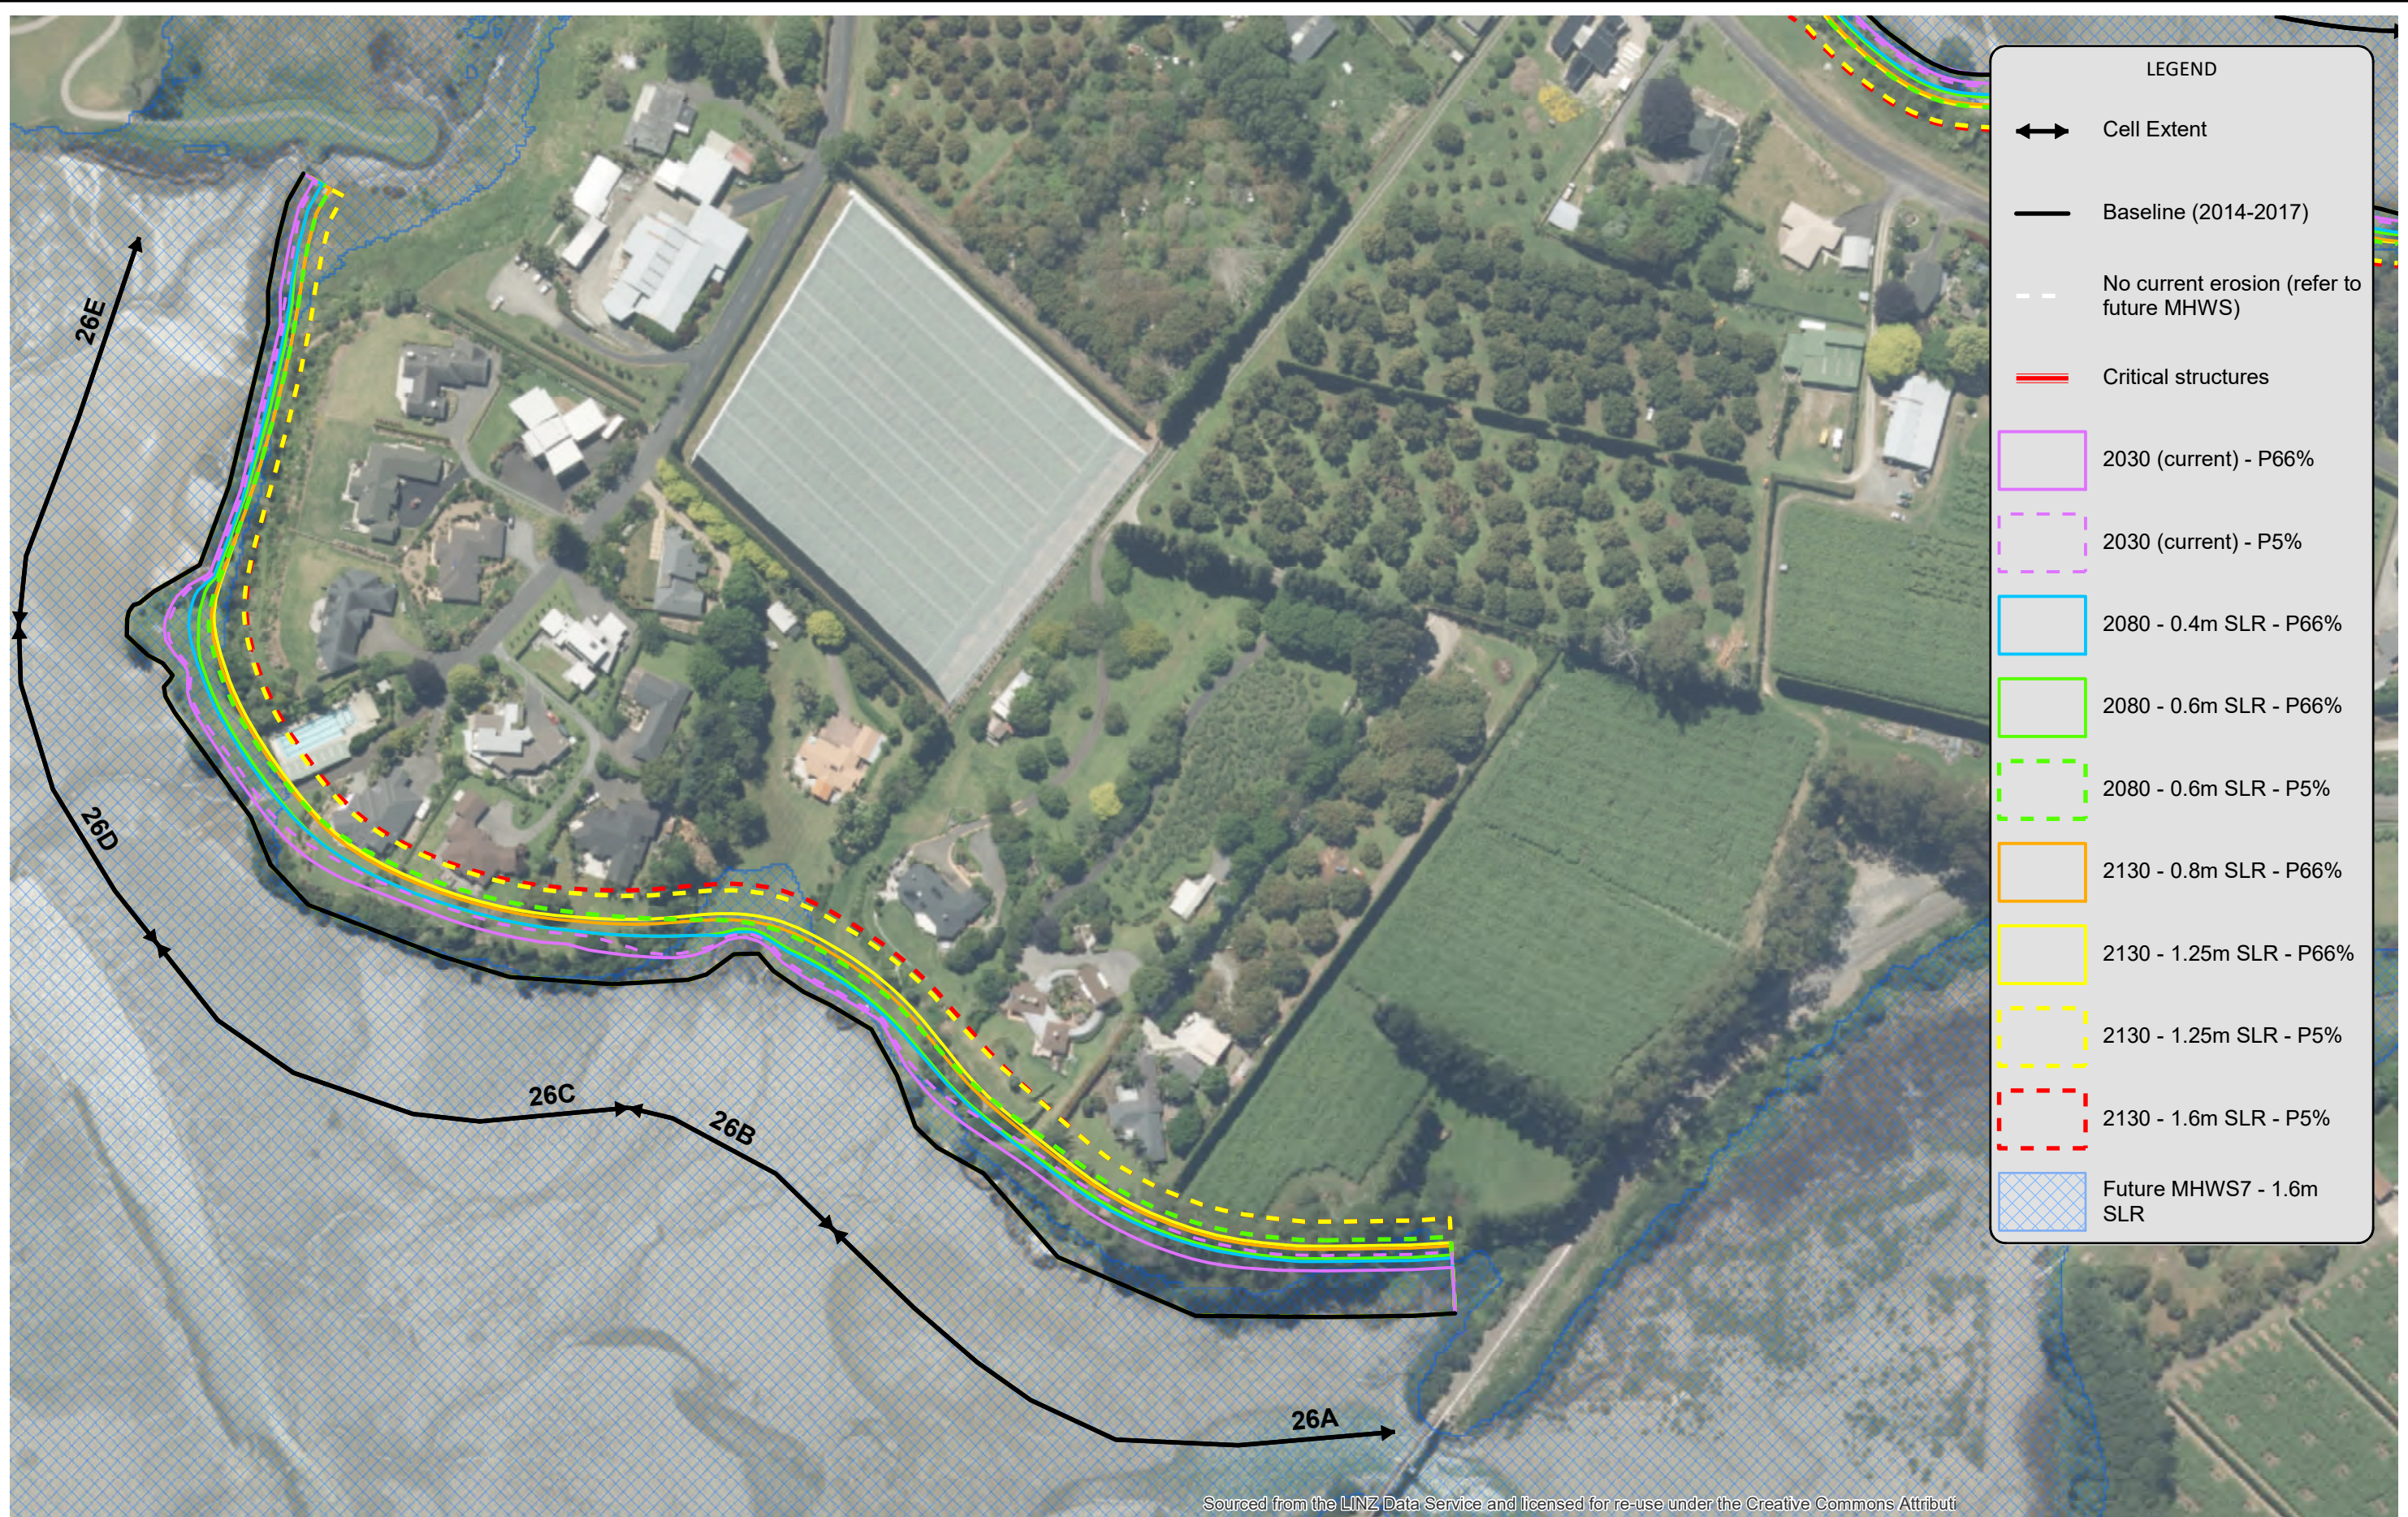
FIGURE No. Figure 26-4

Coastal erosion hazard distances for Plummers Point West are presented within Table 26-2 and an overview map in Figure 26-4. Histograms of individual components and resultant erosion hazard distances using a Monte Carlo technique are shown in Appendix B. For the purpose of this assessment all coastal erosion protection structures have been ignored (refer to main report Section 4.5.4).

The current P_{66%} erosion hazard ranges from -4 m to -19 m along the Plummers Point West shoreline. The future P_{5%} erosion hazard for 1.6 m SLR in 2130 is up to -29 m in Cell 26C where the cliff height is largest.
