**From:** Jewel Zhu – Fire Engineer

**Date:** 23 June 2022

**Action:** 19 Derrimore Heights Residential House Fire

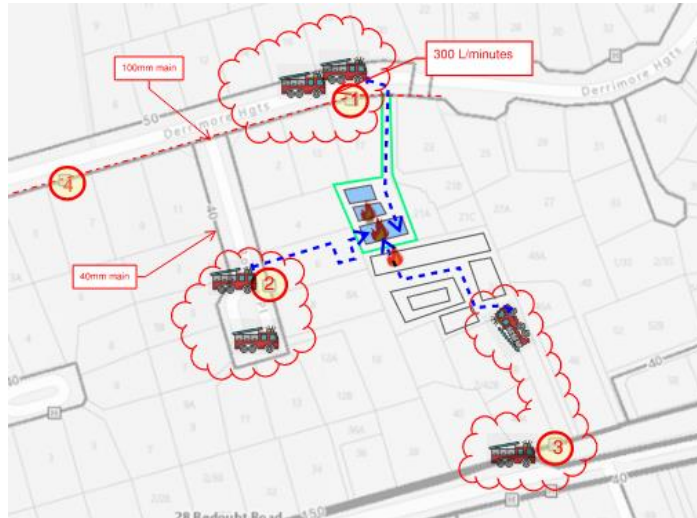
Access to the building is straight from Derrimore Heights (i.e. public road to the north), via an approximately 40m long pan-handle shaped private driveway. As the driveway was covered in gravel and only provides 2.9m effective width, it is not suitable for a fire appliance. Consequently, fire appliances had to park on Derrimore Heights. The hose run distance from Derrimore Heights to the furthest point of each building is within 75m, however, this is noted to be marginal.

Figure 3: Firefighting access; Reticulated line and locations of the street hydrant - from Smart Map

The flow test conducted by Fire and Emergency indicates that the hydrant located outside the 17 Derrimore Heights (denoted as H1 shown in Figure 3) has a flow rate of 300L/minute. As the two hydrants outside the 7 Derrimore Heights (denoted as H4) and 6 Rochas Place (denoted as H2) are served by the same water main as H1, the three hydrants (i.e. H1, H2 and H4) combined would provide a flow rate of 900L/min in a best-case scenario. It is noted that in reality, the combined flow rate is likely to be much less as the flow and pressure would reduce significantly as additional hydrants are opened. Therefore, when comparing the water flow available with the requirement of SNZ PAS 4509, the shortfall is noted to be 600L/min at least.

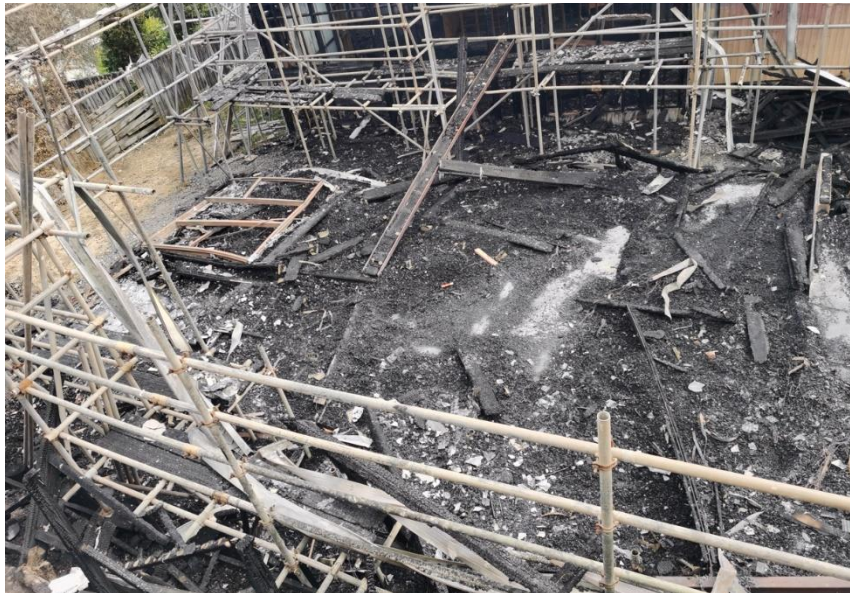
The three dwellings on site are generally comprised of timber framing, timber subfloor and cladded with weatherboard type of façade. In Dwelling 3, the roof, subfloor, and majority supporting structure collapsed, combustible internal partitions and external facade were entirely consumed. The top floor of dwelling 2 was also extensively damaged by fire, including majority section of the roof and upper floor façade burnt through.

The extent of damage to dwelling 2 and 3 (as shown in the figures below) was generally in line with expectation given the type of structure and the severity of the fire. Refer to Appendix A for more details.

*Figure 6: The extent of damage to Dwelling 3 – Overlook from South*

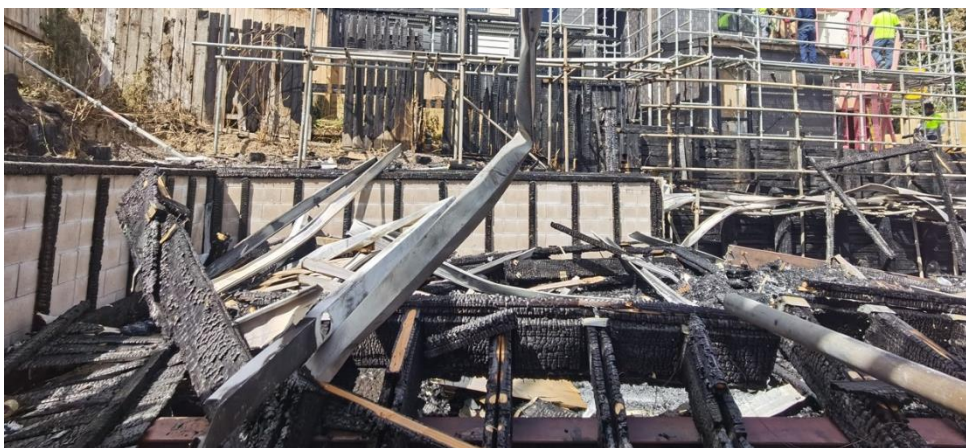
*Figure 7: The extent of damage to Dwelling 3 – View from North (entry access way)*

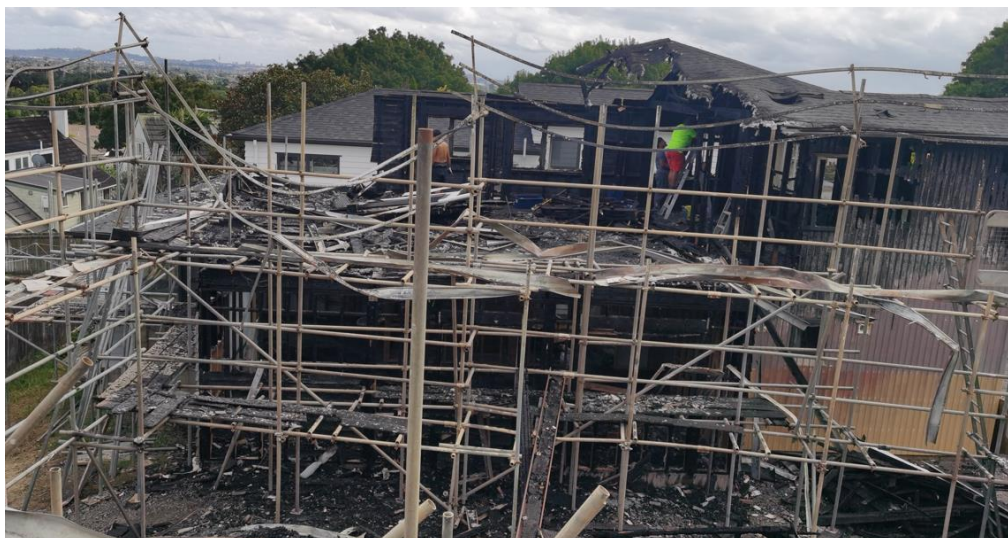
*Figure 8: The extent of damage to Dwelling 2 – Overlook from South*

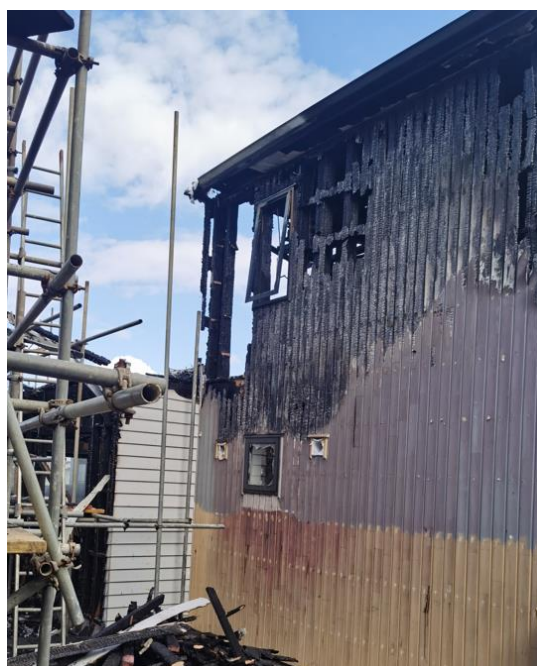
*Figure 9: Partial northern external wall of Dwelling 2 – View from Dwelling 3*

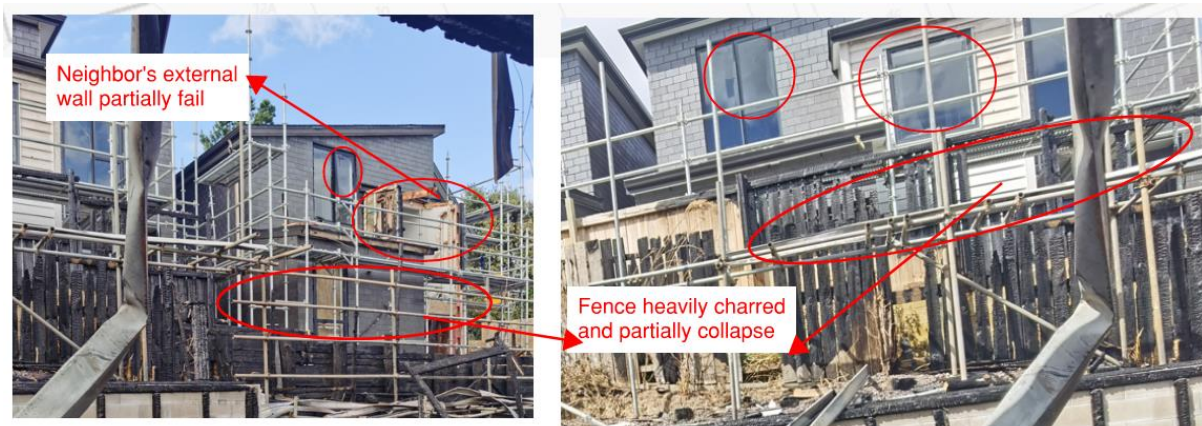
The fire in the dwelling 3 spread throughout the building envelope and then into the neighbouring Redoubt Rd properties that backs on the Derrimore Heights site. The neighbouring subdivisions which are also under construction, sustained some fairly severe damage to its boundary fencing, cladding and external glazing. Attending crews indicated that the wind direction was north to south (i.e. from Derrimore site to Redoubt Rd site) on the day of the incident, compounded with other factors such as short separation distance (i.e. 3m) in between, the fire was therefore driven towards the rear neighbouring subdivision, the intense heat and direct flame impingement would have been sufficient to cause fence collapse, glazing fracture and ignition of the external wall. Refer to Figure 10 for details.

Figure 10: Extent of damage neighbouring Redoubt Rd subdivisions at the rear

- It is acknowledged that the fire design complies with C/AS1 in relation to the external fire spread, substantial damage to the rear neighbouring properties (located at 42 Redoubt Road) were observed on site. This suggests that the requirements outlined in Compliance Documentation, i.e. C/AS1 part 5, consisting of a minimum 1m separation distance may not be sufficient to address the control of external fire spread, particularly in situations where firefighters may not be able to readily protect neighbouring properties.

- a. Additional separation distance – When determining the distance to the boundaries during the planning stage, it is recommended to use more sophisticated method (e.g. Calculation or Tabulated values as outlined in C/VM2 4.5 or C/AS2 part 5), to satisfy NZBC C3.6.

- b. Additional fire rated construction – If the distance to the boundary cannot be increased, additional fire rated construction to the external façade could be used to reduce the risk.

- c. Residential sprinkler system, designed to NZS 4517 *Fire sprinkler systems for houses*. Sprinklers have an excellent track record for reducing fire risk as they can react quickly to reduce the heat and flames from a fire.

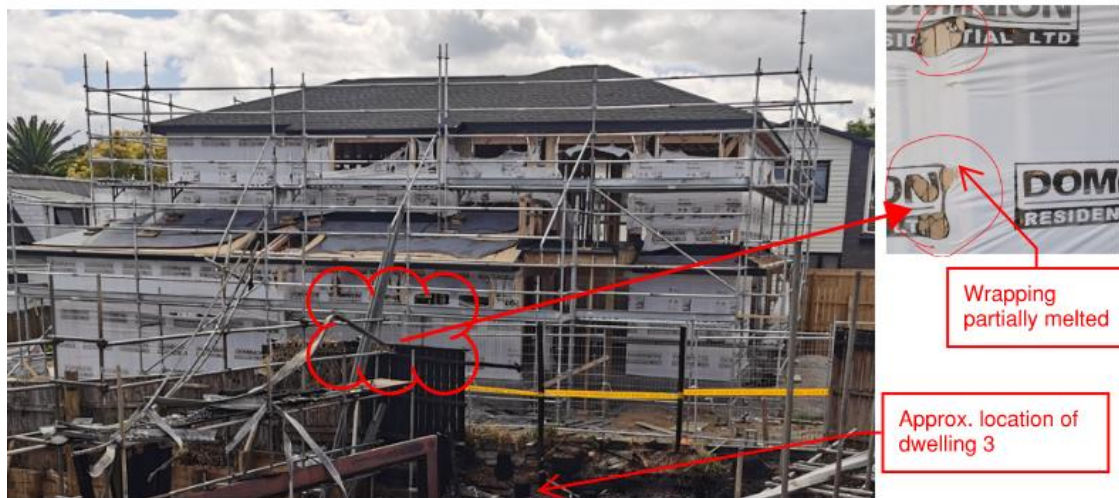
It is also noted that the building to the east of the Derrimore site had very minor damage around the wrapping material around the building envelope, which had partially melted. As part of the that building located approximately 4m away from dwelling 3, the extent of damage was limited by a combination of separation distance, wind direction (driving the fire in the opposite direction) and the action of firefighting crews.

Figure 11: Extent of damage neighbouring properties under construction from the east

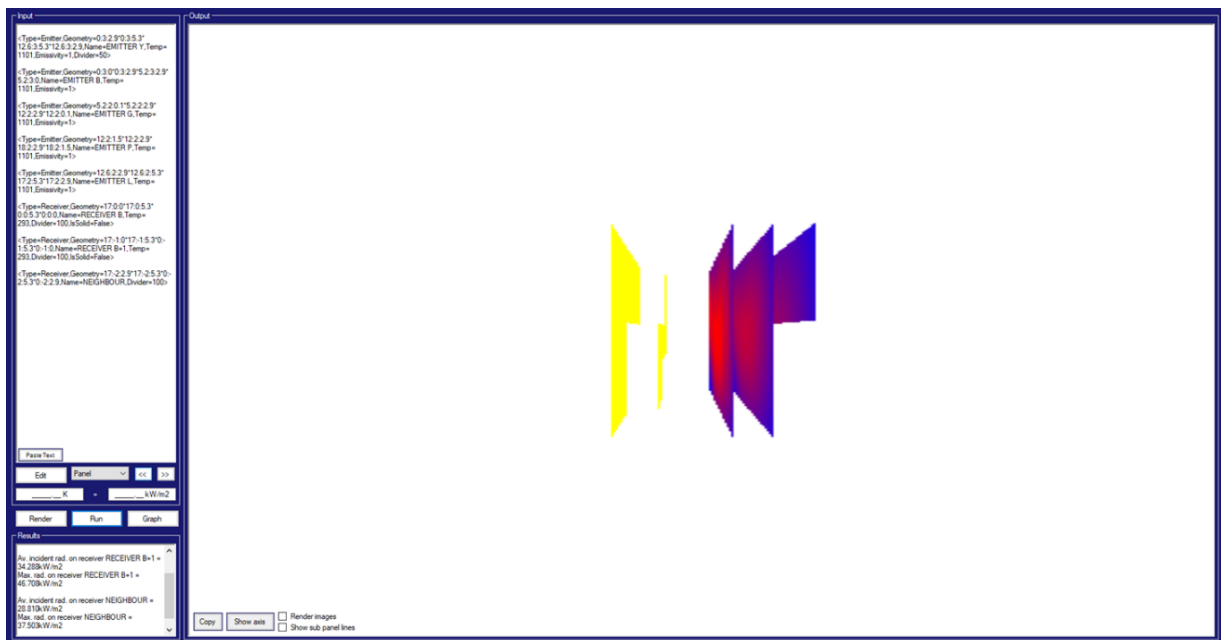
Figure 15: TRA output – snapshot from TRA software

In Figure 15 above, areas shown in red/purple are identified as receivers, whilst areas shown in yellow are emitters. The incident flux at the boundary, 1m beyond the boundary and at the closest façade line of neighbouring building are tabulated in Table 2 below:

It can be concluded that, although the Derrimore development was designed and constructed in compliance with C/AS1, a more thorough assessment of the boundary conditions would not have demonstrated compliance with the Building Code, Clause C3.6.

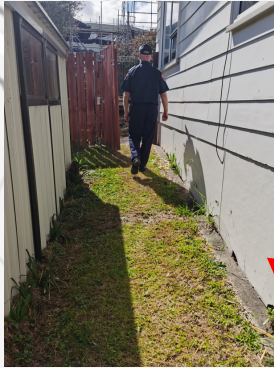
Back of the neighboring residential property (obstruction)

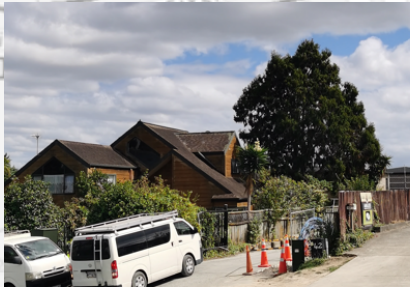
access via other development (under construction) from Redoubt Rd
