3 Ongare

Tauranga Harbour Coastal Erosion Assessment
 Erosion Hazard Overview
 Site 3: Ongare

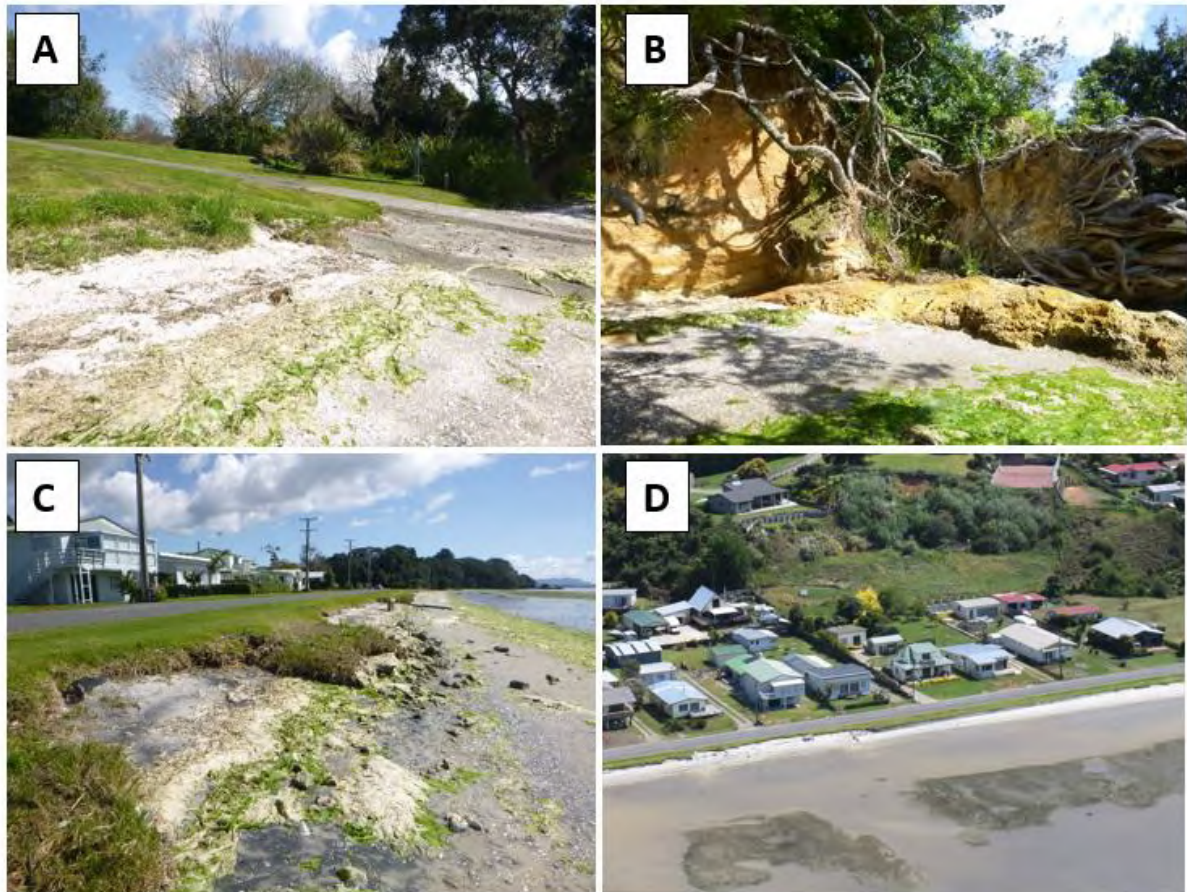
At the northern end is a small boat ramp which extends from the end of Ongare Point Road. Surrounding the boat ramp is unprotected grass shoreline which gradually slopes on to a small, sandy, high-tide beach (Cell 3A) (Figure 3-2A). Within Cell 3B the shoreline is characterised by cliffs, elevated approximately 8 m above RL, with large pohutukawa trees overhanging (Figure 3-2B). South from the cliffs there is a low grass shoreline which runs parallel to Esplanade Road (Cell 3C) (Figure 3-2D). The shoreline lacks a high tide beach and the Esplanade Road sits approximately 400 mm above the high tide water line.

Figure 3-2 Site photos for Ongare. (A) Unconsolidated shoreline (Cell 3A), (B) cliffs with overhanging pohutukawa (Cell 3B), (C) erosion of the grass bank within Cell 3C, (D) aerial view of the unconsolidated shoreline within Cell 3C.

Recent field observations indicate high tide water levels and waves are overtopping and undercutting the grass bank. Wind waves generated from the northeast around to the southeast are likely to contribute to erosion along the Ongare shoreline. Based on a 1.5 km fetch from the northeast, the theoretical significant wave height at Ongare is approximately 0.7 m. Based on model results the short term storm cut is estimated to range from 2 to 5 m.

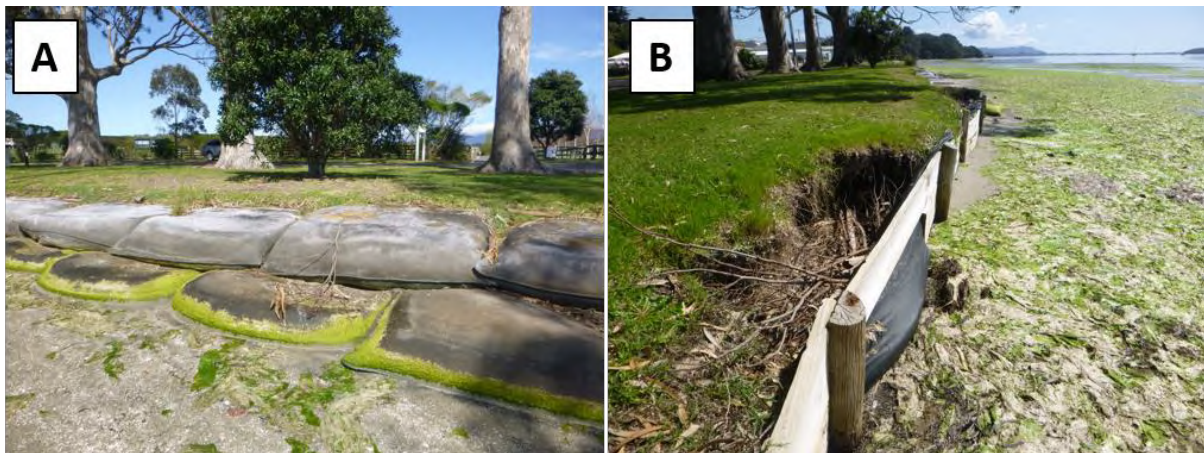
At the southern end of Esplanade Road, the shoreline is protected by a sandbag seawall (Figure 3-3A). Although the seawall is generally in good condition, some of the sandbags have ripped and are in poor condition. Along a short section, south from the end of Esplanade Road, there is an old timber seawall (approximately 0.5 to 1 m high) which is in poor condition. There is significant bank erosion behind the structure (Figure 3-3B). The middle section of Esplanade Road also has some patches of rip rap and rock structures, and there is evidence of undercutting of the low grass bank around the structures.

Figure 3-3 Examples of protection structures along the Ongare shoreline. (A) Sandbag seawall (Cell 3C), (B) timber seawall (Cell 3C).

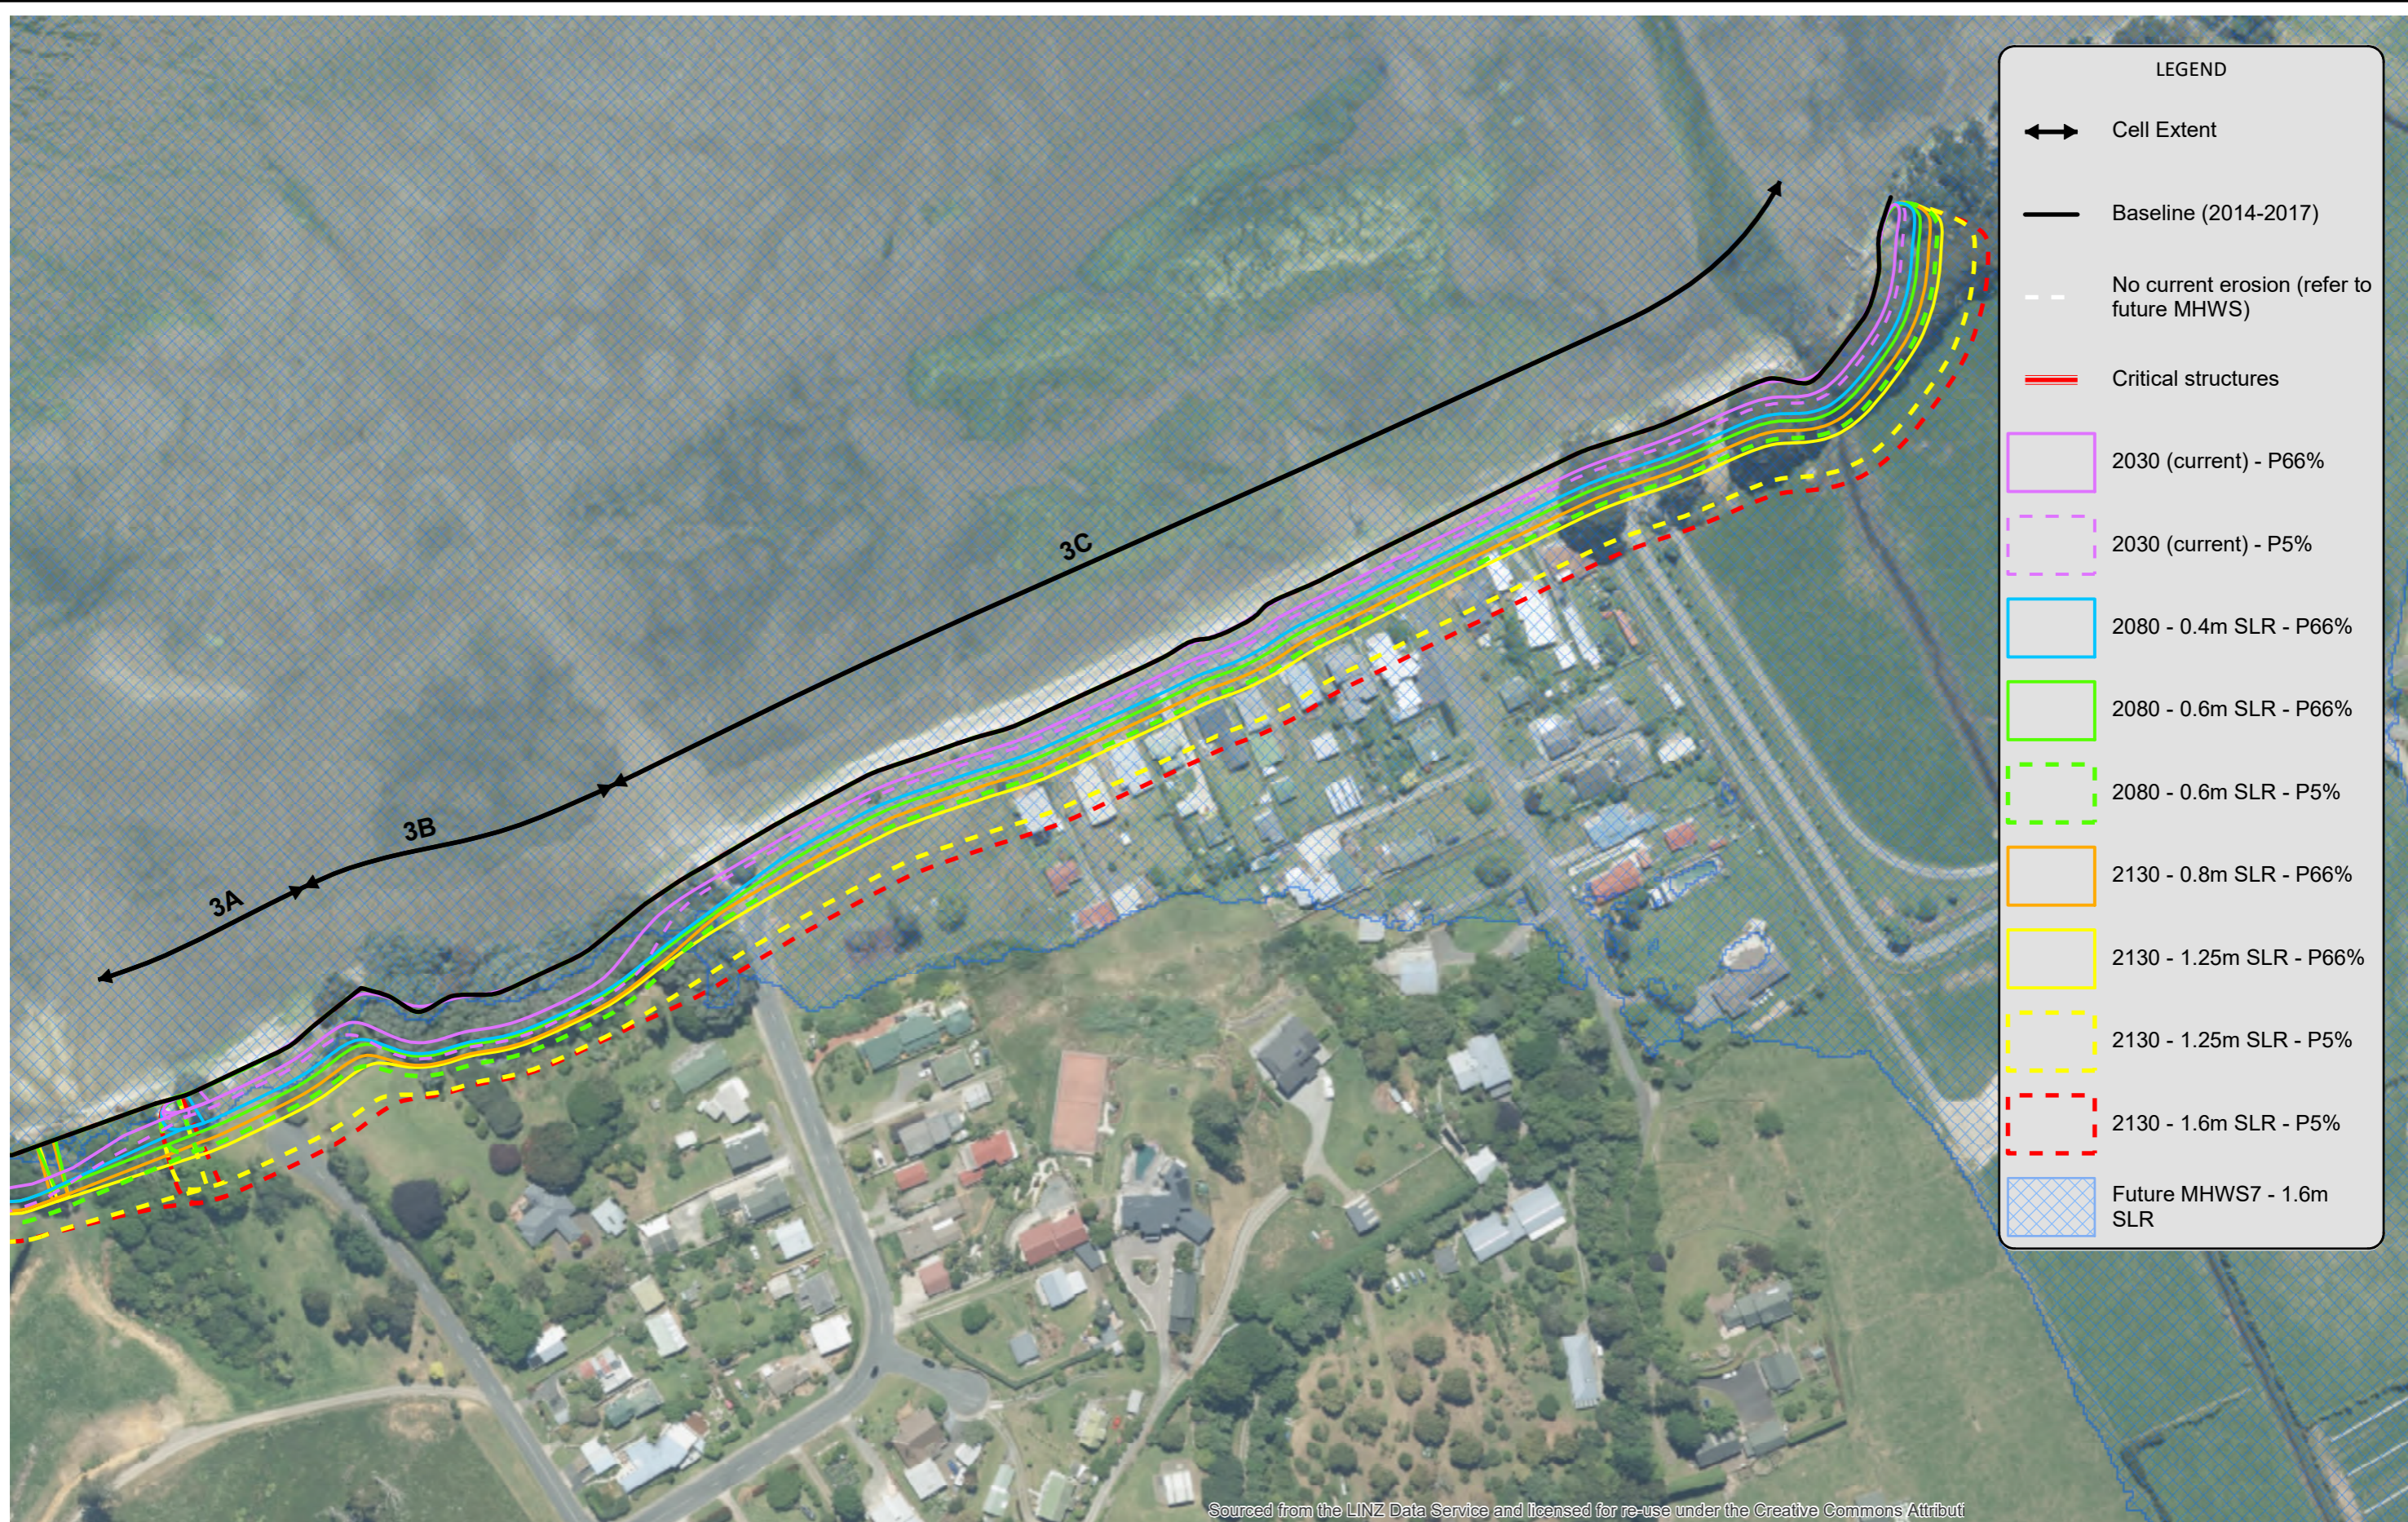
FIGURE No. Figure 3-4

The current P_{66%} erosion hazard ranges from -5 m for the beaches to -11 m for the cliffs. For the future erosion hazard, the P_{5%} for 1.6 m SLR in 2130, ranges from -28 m for the cliffs to -35 m for the unconsolidated beaches.
