# Minden Rural 3 Zone Structure Plan Geotechnical Appraisal

Prepared for Western Bay of Plenty District Council (Client)

By Beca Carter Hollings & Ferner Ltd (Beca)

31 August 2009

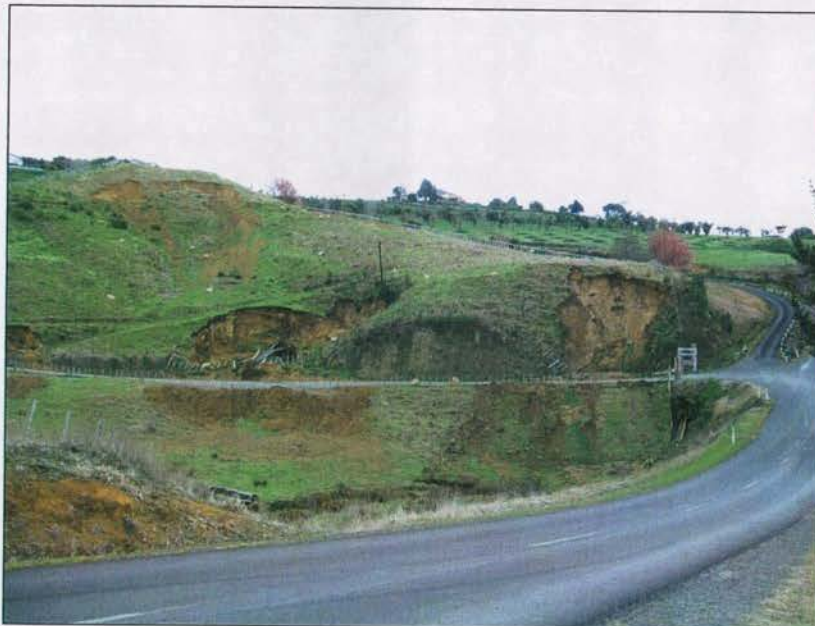
Evidence of historic and recent instability was found to be widespread across the site. Active deep seated movement was found on slopes steeper than about 1V:2.5H (20 to 22 degrees). Shallow movement (e.g. creep) was observed on slopes steeper than 16 degrees. Much of this instability appears to be shallow seated and may be restricted to the ash deposits that mantle the slopes sliding over the weaker soils below. Many areas of recent instability were observed to be associated with saturation following heavy rainfall, surface water flows and significantly, changes in land form, e.g. cutting (see Photo 1). Localised erosion was also noted.

**Photo 1: Recent slips adjacent road cut into existing slope following a period of heavy rainfall**

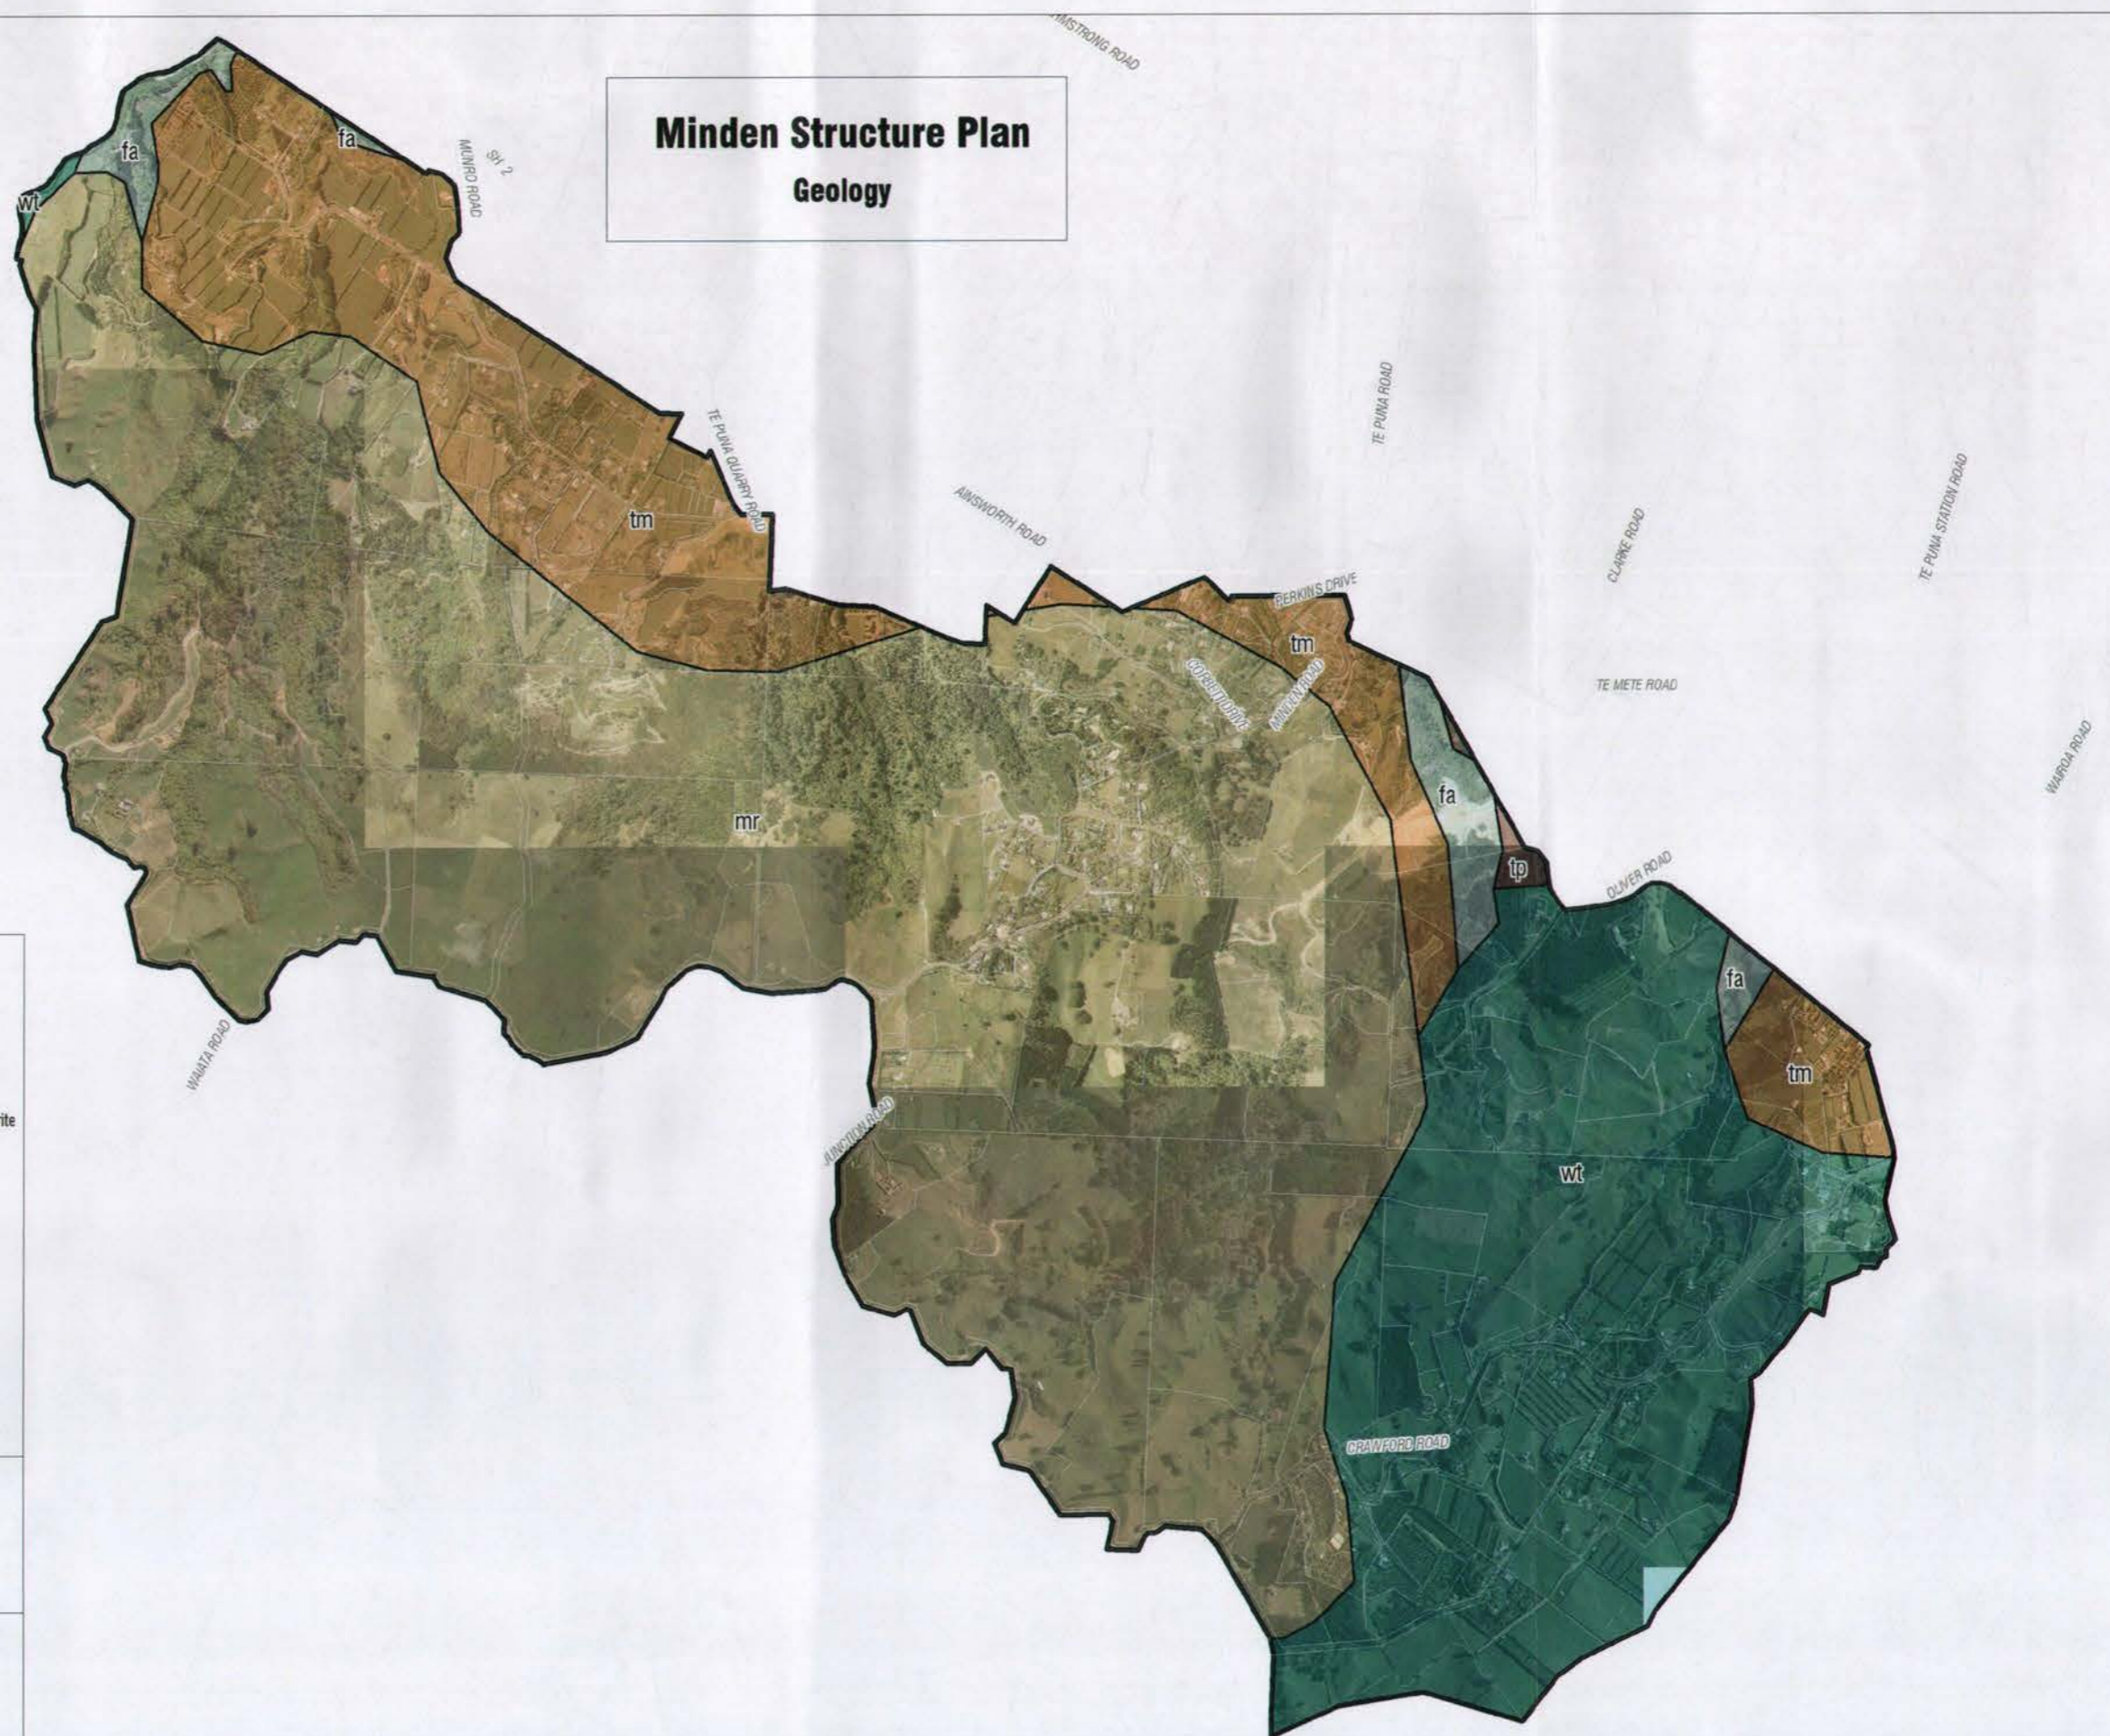
Figure 1

The published geology for the site (after Briggs, *et al*, 1996) is shown on Figure 1.

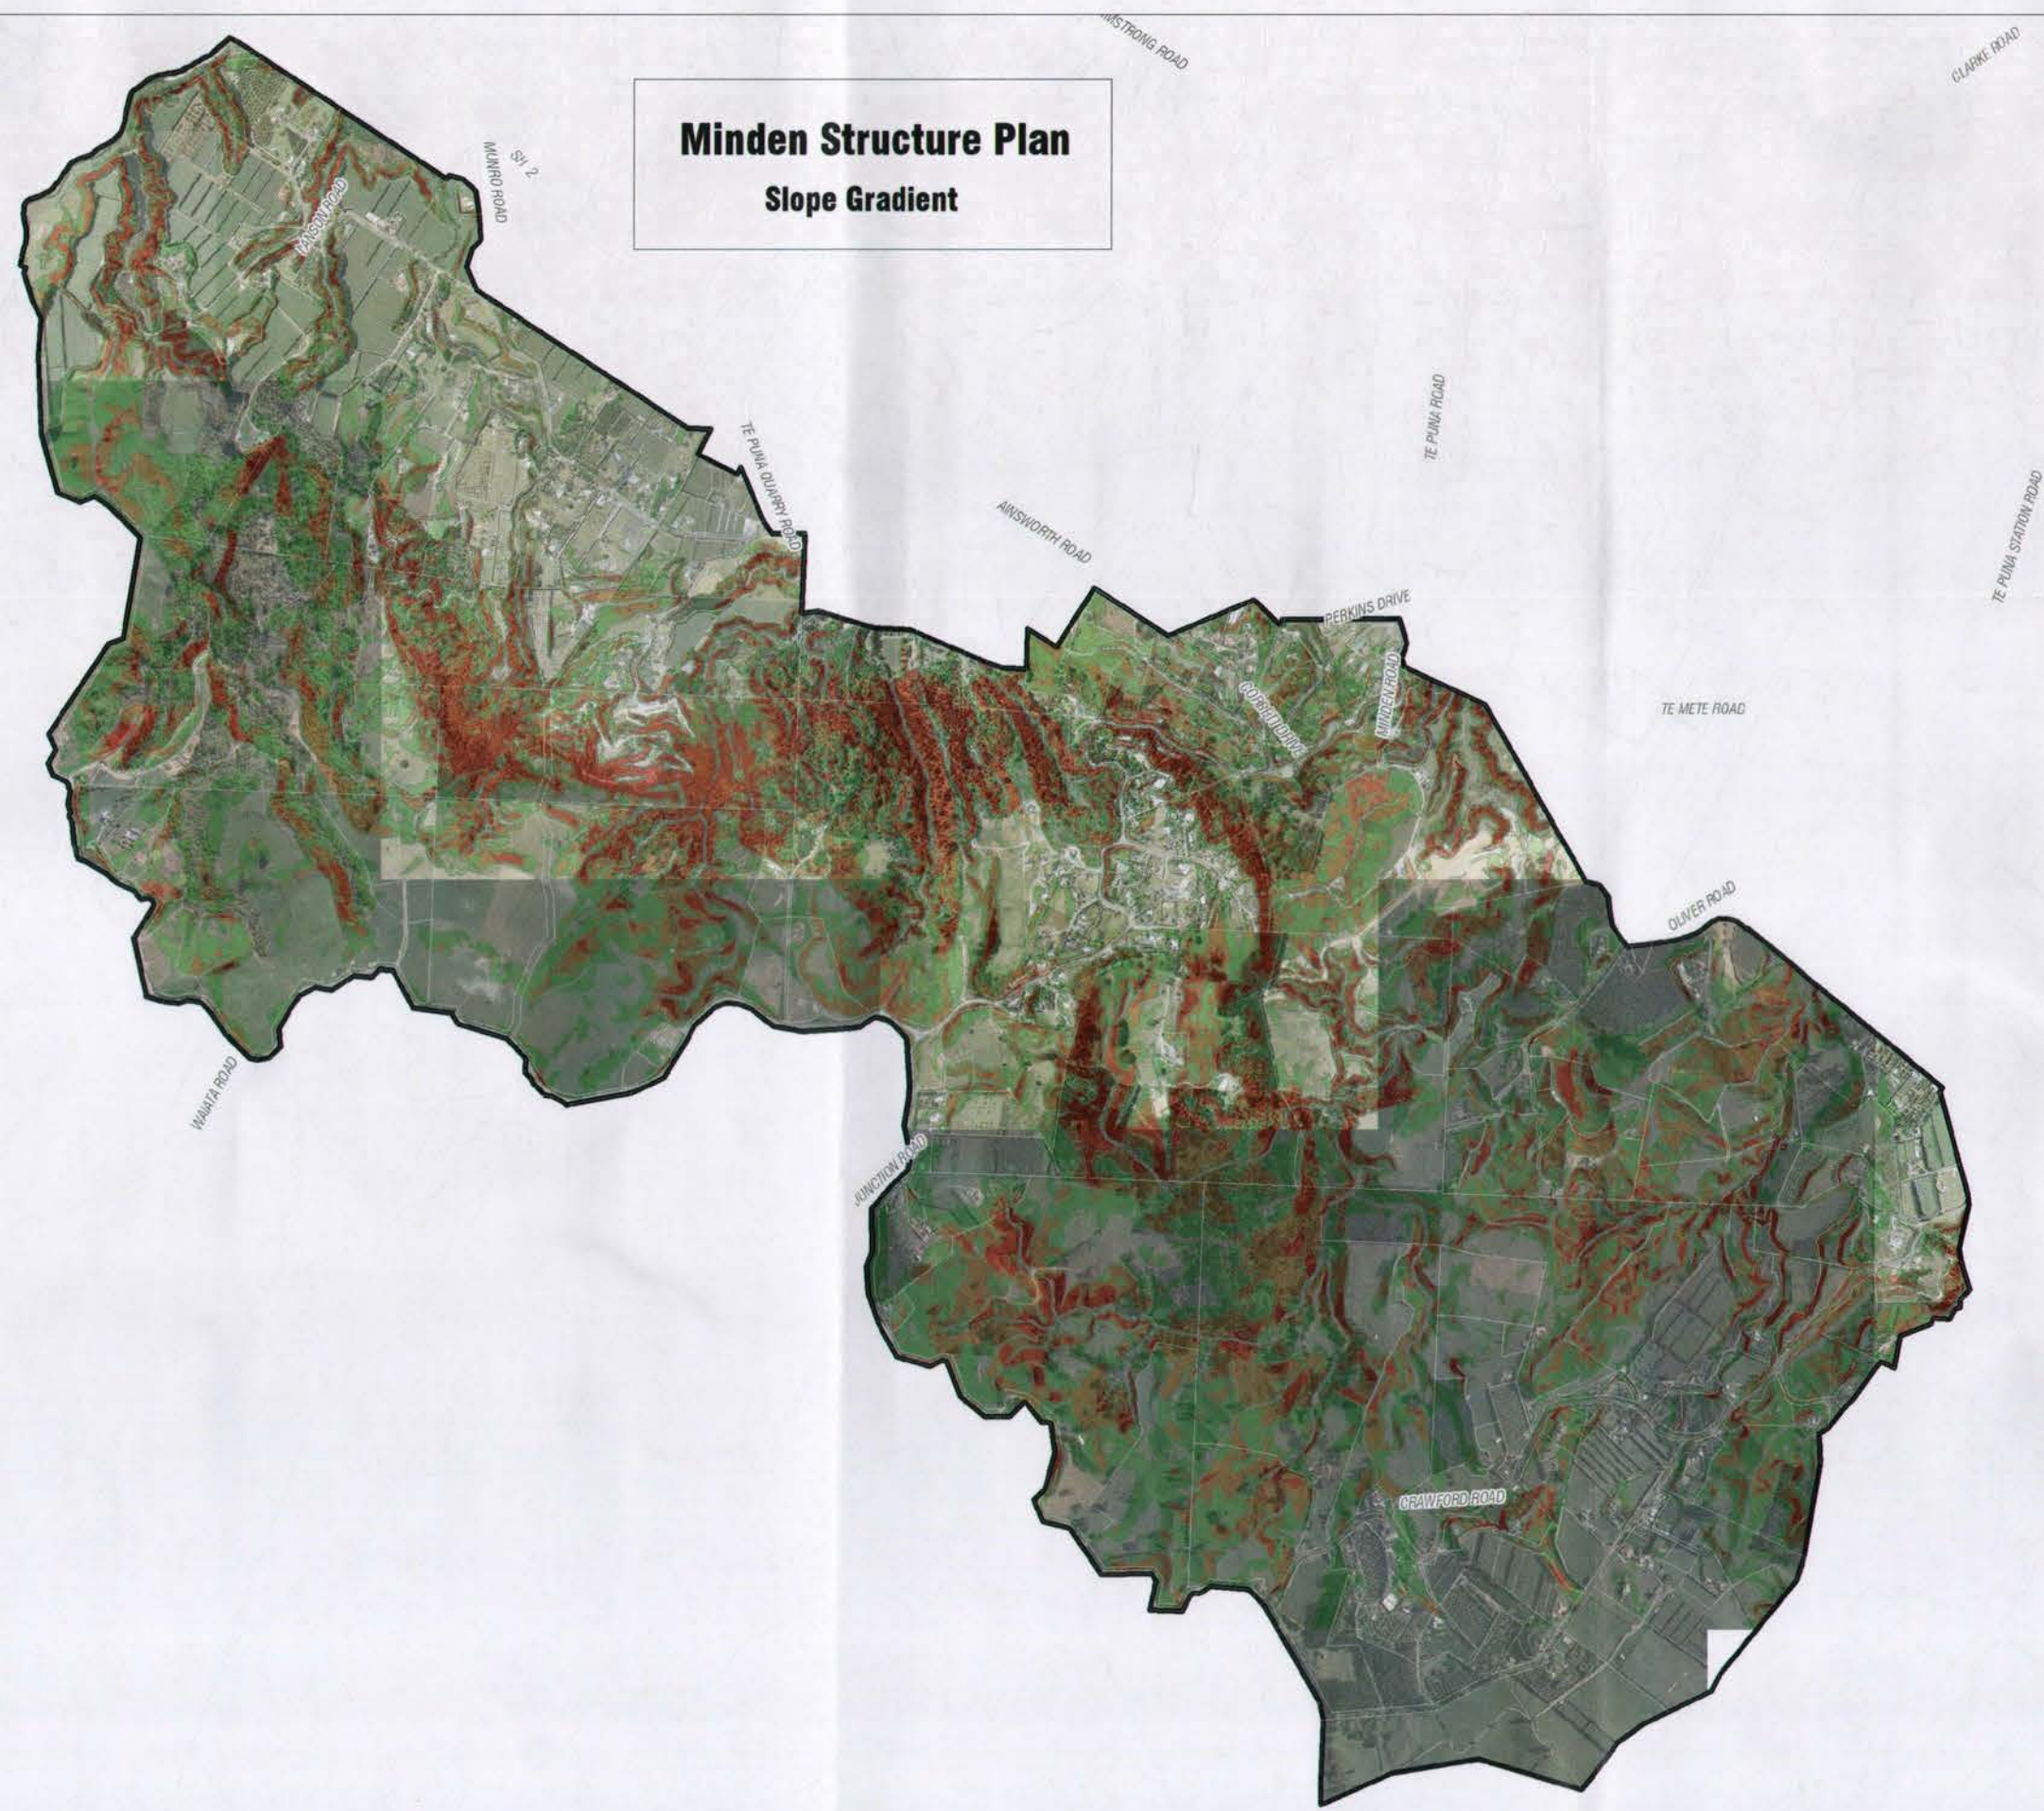
Figure 2

The topography and contour information for this site can be seen on Figures 1 and 2 appended to this report. The existing Minden rural residential zone lies at the centre of the Rural 3 Zone and is mostly clustered around Minden Road.

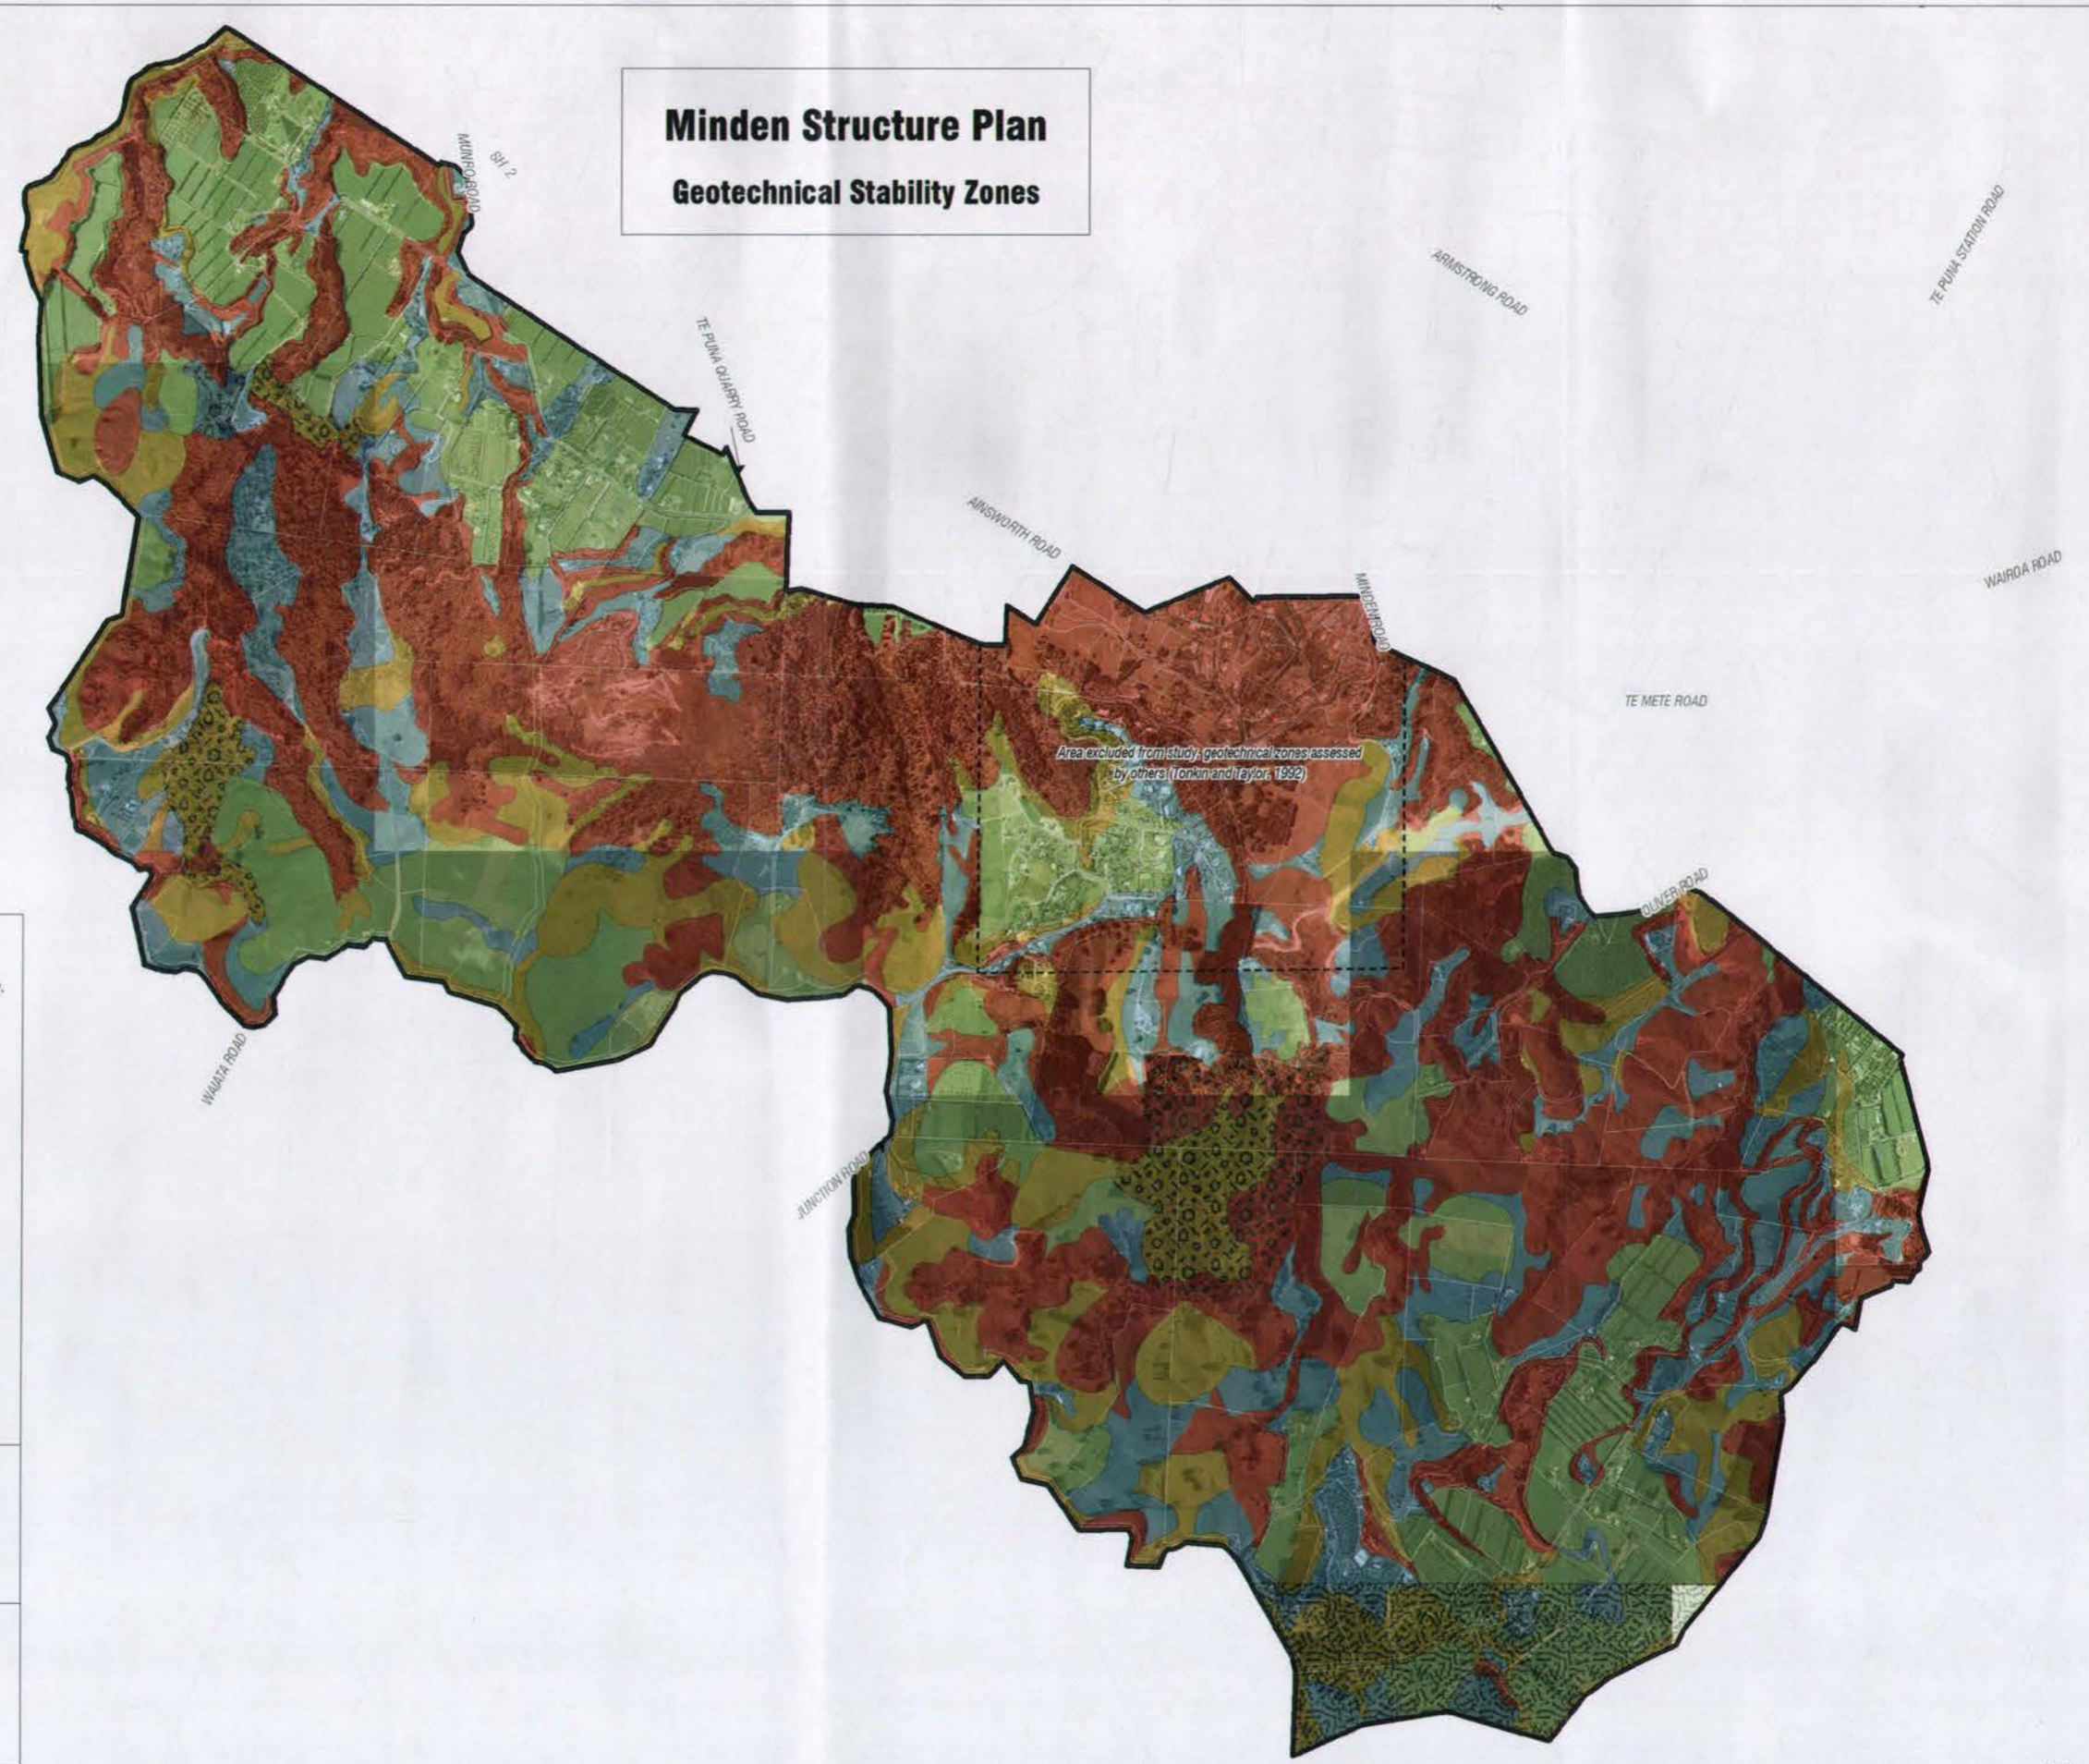
We have developed a Stability Risk Zone plan based on the published geology combined with the slope gradients across the Minden Rural 3 Zone. This is shown on Figure 3. In developing the plan, for ease of referral, we have applied the existing Minden residential rural Stability Zones A, B1, B2 and C (Tonkin & Taylor, 1992) to the wider Minden Rural 3 Zone. The Stability Zones are described as follows:

The geotechnical zone maps have been produced at broad scale (1:20,000) with boundaries having an estimated accuracy of  $\pm 20\text{m}$ . In some areas topographic data was either not available or limited by the thick bush cover. Similarly bush cover limits aerial assessment of slope instability. Areas that have these limitations are shown on the map (Figure 3).

We recommend that these geotechnical zones are used as a guide only, with each site requiring further and more detailed geotechnical assessment at the subdivision stage.

Development within the Minden Rural 3 Zone should be guided by the Stability Zoning plan provided in Figure 3 to this report. Whilst we have identified a number of areas which are not well suited to development, there are a number of locations which may be more suited such as the elevated plateaus in the southwest of the site and the wide terraces to the northwest and south east.
