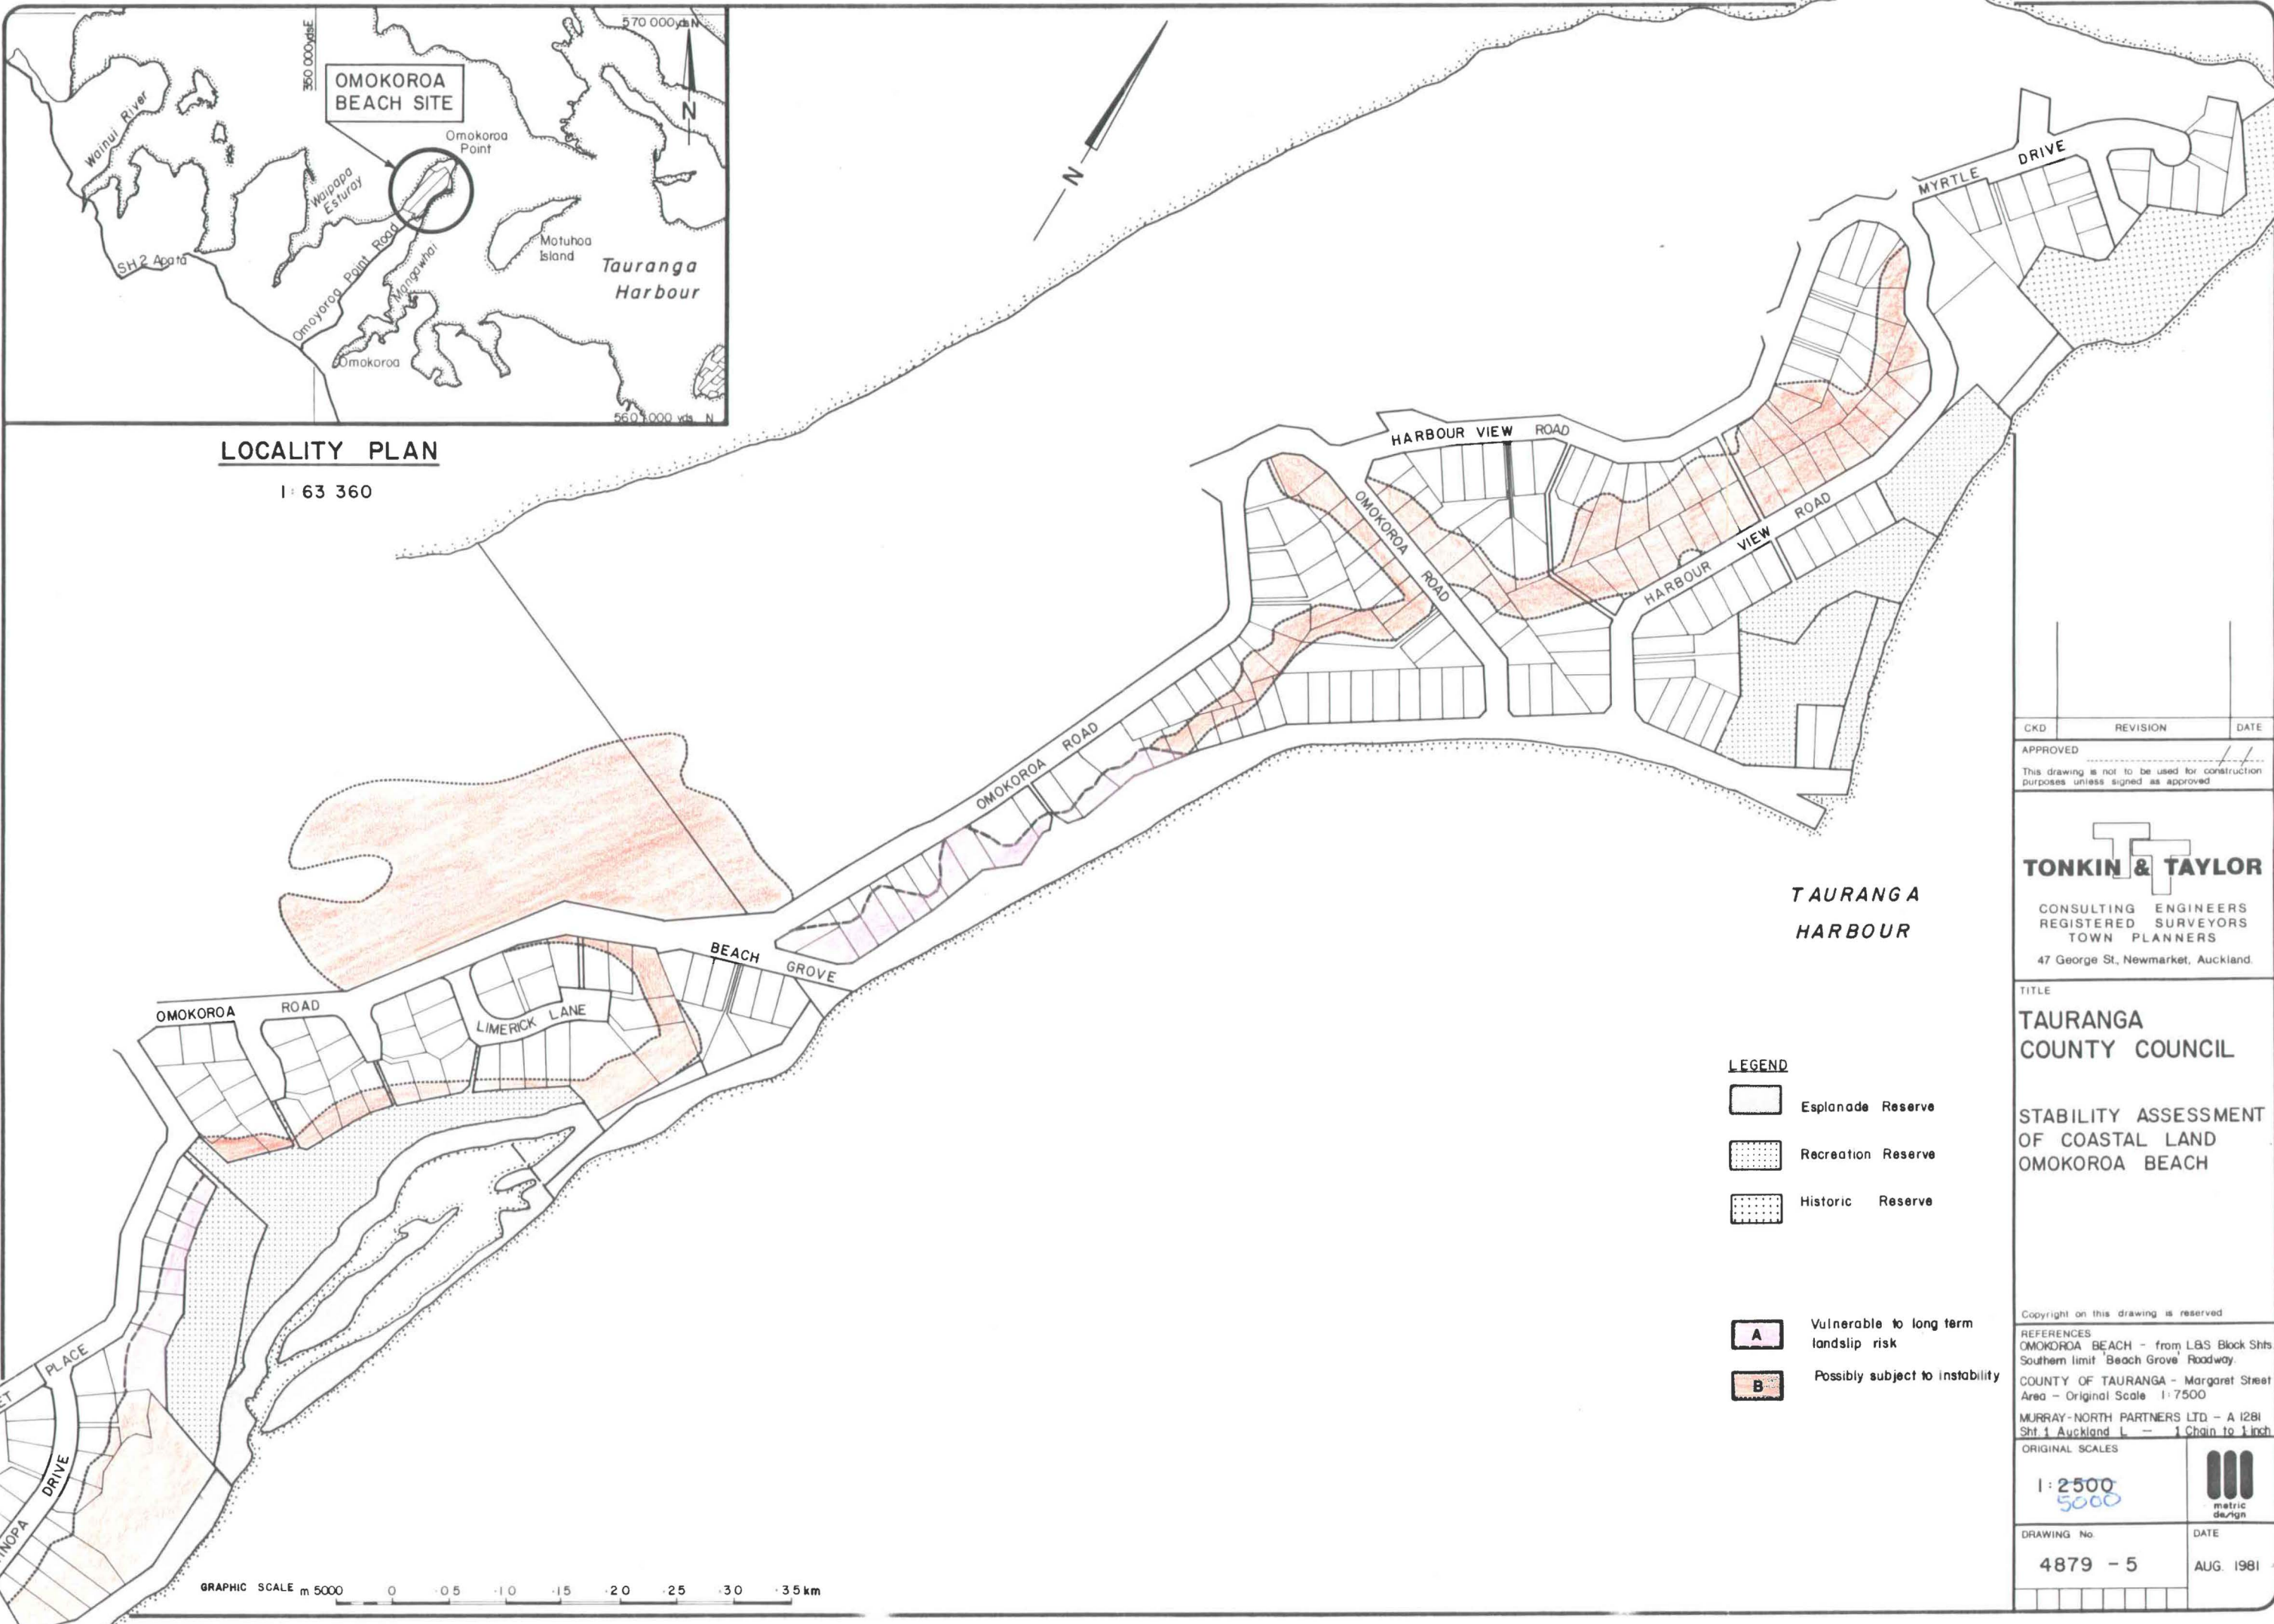
ORIGINAL SCALES 1: 2500 5000	
DRAWING No. 4879 - 5	DATE AUG. 1981

The section of coastal land examined is the cliffed coastal margin along the eastern margin of the Omokoroa Peninsula, shown on Drawing 4879-5. We have previously undertaken an investigation of the western and north-eastern coastal margin (Tonkin and Taylor Report 4487/2) and an area of elevated land to the east of Margaret Place (Tonkin and Taylor Report 4487/1).

With the exception of a 100 m section north of the end of Beach Grove, the coastal cliffs are now relic and no longer subject to active coastal erosion processes at the base of the cliffs. The cliffs on the eastern margin do not therefore appear to be actively eroding at the base, although backwearing at the cliff top is apparent.

From cliff exposures and from borehole information the area appears to be comprised of younger ashes overlying older ashes, in turn underlain by sediments (Tauranga beds), these beds being evident in the tidal/wave zone north of Beach Grove. Prior slope failure is evident along most of the eastern margin, although most of these landslips appear to be relatively old (compared to those on the western margin). However, some minor recent slope failures are evident, in particular on slopes where the vegetation has been removed.

The relic coastal cliffed areas, and inland areas which appear to be of marginal stability, are delineated B. North of Beach Grove, where active erosion is evident at the base of the slopes, the area is delineated A. An area of land off Margaret Place, although a relic coastal cliff, is also delineated A as recommended in the light of our detailed investigation.

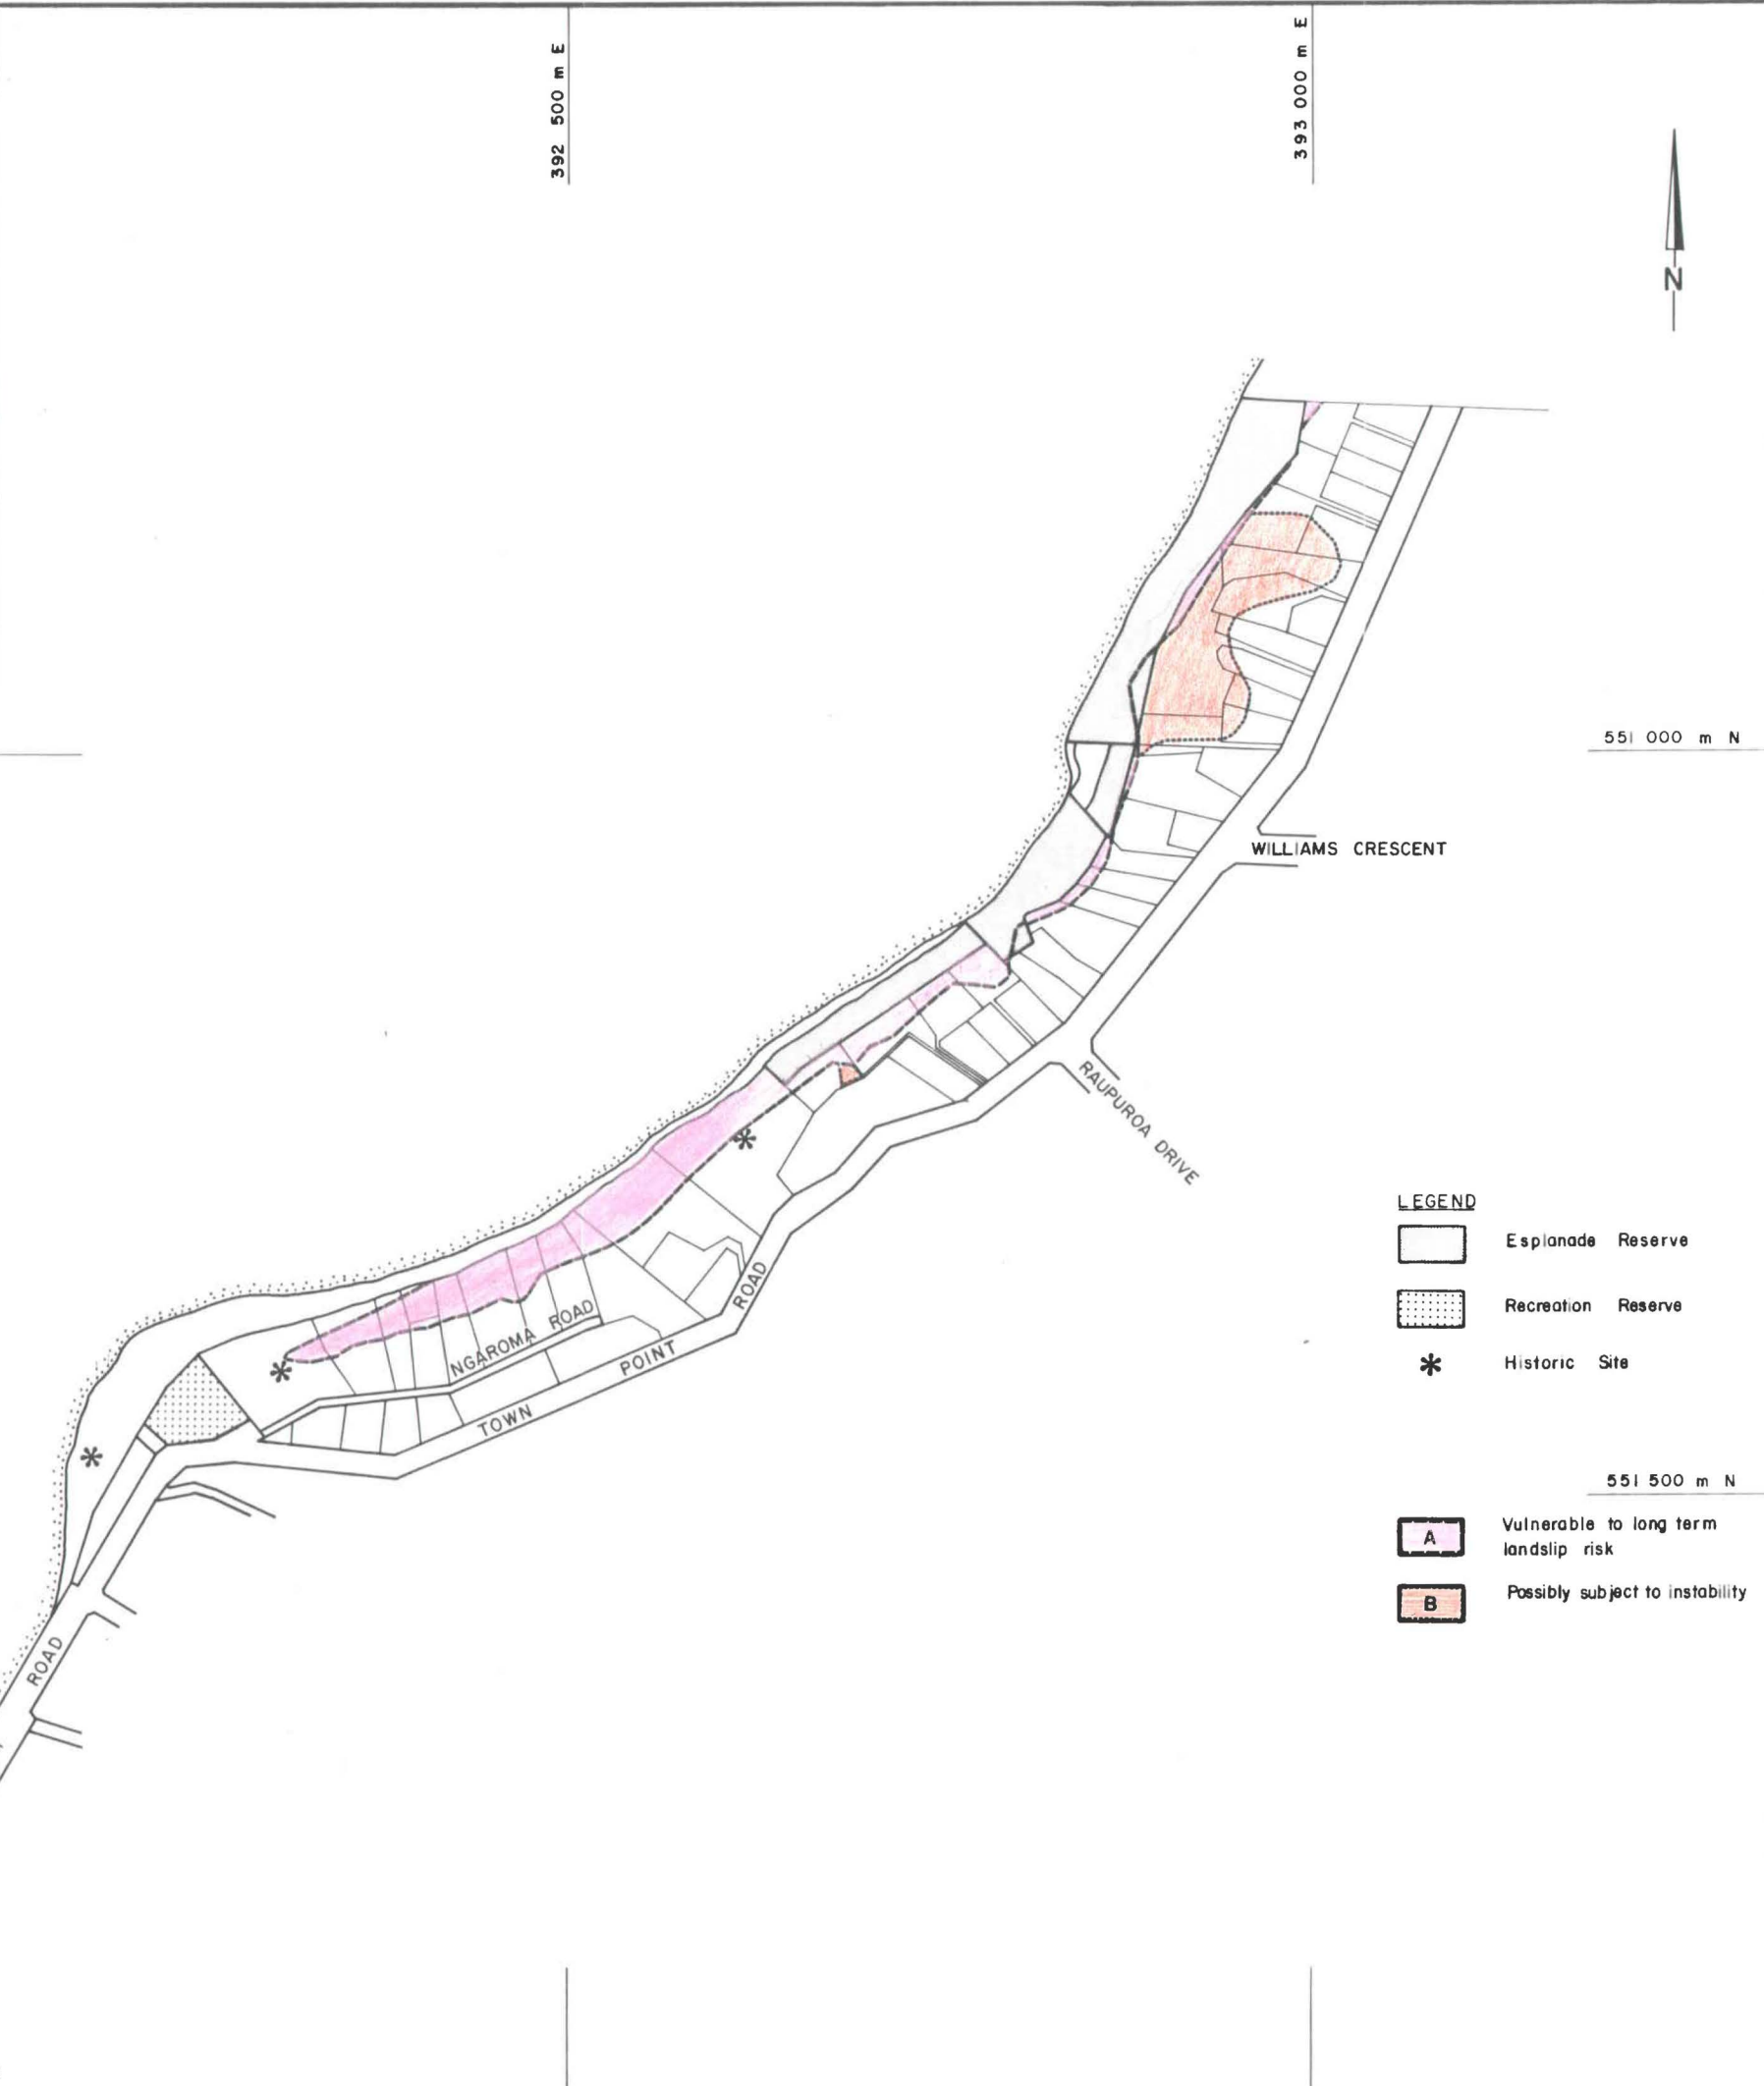
The section of coastal land examined is the northwestern cliffed area of the Maketu Peninsula, shown on Drawing 4879-8. The cliff ranges in height from 10 m at the southern end to 20 m at the northern end, and is mainly comprised of 3 to 8 metres of younger ashes (mainly Mangaoni Lapilli and Rotoehu Ash) overlying 1 to 2 m of older ashes, overlying terrestrial sediments which extend to, and below, the tidal/wave zone. These terrestrial sediments appear slightly to moderately resistant to erosion.

Bordering the Pacific Ocean the coastline is largely unprotected from waves. From comparison of vertical aerial photographs (1943 to 1978) and survey measurements (1932 to 1981) it is apparent that, contrary to popular belief, this particular section of coastline is essentially static, with little regression of the cliff base or backwearing of the cliff top evident over the past 30-50 years. This conclusion is also supported by long term local knowledge.

In general the cliff top is also the ridge top and thus there is little surface catchment area above the cliffs. On the section of coastline examined minor localised slope failures are evident. Where landsliding has occurred it appears that induced groundwater seepage, together with undercutting or removal of lateral support, has been a contributing factor. Seepage is evident at the younger ashes/older ashes interface and in particular where coarse permeable sands and silts (apparently Lower Rotoehu Ash) overlie considerably less permeable clay (older ashes and paleosols) a feature generally absent south of Rauporoa Road. This seepage appears to have caused erosion and minor slipping, with the result that localised regression has occurred. Continual erosion at the base of the cliffs will probably also inevitably lead to both localised and more general instability in the future.

However, factors appear to be such that we consider major deep seated slope failure is unlikely to occur. Accordingly the cliffed coastal areas are delineated A, with upslope gully areas delineated B.
