6 Motuhua Island

Tauranga Harbour Coastal Erosion Assessment

Erosion Hazard Overview

Site 6: Motuhoa Island

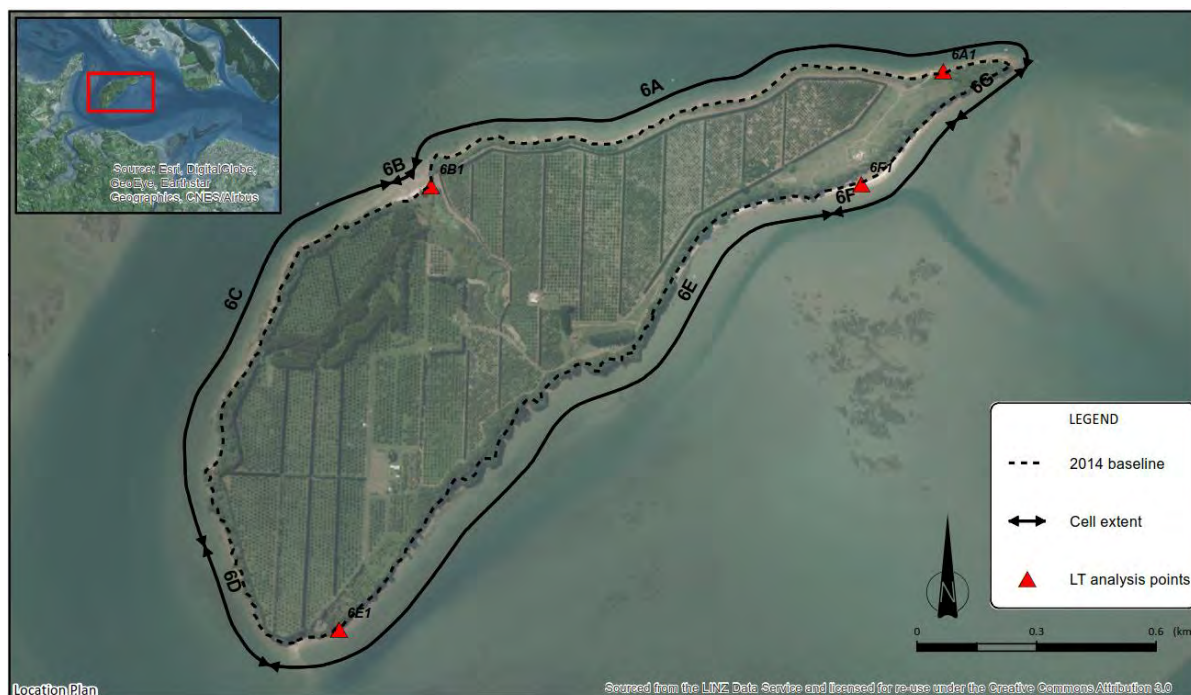
Figure 6-1 Location and cell extent for the Motuhua Island shoreline within Tauranga Harbour.

Motuhua Island is located in the middle section of Tauranga Harbour, approximately 1.5 km south-east from Omokoroa Peninsula. The island is characterised by approximately 5 km of cliff shoreline and 0.45 km of low-lying, unconsolidated shoreline. The site is split into 8 cells based on differences in morphology, exposure and shoreline elevation (Figure 6-1).

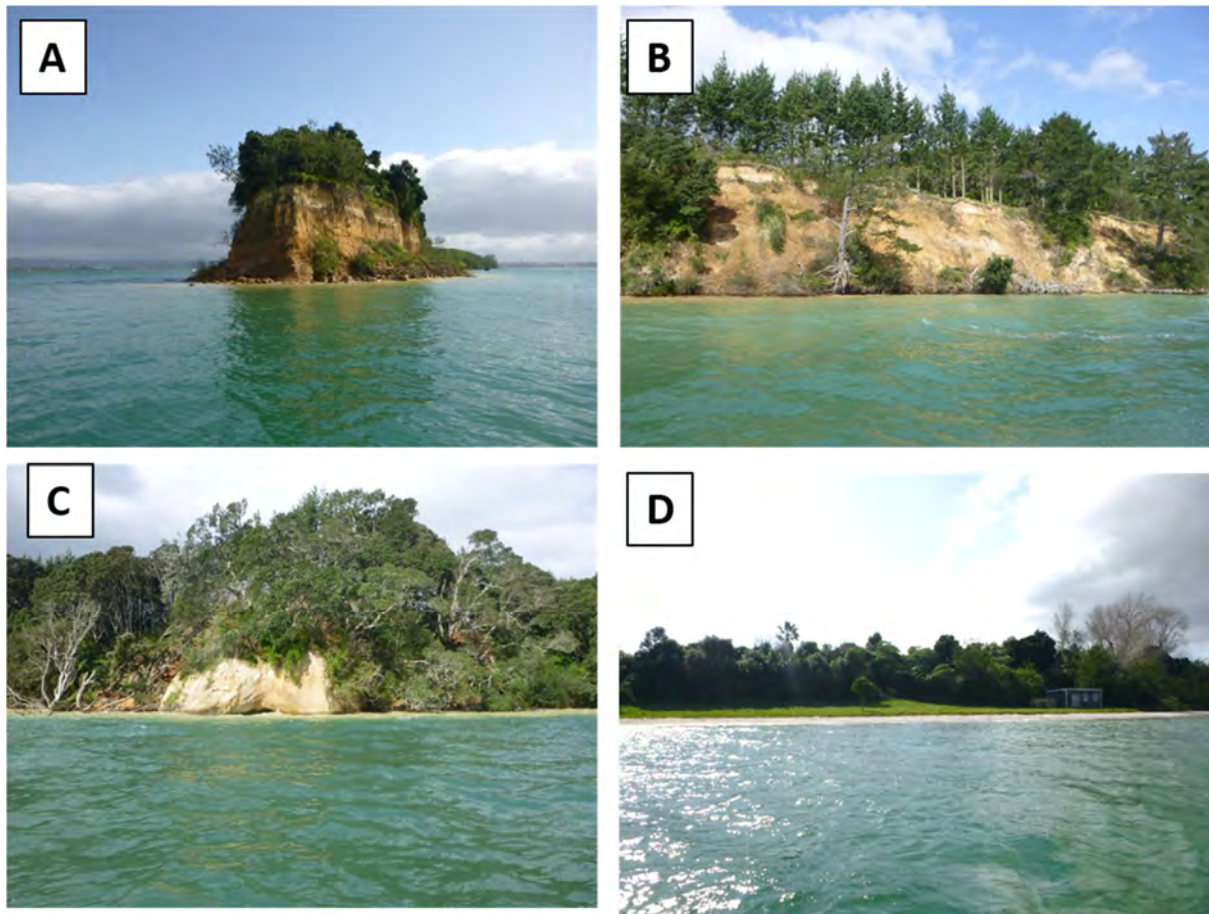
Figure 6-2 Site photos for Motuhua Island. (A) Exposed eastern tip (Cell 6A), (B) exposed northwest-facing cliffs (Cell 6C), (C) well-vegetated cliffs (Cell 6D), (D) low-lying, unconsolidated shoreline (Cell 6F).

Along the northern side of the island (Cell 6A) the cliffs are orientated directly towards the north and range in elevation from RL 8 to 12 m. The average fetch is approximately 8 km from the northwest. The cliffs are very exposed with almost no vegetation on the cliff face (Figure 6-2A). Towards the west (Cell 6B) there is a small section of low-lying, unconsolidated shoreline that gradually rises to a backshore elevation of 2 m to 3 m. The shoreline in this area comprises a small high-tide beach which is backed by a grass area.

Further towards the west is a section of cliffs that gradually wrap around to face the north-west and west (Cell 6C). The cliff elevations range from RL 20 m to 25 m and are mostly vegetated, however there are sections where large slips have occurred (Figure 6-2B). Further south, the cliffs are orientated towards the southwest and are exposed to an average fetch of 1 km. The cliff face is well-vegetated with large pohutakawa trees (Cell 6D) (Figure 6-2C).

At the eastern end of the south-facing shoreline there is an unconsolidated beach (Cell 6F) (Figure 6-2D). The beach has a berm width of approximately 3 m to 6 m above the high-tide line. East from the beach is a small section of southeast-facing cliffs (Cell 6G) which wrap around to the cliffs within Cell 6A. The cliffs have a small amount of vegetation across the cliff face, however similarly to the
