# 1 Bowtown

**Tauranga Harbour Coastal Erosion Assessment**  
 Erosion Hazard Overview  
 Site 1: Bowentown

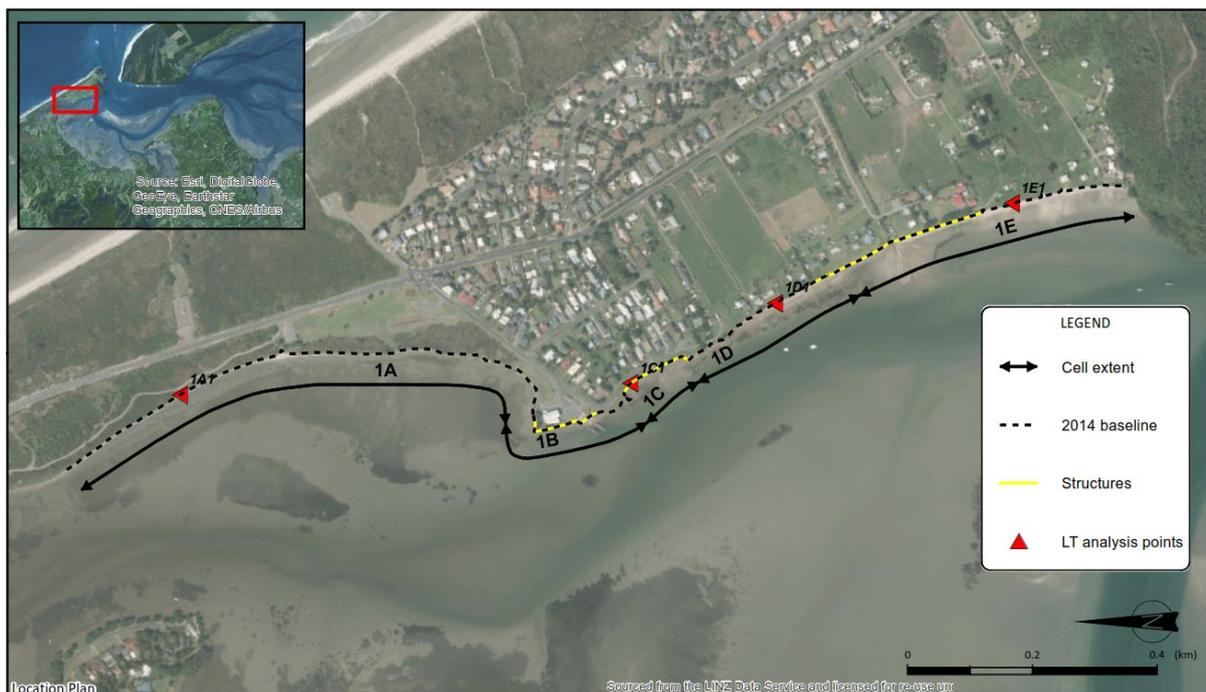
Figure 1-1 Location and cell extent of the Bowtown shoreline within Tauranga Harbour.

The Bowtown shoreline is located in the northern basin of the Tauranga Harbour, approximately 0.75 km north-west from Bowtown Heads. The site consists of approximately 1.4 km of unconsolidated shoreline and 0.4 km of low coastal cliffs. The site is split into 5 cells based on differences in morphology, exposure and shoreline elevation (Figure 1-1).

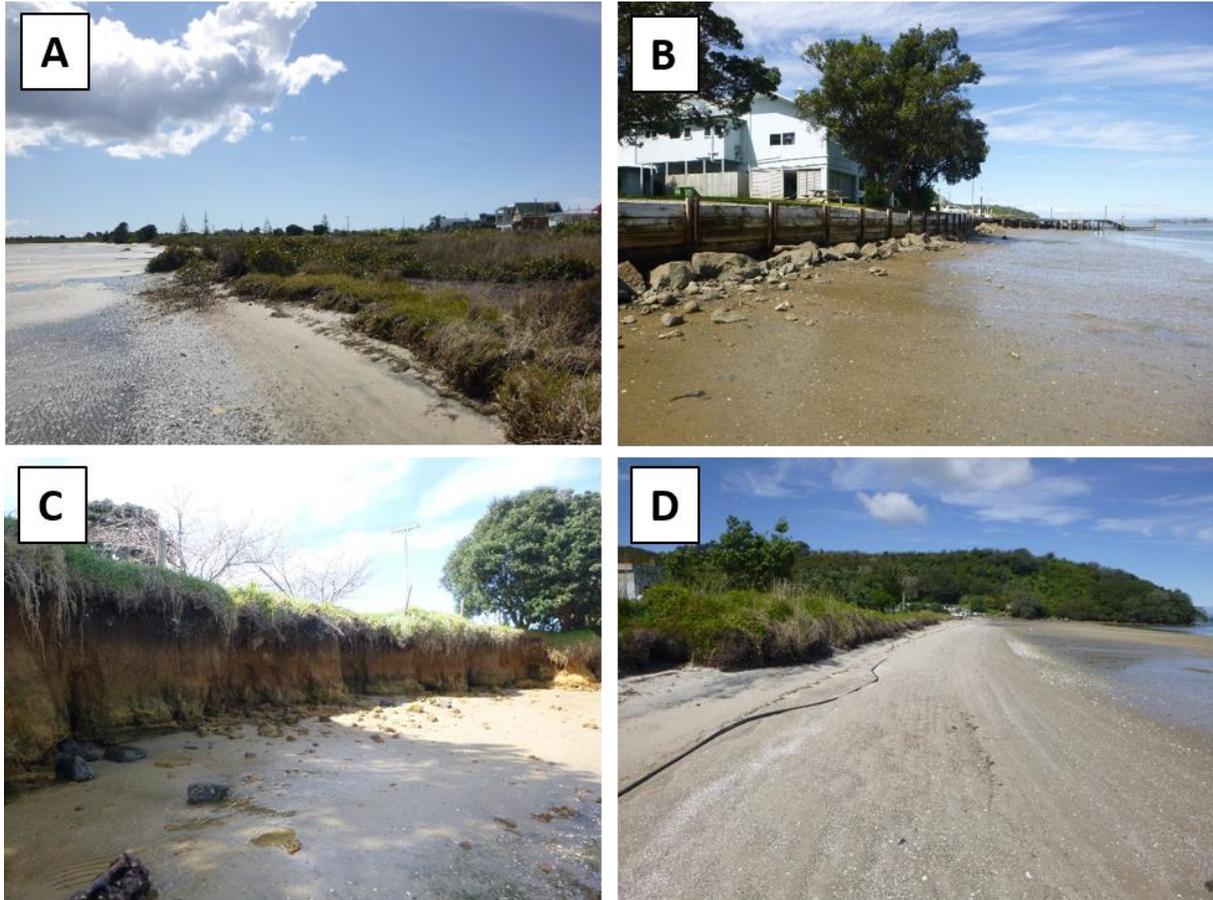
Figure 1-2 Site photos for Bowentown. (A) Unconsolidated shoreline (Cell 1A), (B) Bowentown Boating Club (Cell 1B), (C) west-facing cliffs (Cell 1D), (D) unconsolidated beach (Cell 1E).

Along the northern end, the shoreline is unconsolidated with small patches of mangroves that back onto salt marsh (Cell 1A) (Figure 1-2A). Closer to the Bowtown Boating Club there is a small section of north-facing grass bank that is elevated approximately 2 m above RL (MD-53) and runs along the edge of the grass reserve and the boat club carpark. Along the western side of the boat club the shoreline consists of soft cliff that range in elevation from RL 1.5 to 2 m, with a retaining wall along the entire length (Cell 1B) (Figure 1-2B).

South from the boat ramp is a small embayment that is backed by a grass bank that runs parallel to the end of Pio Road (Cell 1C). South from the end of Pio Road the shoreline topography gradually rises to soft coastal cliff, ranging in elevation from RL 2 to 6.5 m (Cell 1D) (Figure 1-2C). The northern end of the cliff face is exposed but the southern end is well vegetated with shrubs. Along the top of the cliff are several dwellings set back approximately 10 m from the cliff edge. At the southernmost end of Bowtown, the shoreline comprises low-lying, unconsolidated beach sand which gradually slopes up to a small grass bank (Cell 1E) (Figure 1-2D). The backshore elevation is approximately 2 m above RL and comprises of several dwellings, including Otawhiwhi Marae.

The Bowentown shoreline has a range of protection structures, plus the boat ramp in the middle (Cell 1B). Around the Bowentown Boating Club there is a timber seawall, which has been reinforced with steel beams (now very rusty) and rock rip rap along the base (Figure 1-2B). The seawall is approximately 2 m high and protects around 85 m of the shoreline north from the boat ramp. However, the wall does appear to be deteriorating in sections. The low shoreline that runs parallel to the end of Pio Road has approximately 110 m of rock revetment which is around 1 to 1.5 m high (Figure 1-3A). In a couple of sections there is evidence of small bank erosion behind the structure, indicating wave overtopping. While the coastal cliffs within Cell 1D are mostly unprotected, there are sections with rip rap along the base. Along the northern end of Cell 1E there are several seawalls, which vary in height from 0.5 to 1.5 m high (Figure 1-3B). Although some of the seawalls are reasonably well-structured, there is evidence of wave overtopping and bank scour behind the structures

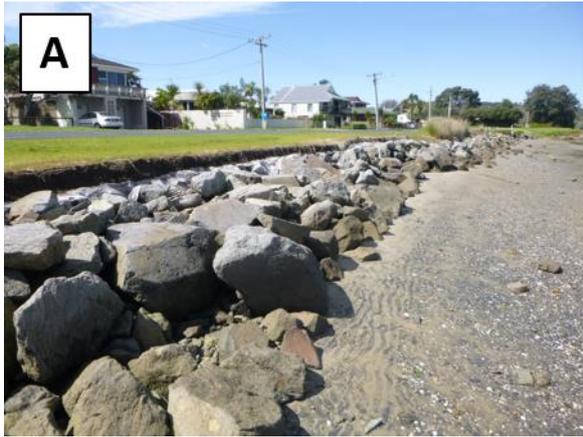
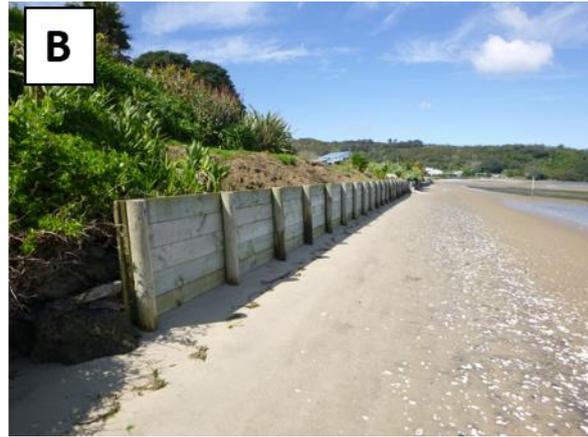
Figure 1-3 Examples of protection structures around the Bowentown shoreline. (A) Revetment along the grass bank (Cell 1C), (B) timber seawall (Cell 1D).
