## 4 Omokoroa

**Tauranga Harbour Coastal Erosion Assessment**  
 Erosion Hazard Overview  
 Site 4: Omokoroa

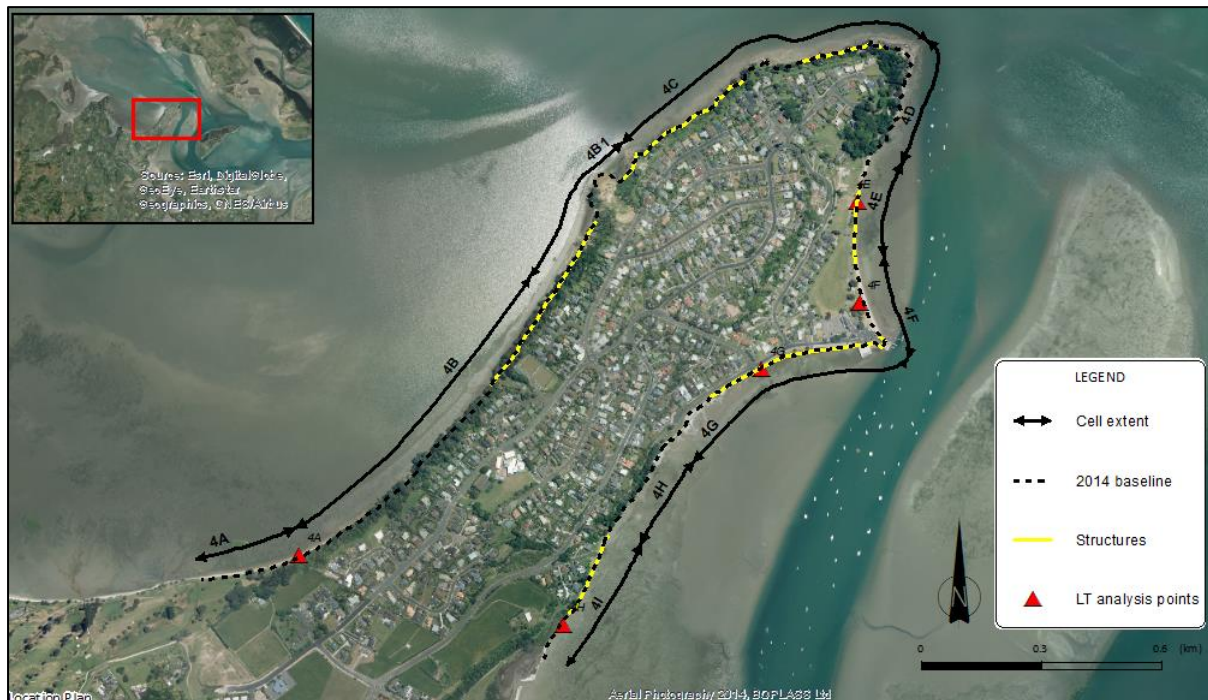
Figure 4-1 Location and cell extent of the Omokoroa shoreline within Tauranga Harbour.

Omokoroa Peninsula is located within the central part of the Tauranga Harbour, just north of Motuhoa Island. The shoreline has approximately 2.5 km of cliffs and approximately 1.5 km of unconsolidated beach shoreline. The site is split into 10 cells based on differences in exposure, morphology, shoreline elevation and long term erosion trends (Figure 4-1).

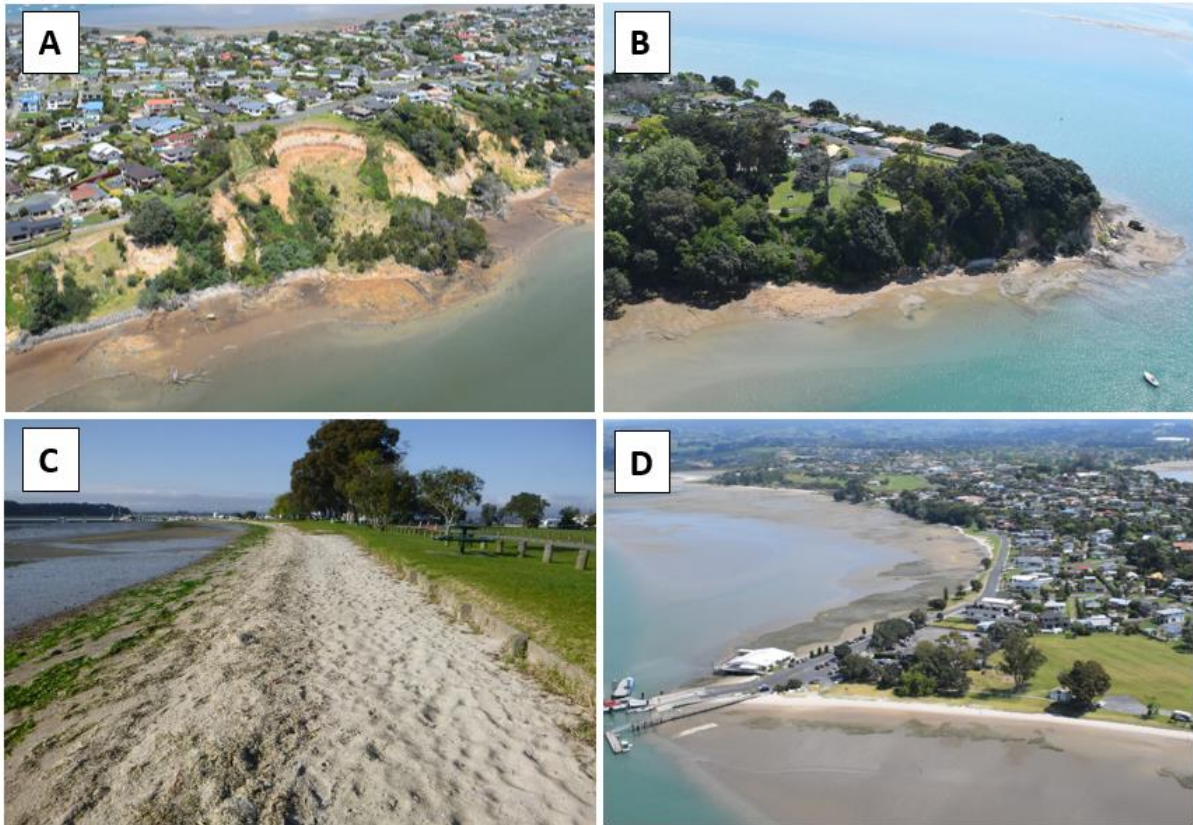
Figure 4-2 Site photos for Omokoroa. (A) Exposed, northeast-facing cliffs (Cell 4C), (B) east-facing cliffs below Gerald Crapp Historic Reserve (Cell 4D), (c) unconsolidated shoreline north from the ferry terminal (Cell 4F), (D) Omokoroa Ferry Terminal (Cells 4F & 4G).

At the north-eastern tip of Omokoroa, below the Gerald Crapp Historic Reserve, the cliffs are 10 m to 15 m high with an eastern aspect (Cell 4D) (Figure 4-2B). Around the north-eastern tip there is a shore platform at the base of the cliff which extends approximately 50 metres into Tauranga Harbour and is exposed at low tide. Due to the proximity of the deep channel that runs between Matakana and Omokoroa, the north-eastern tip of the peninsula is exposed to strong tidal currents.

Between Gerald Crapp Historic Reserve and the Omokoroa Ferry Terminal is a section of low unconsolidated shoreline. The northern end of the unconsolidated shoreline has a narrow high tide beach (Cell 4E), while the southern end has a large high-tide beach which is approximately 4 m wide (Cell 4F) (Figure 4-2C). South of the Omokoroa Ferry Terminal the unconsolidated shoreline has a south to south-east aspect, running parallel with The Esplanade (Cell 4G) (Figure 4-2D). The shoreline is mostly protected by a combination of rock and timber seawalls.
