25 Te Puna Estuary

Tauranga Harbour Coastal Erosion Assessment
 Erosion Hazard Overview
 Site 25: Te Puna Estuary

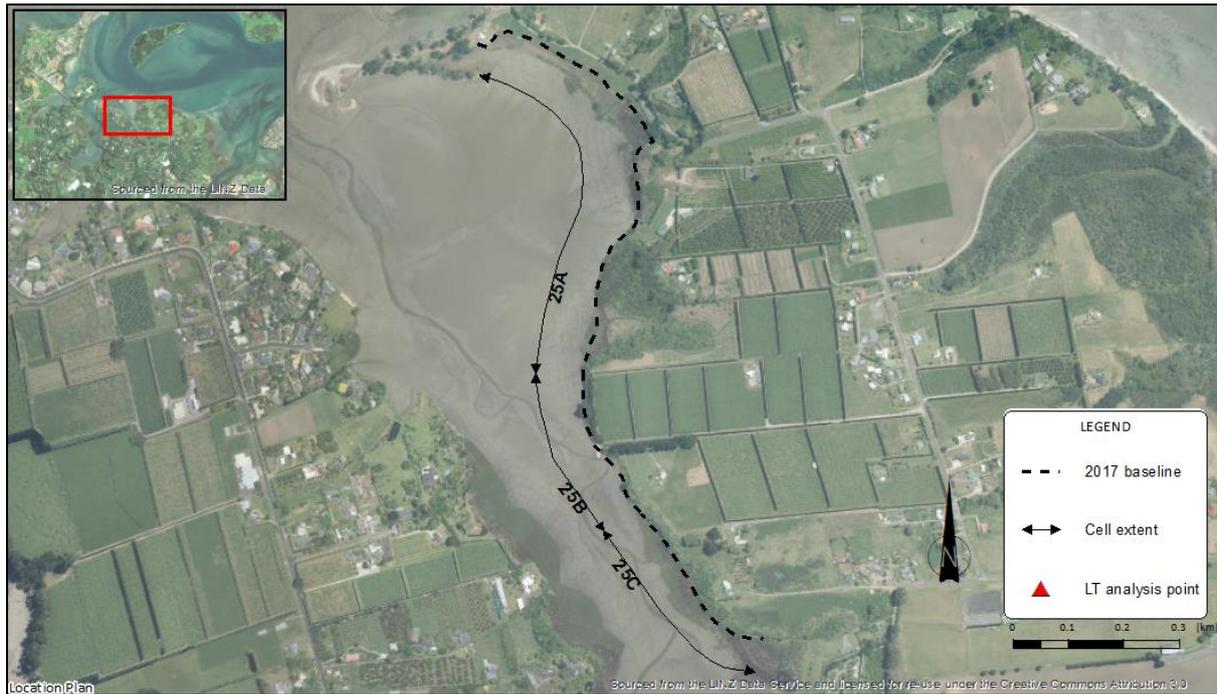
Figure 25-1 Location and cell extent of the Te Puna Estuary shoreline within Tauranga Harbour

The Te Puna Estuary shoreline is located on the western side of Te Puna. The site consists of approximately 0.3 km of consolidated shoreline and 1 km of low-lying estuarine area. The site is split into 3 cells based on differences in morphology, exposure and shoreline elevation (Figure 25-1).

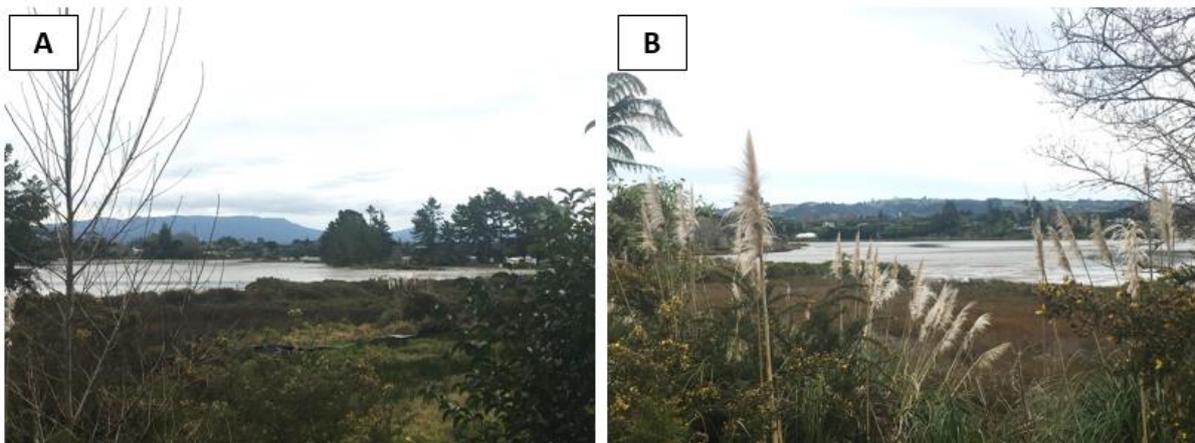
Figure 25-2 Site photos for the Te Puna Estuary shoreline. (A) Low-lying estuarine shoreline at the northern end (Cell 25A), (B) low-lying estuarine shoreline at the southern end (Cell 25B).

The northern and southern extents of the shoreline consists low-lying estuarine area with mangroves and salt marsh vegetation (Cell 25A and Cell 25C). In the middle there is a small section of well-vegetated, west-facing cliff (Cell 25B).
