## 9 Te Puna

**Tauranga Harbour Coastal Erosion Assessment**  
 Erosion Hazard Overview  
 Site 9: Te Puna

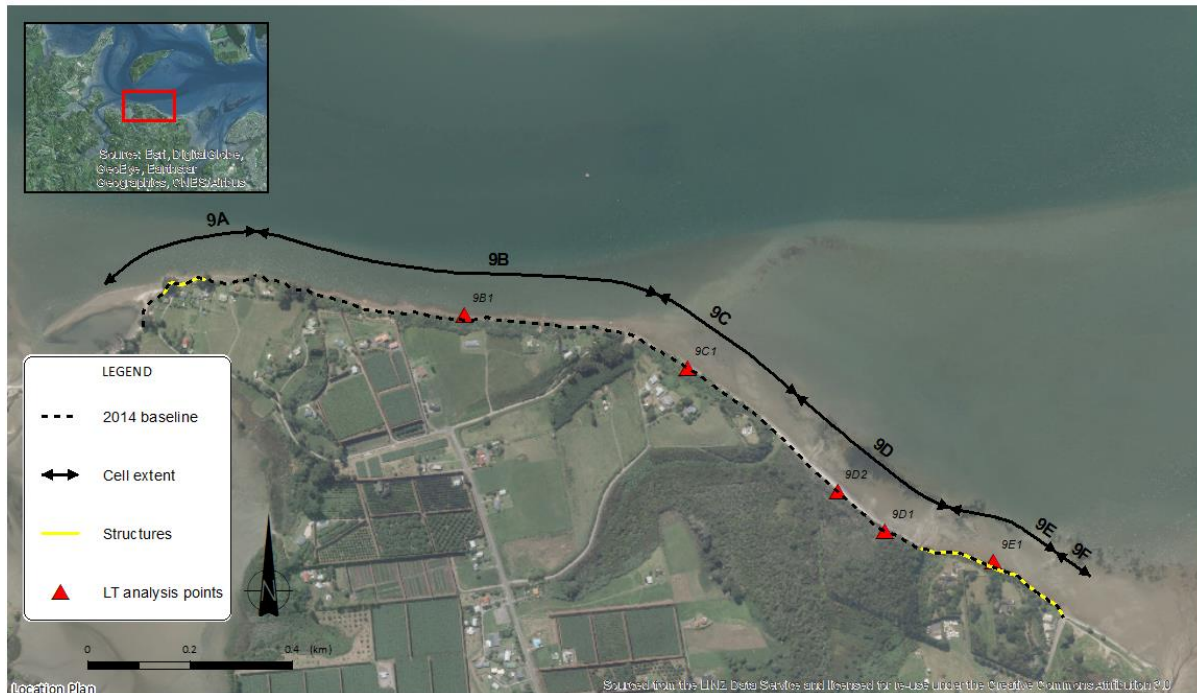
Figure 9-1 Location and cell extent for the Te Puna shoreline within Tauranga Harbour.

Te Puna is located in the southern basin of Tauranga Harbour, approximately 1 km south from Motuhoa Island. The shoreline comprises around 1.5 km of coastal cliffs and 0.3 km of unconsolidated shoreline. The site is split into 6 cells based on differences in exposure, morphology and shoreline elevation (Figure 9-1).

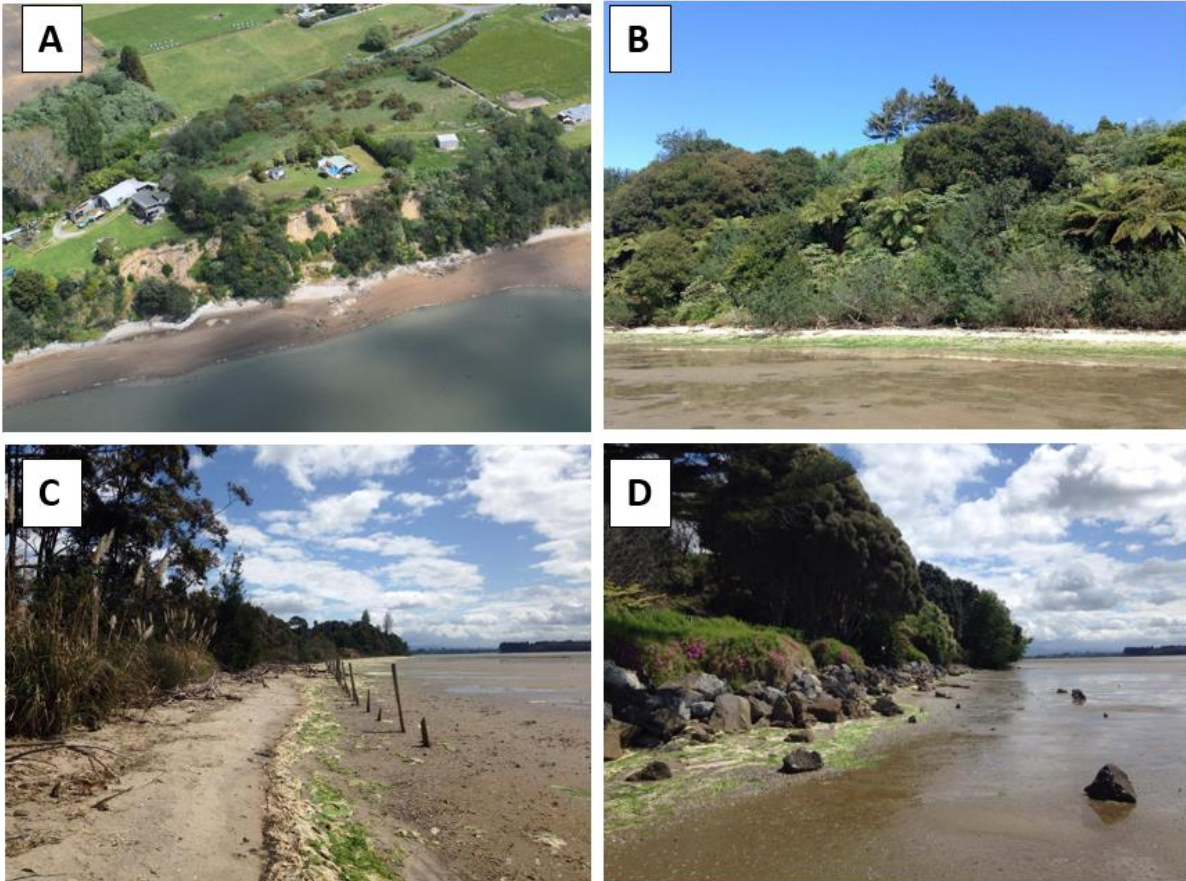
Figure 9-2 Site photos for Te Puna. (A) Exposed cliffs (Cell 9B), (B) stable cliffs with high tide beach (Cell 9C), (C) unconsolidated shoreline (Cell 9D), (D) low cliffs with rip rap (Cell 9F).

At the western end, the shoreline is characterised by low cliffs, ranging in elevation from RL 4 to 9 m (Cell 9A). Several residential dwellings are located along the cliff crest. Further east the cliffs continue to rise in elevation to approximately 20 m RL (Cell 9B) (Figure 9-2A). While most of the cliff face is vegetated with shrubs and trees, there are sections of bare cliff face, where recent slips have occurred and the debris has extended out onto the shore platform. The shoreline is exposed to an average fetch of 2 km from northeast and a maximum fetch of 10 km from east. In addition, the main harbour channel which circulates Motuhoa Island is approximately 100 m from the cliff toe.

South from Waipa Road is another section of coastal cliffs, ranging in elevation from RL 15 to 20 m (Cell 9C). The cliffs are orientated with a north-easterly aspect and are well-vegetated with no evidence of recent slips. A high-tide sandy beach that is approximately 2 to 5 m wide occurs along the entire cliff toe (Figure 9-2B). The shoreline is exposed to an average fetch of 4 km from the east.

The shoreline continues south to a section of unconsolidated shoreline which ranges in elevation from RL 0.8 to 1.7 m (Cell 9D) (Figure 9-2C). The backshore is low and is vegetated with shrubs and grasses. The high-tide beach continues along from the cliff section.

Further south the shoreline topography rises again to coastal cliffs, ranging in elevation from RL 14 to 16 m (Cell 9E). The cliffs are mostly well-vegetated with protection structures along the toe. At the southernmost extent the cliffs gradually decrease in height, down to Pitua Road which is elevated approximately RL 1.3 m (Cell 9F) (Figure 9-2D).
