**Omokoroa Stage 3 Structure  
Plan Area**

**Supplementary Level B Liquefaction  
Assessment**

**Prepared for**  
Bay of Plenty Regional Council

**Prepared by**  
Tonkin & Taylor Ltd

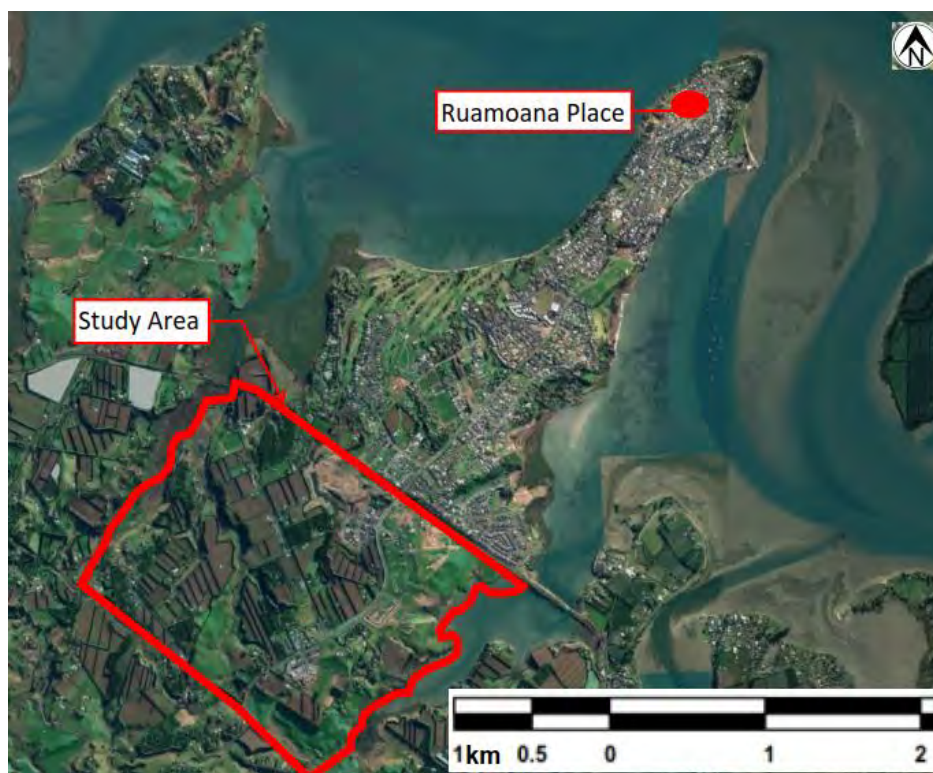
Figure 4.1: Omokoroa Study Area in relation to Ruamoana Place overlain on an Aerial Photograph

The location of Ruamoana Place in relation to the site is provided in Figure 4.1.

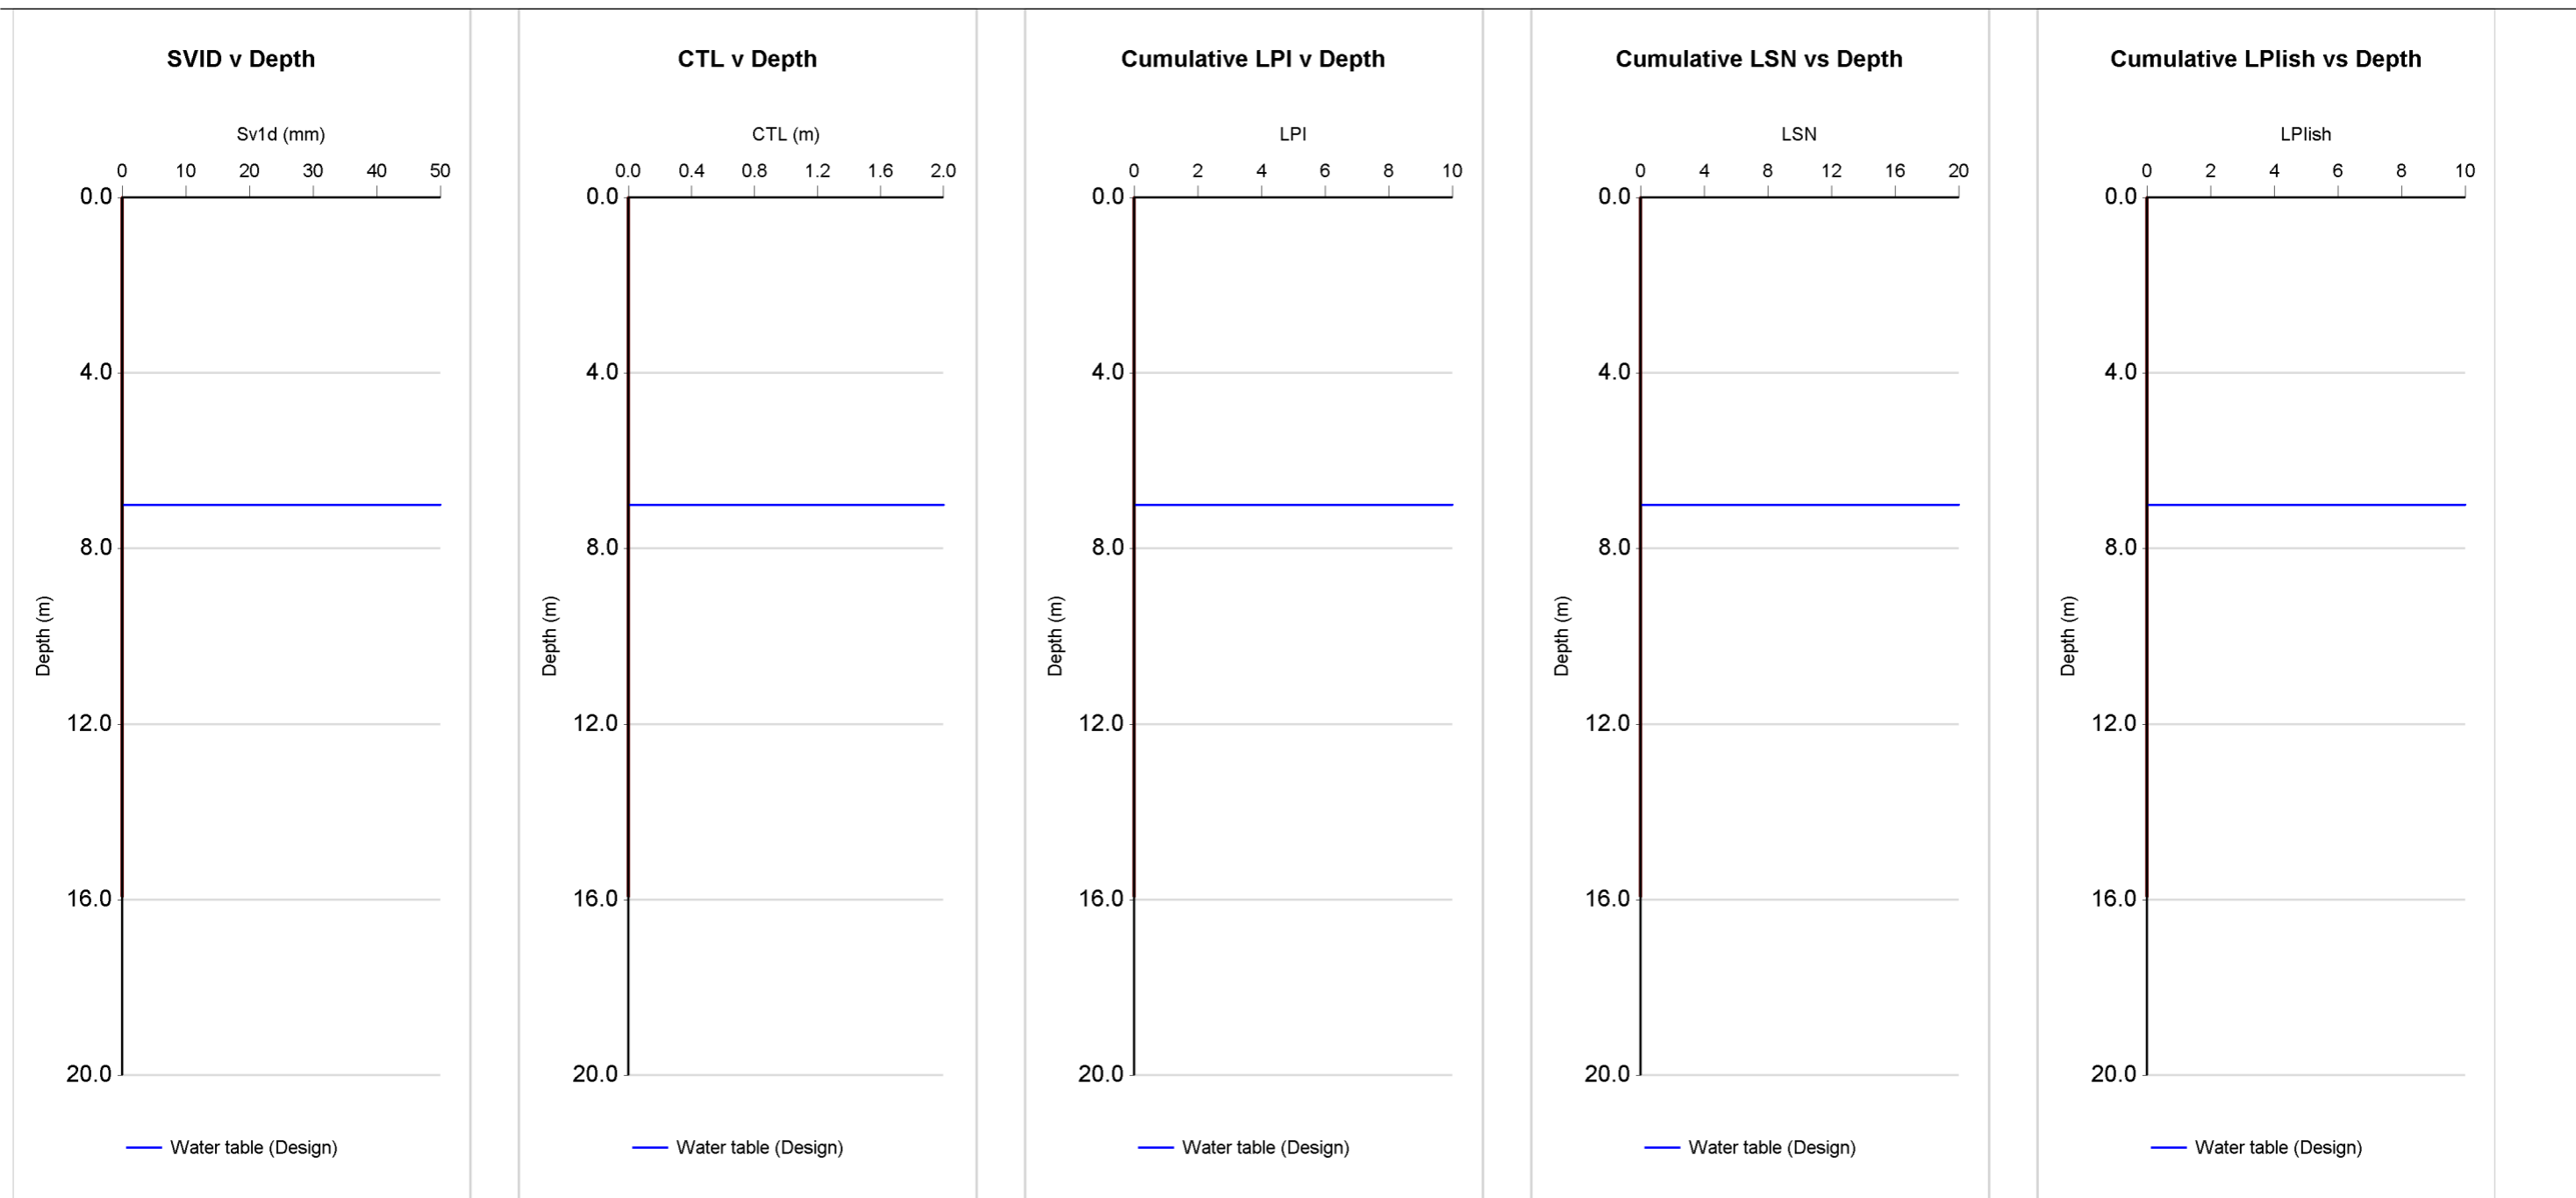
Run Description	NZGD ID	Investigation Date	Pre-drill (m)	Magnitude	PGA (g)	Trigger Method	Settlement Method	$\gamma$ (kN/m <sup>3</sup> )	Surcharge/Cut/Fill	Surcharge (kPa)	Cut/Fill Height (m)
INPUT CPT101	138340	28/01/2020	0	5.9	0.26	BI-2014	ZRB-2002	18		0

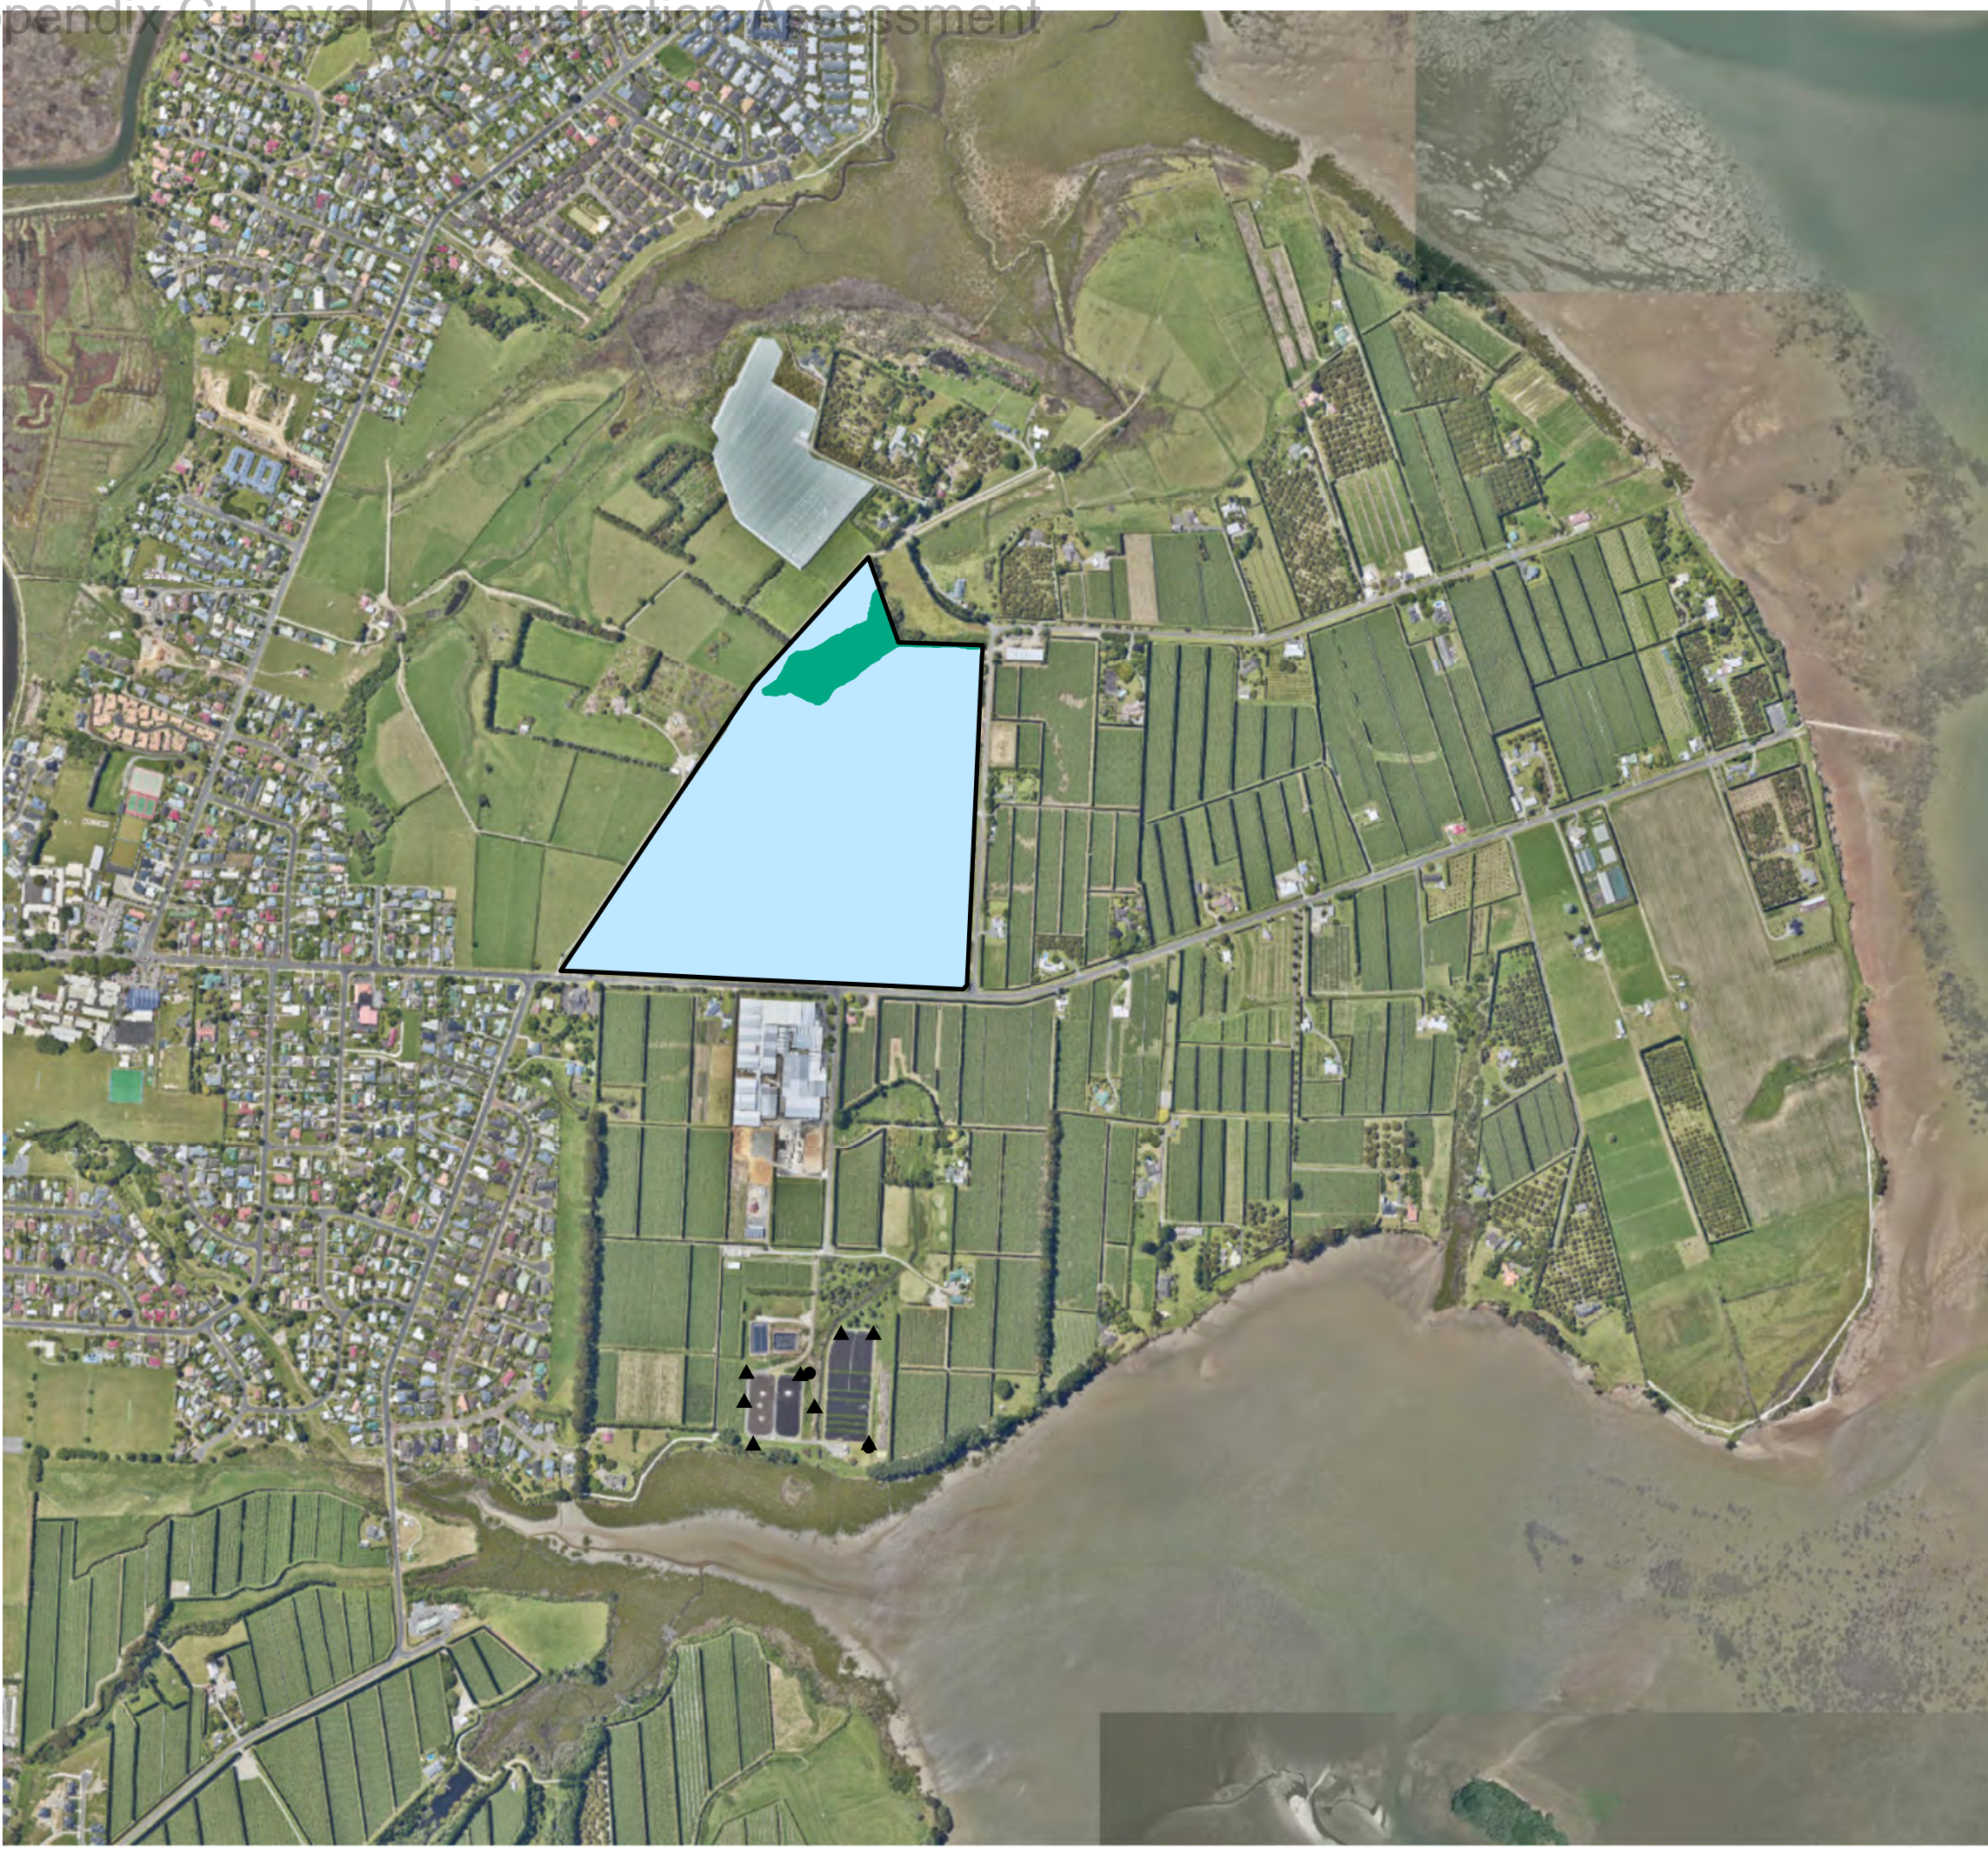
Figure A6

**BAY OF PLENTY REGIONAL COUNCIL**  
 KATIKATI LIQUEFACTION ASSESSMENT  
 Geotechnical Investigations overlaid on  
 2015 LiDAR DEM

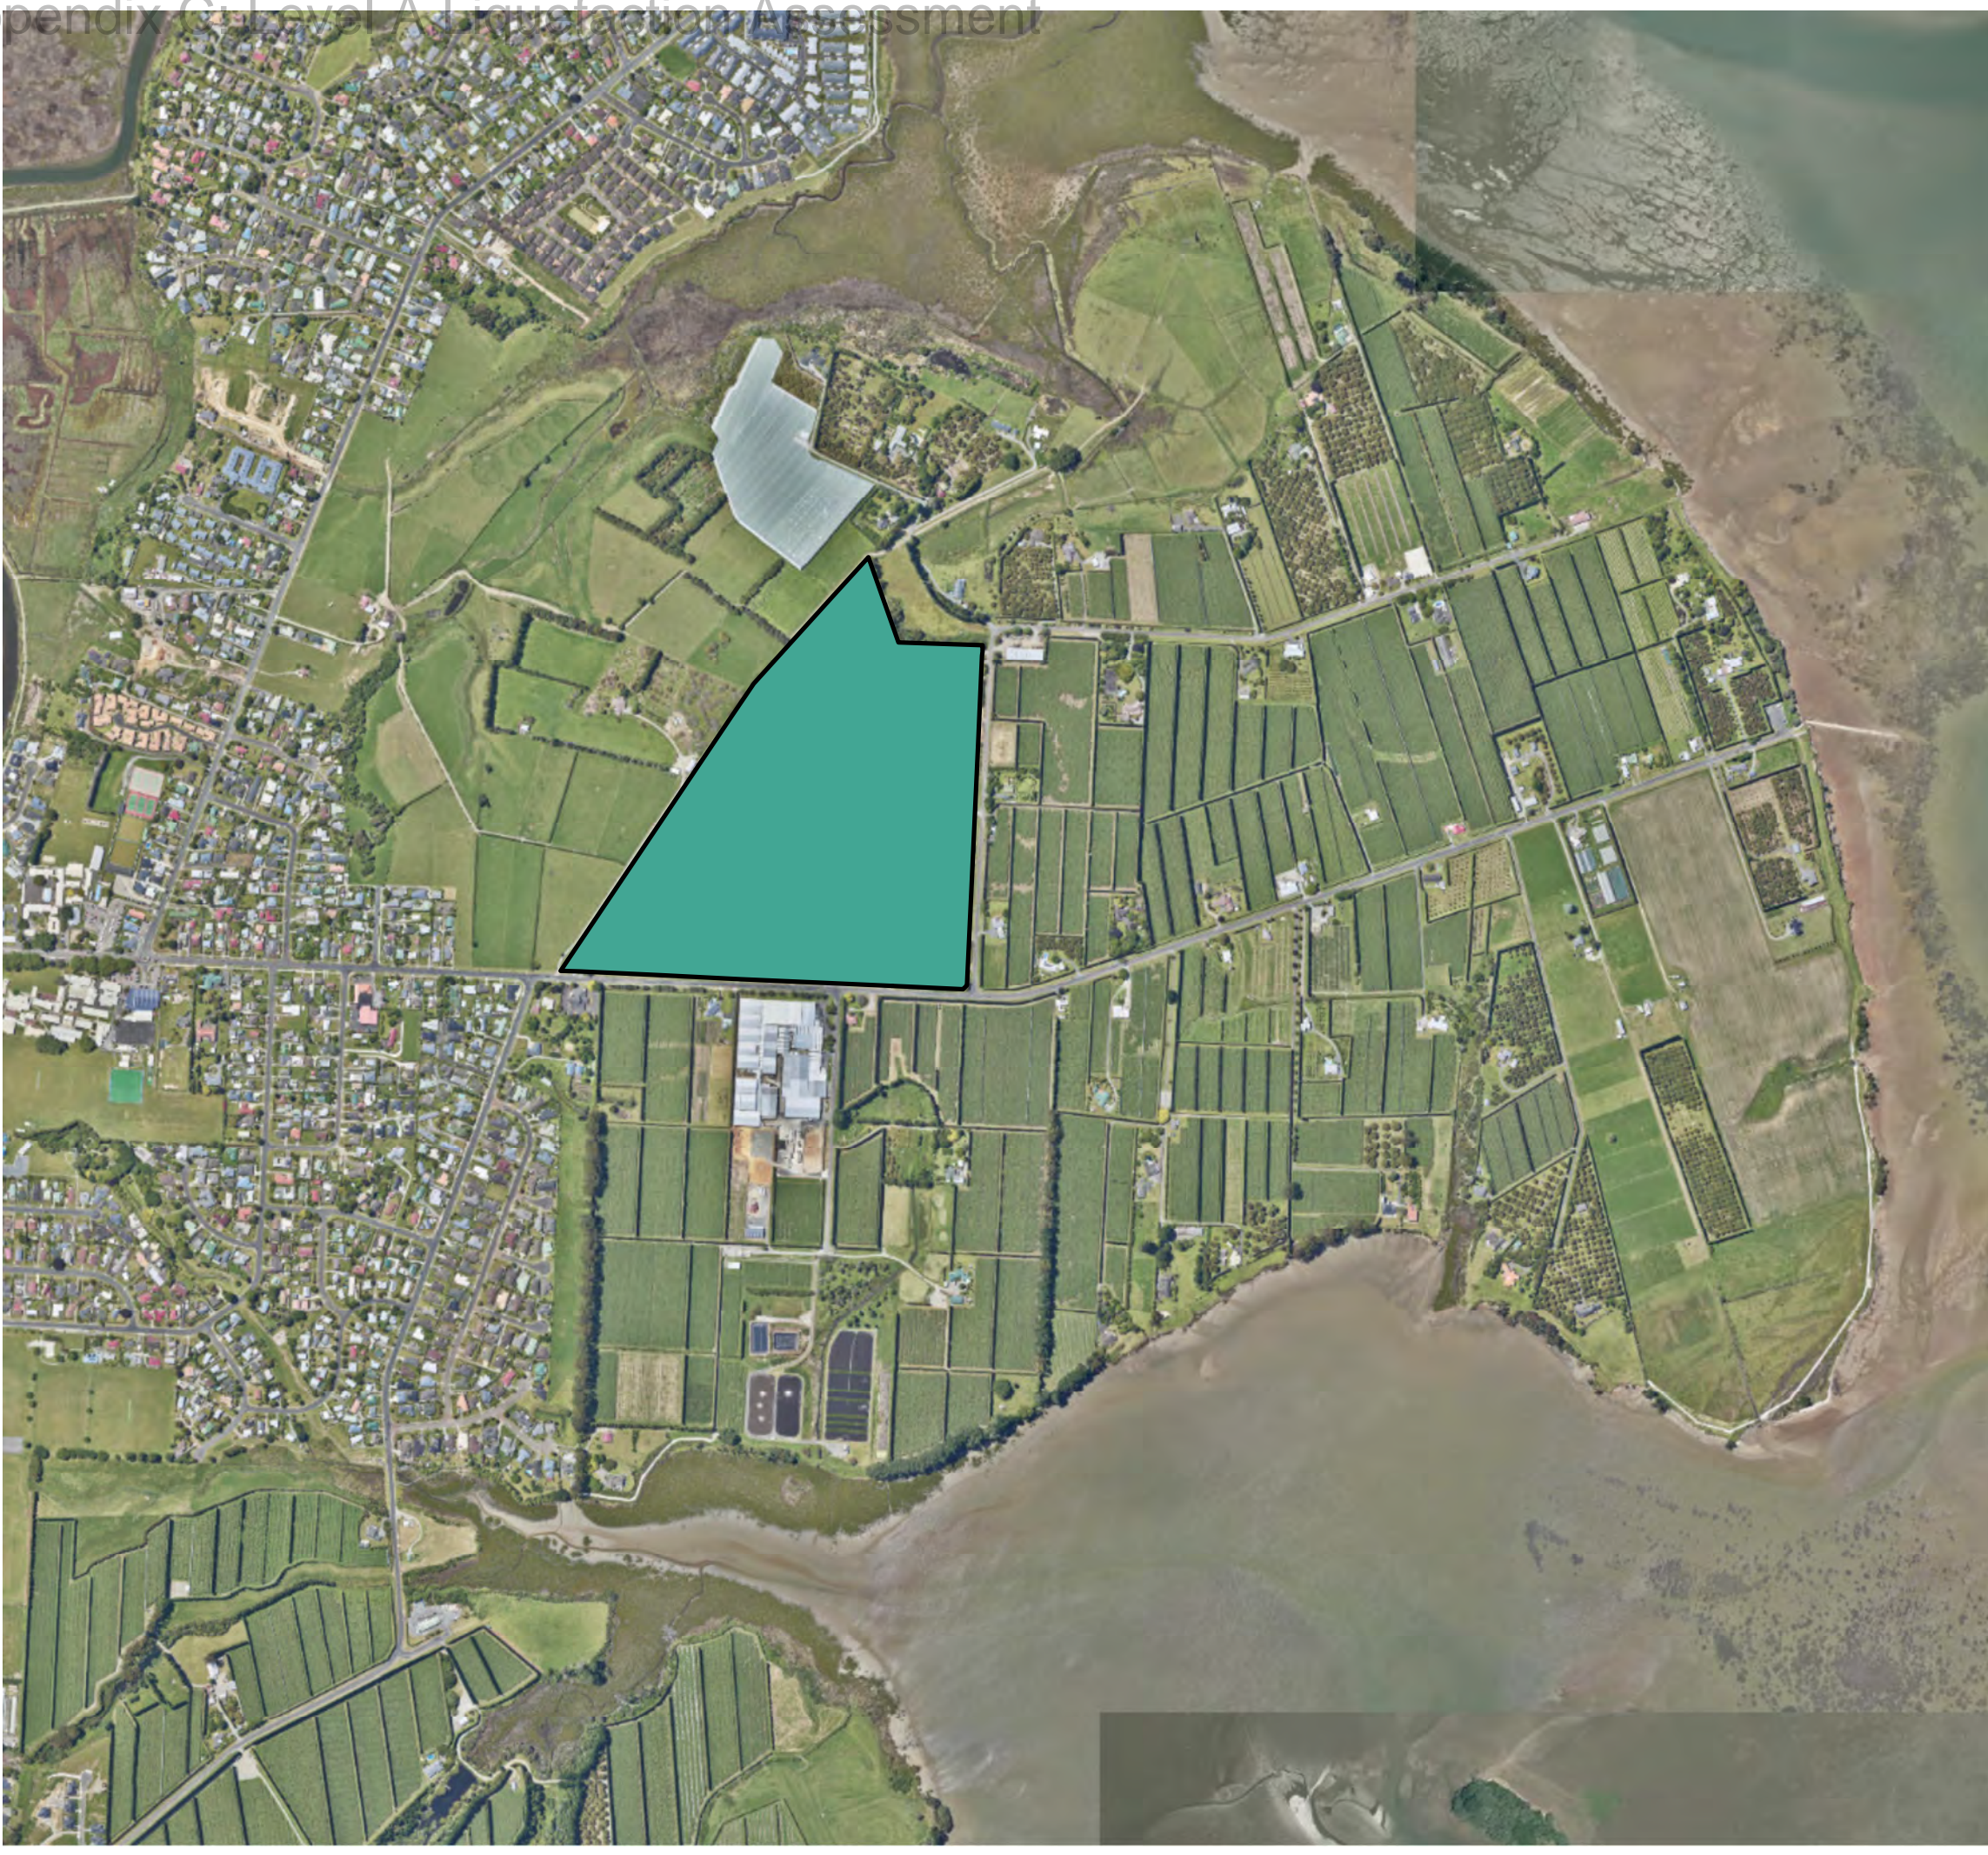
Figure A7

**BAY OF PLENTY REGIONAL COUNCIL**  
 KATIKATI LIQUEFACTION ASSESSMENT  
 Geotechnical Investigations overlaid on  
 Geomorphology

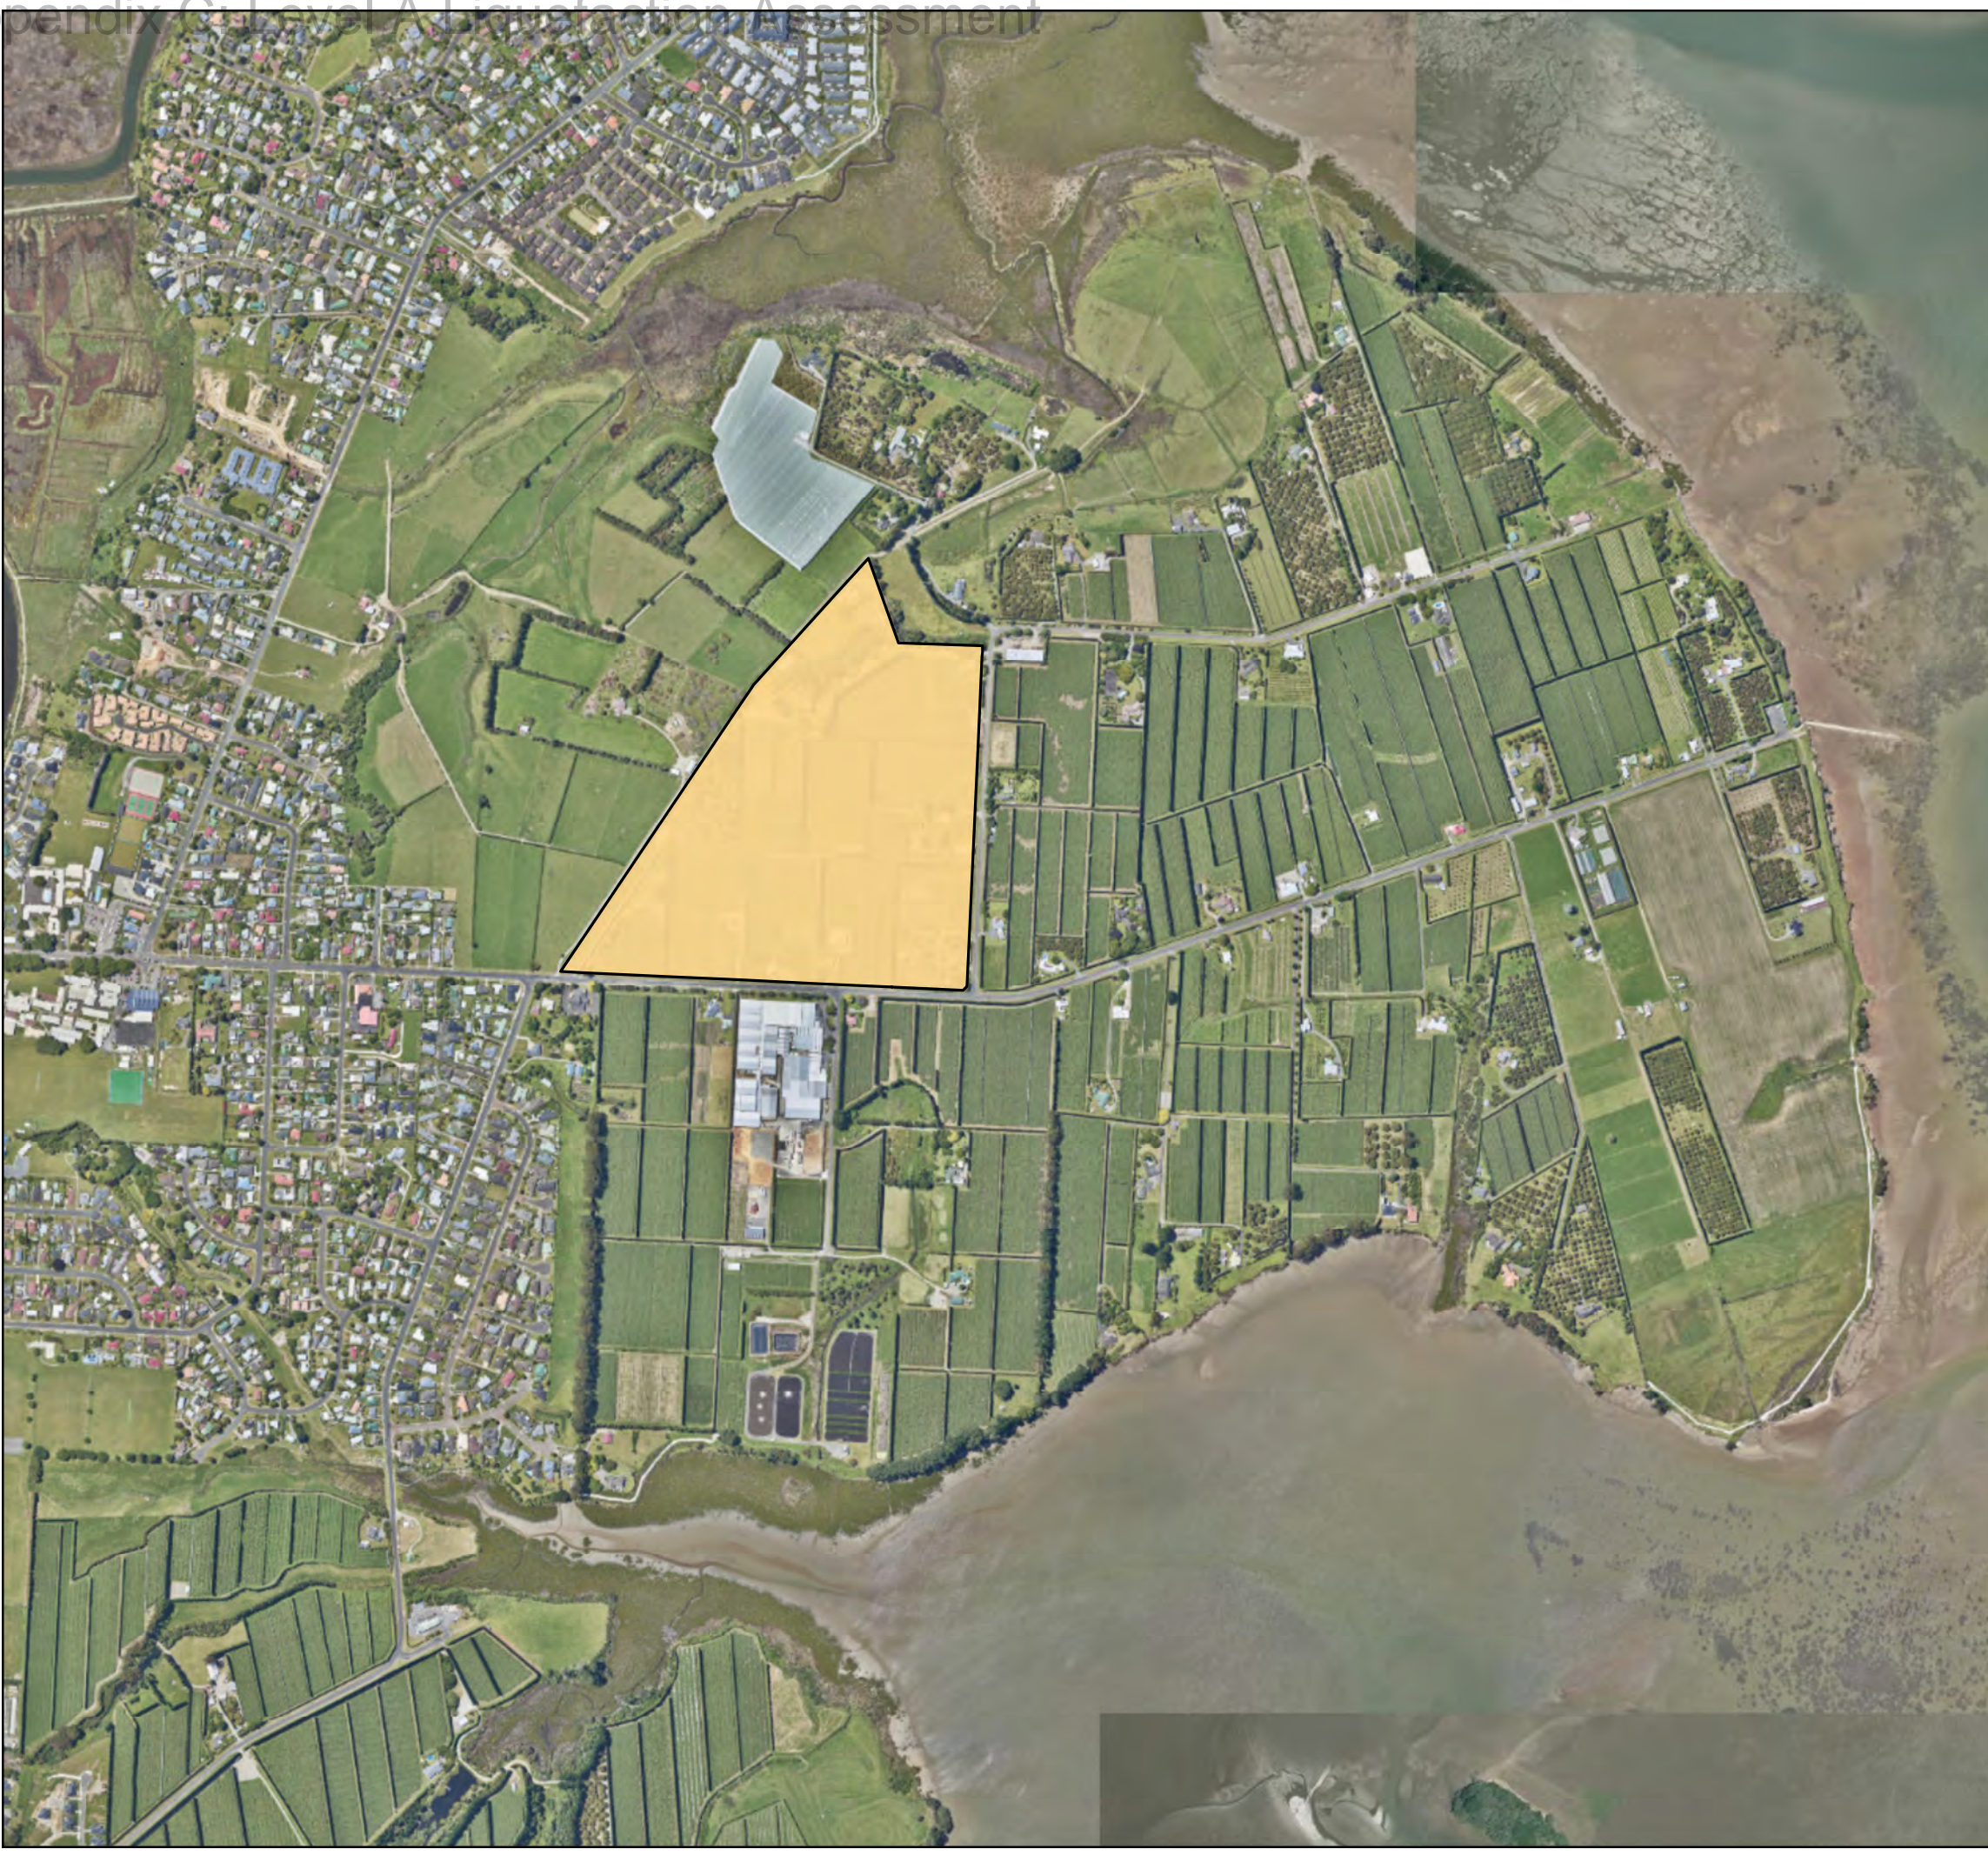
Liquefaction risk assessment maps for Omokoroa

- Study Area
- Liquefaction damage is unlikely
- Liquefaction damage is possible

Tables 2 and 3 of Appendix B present the risk analysis based on liquefaction vulnerability indicators. Figure B1 provides a spatial understanding of the expected degree of liquefaction induced ground damage at 500 year levels of earthquake shaking based on the interpreted CPT based liquefaction vulnerability indicators. It is important to note that there is significant residual uncertainty associated with CPT based liquefaction vulnerability indicators and the actual liquefaction induced land damage may differ from that indicated using this analysis.

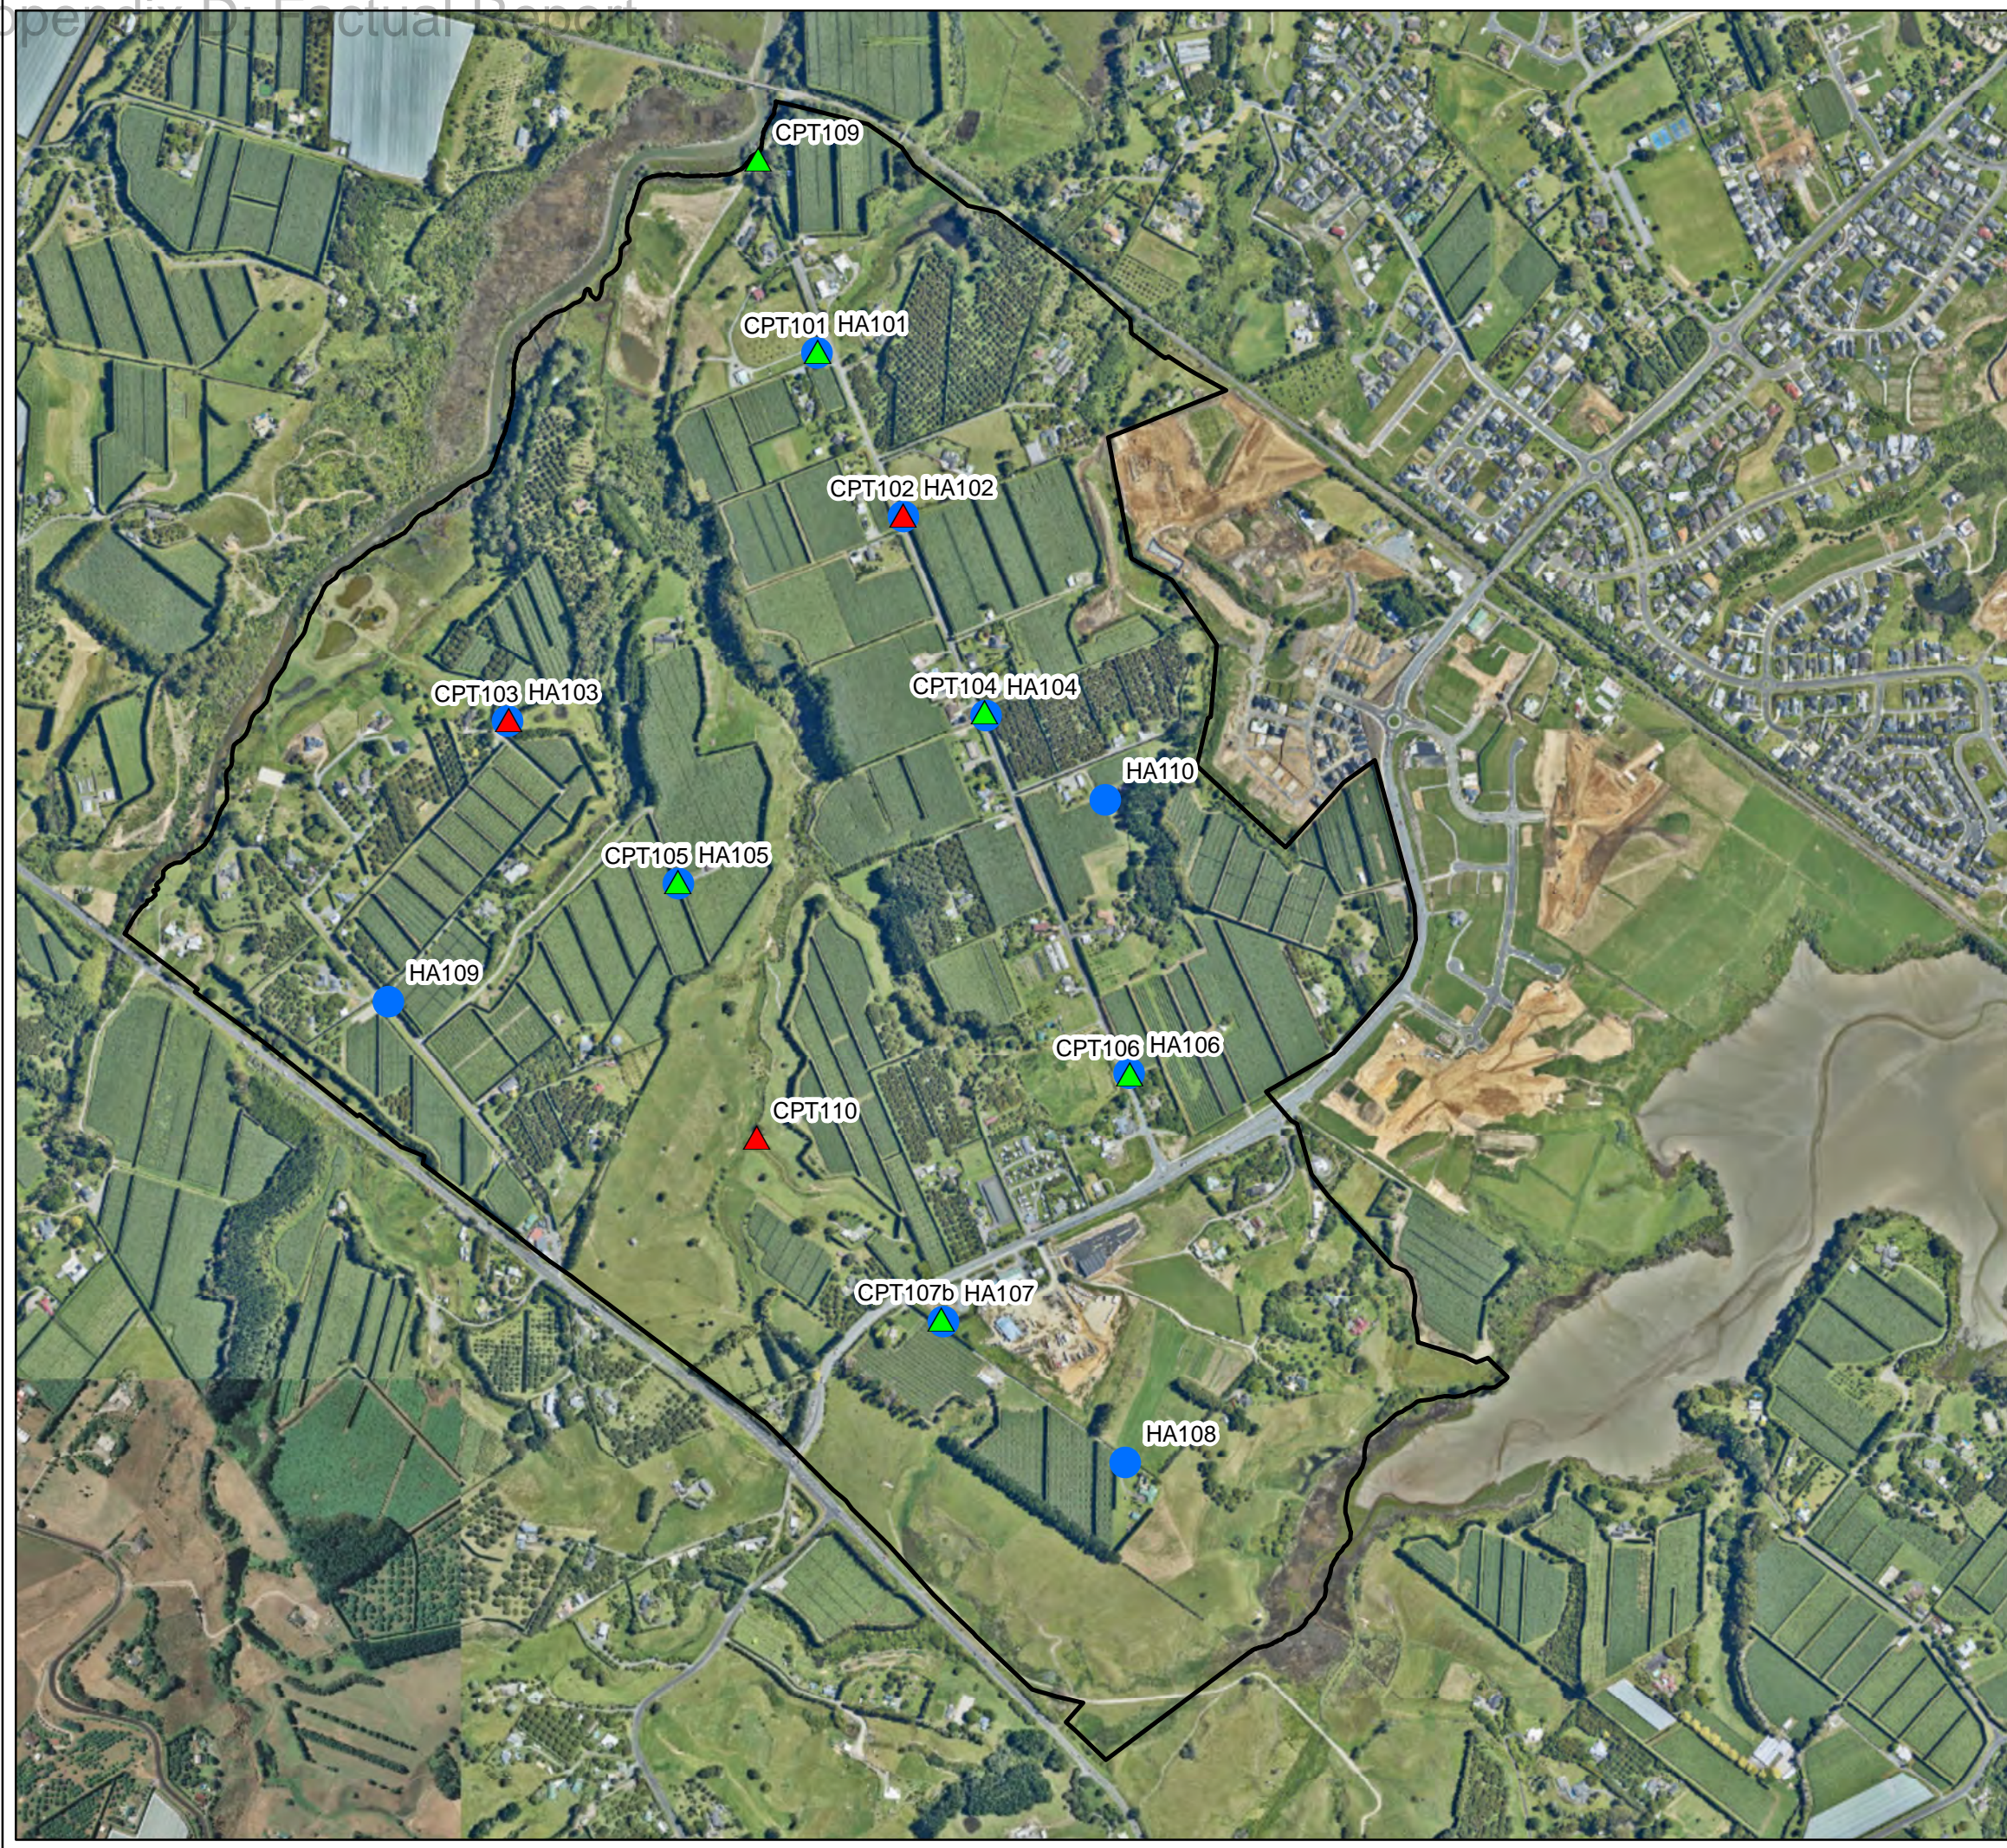
*Figure A1: Ground investigation location plan*

- Completed Geotechnical Investigation**
- ▲ Cone Penetration Test (CPT)
  - ▲ Standpipe Piezometer and CPT
  - Hand Auger
  - Extent of Study Area
