**RC14513 / COASTAL PROTECTION STRUCTURE AND ASSOCIATED ACTIVITIES  
SUPPLEMENTARY EVIDENCE OF ANDREW FRASER (GIPS)**

**Dot Watch Waihi Beach & Surrounds – disturbance in front of 12 Glen Isla Place**

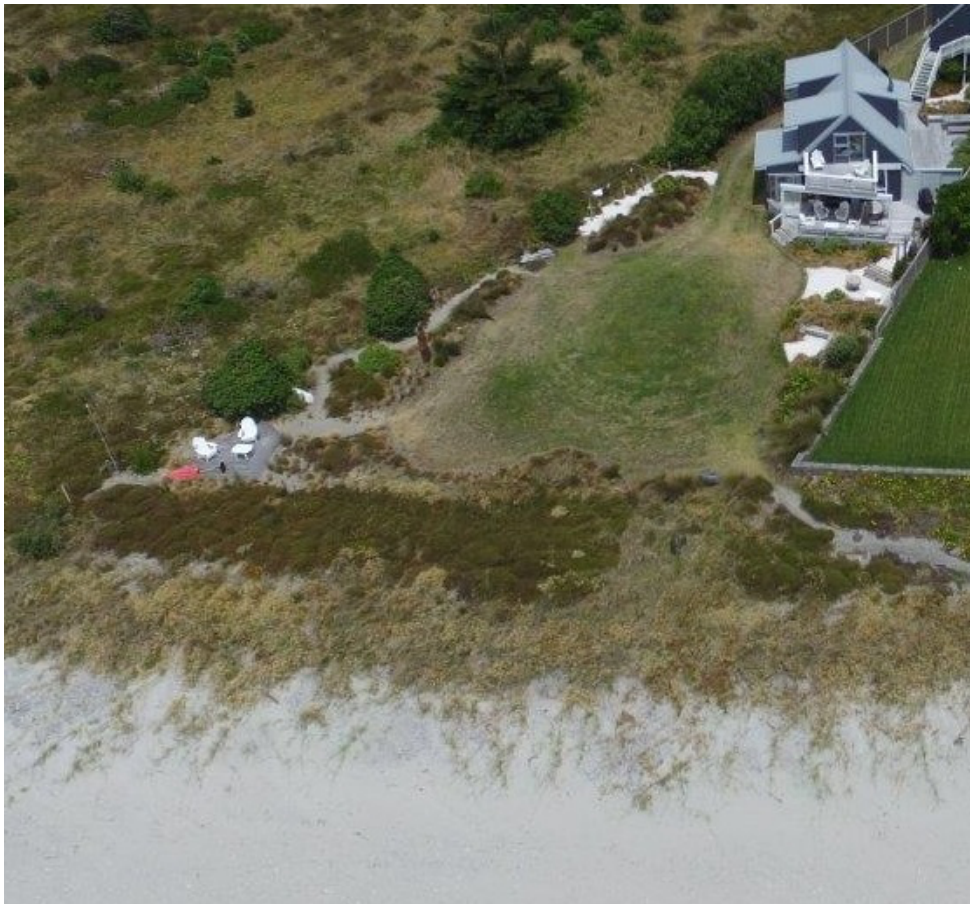
10. Image 1 below, which I believe was taken in January 2017, shows the dune in front of 12 Glen Isla Place prior to the recent erosion.

Image 1 (believed to be January 2017): the dune is relatively uniform in front of 12 Glen Isla Place.

24. The residents of Glen Isla Place, working together with the Council and Coast Care, planted numerous native dune plants on the dune after the dune enhancement was carried out in 2011. In particular, Mrs O’Sullivan and her late husband Mr Mike O’Sullivan at 12 Glen Isla Place, the Fraser family at 16 Glen Isla Place and Mr and Mrs Cory-Wright at 15 Glen Isla Place, have planted hundreds of dune plants, and fertilized and watered the southern end of the Glen Isla Place dune. The outcome of that planting can be seen in the healthy spinifex and pingao visible in Image 1.

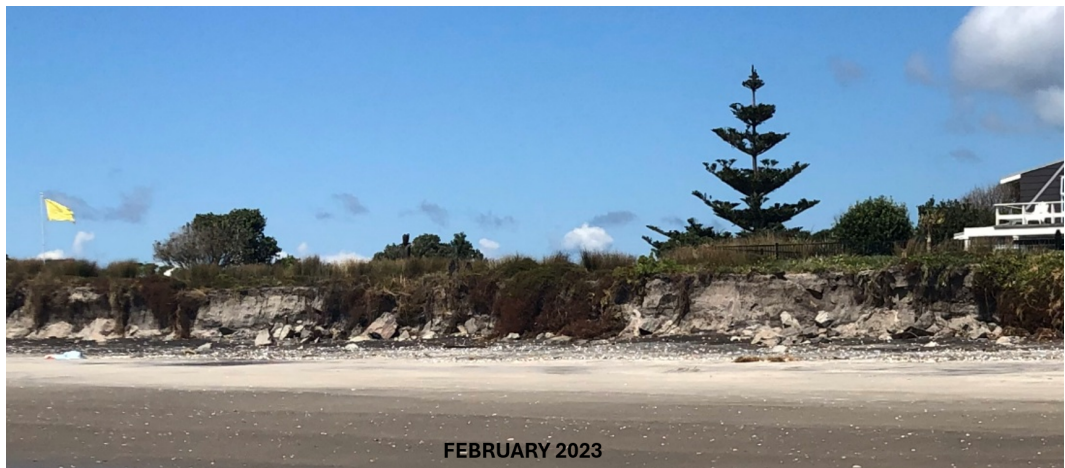
11. Image 2 below shows the effects of the early 2023 storms, particularly Cyclone Gabrielle, on the dune in front of 12 Glen Isla Place, including the lowered level of

the sand on the beach resulting in a substantial near-vertical face on the dunes.  
The house at number 12 is visible on the right-hand side of the image.

Image 2 (February 2023): damage to the dune post Cyclone Gabrielle.

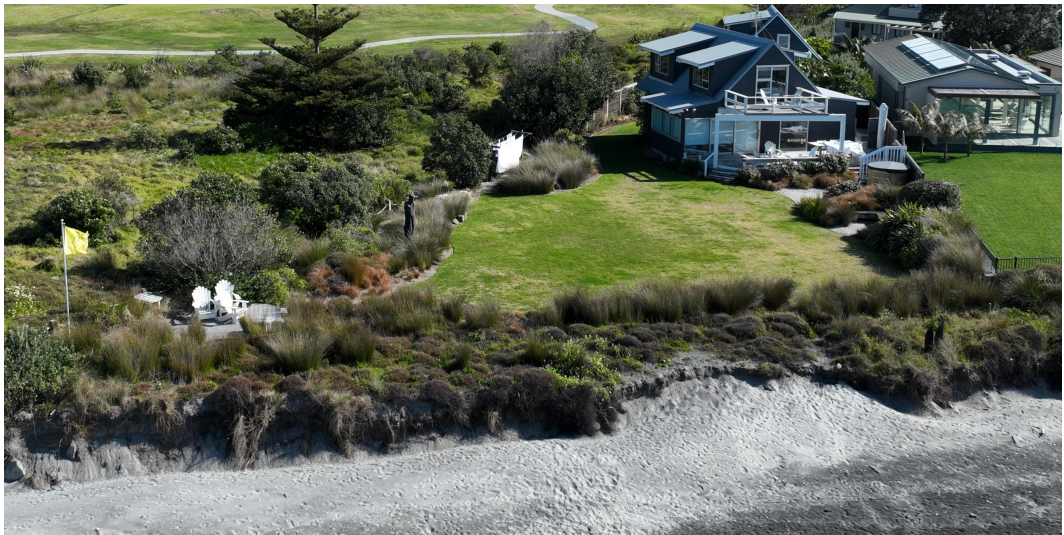
12. Image 3 below, taken in September 2023, shows worsening erosion in front of 12 Glen Isla Place.

Image 3 (1 September 2023): after the storms of early 2023, the area of concern starting to erode more than the surrounding dune.

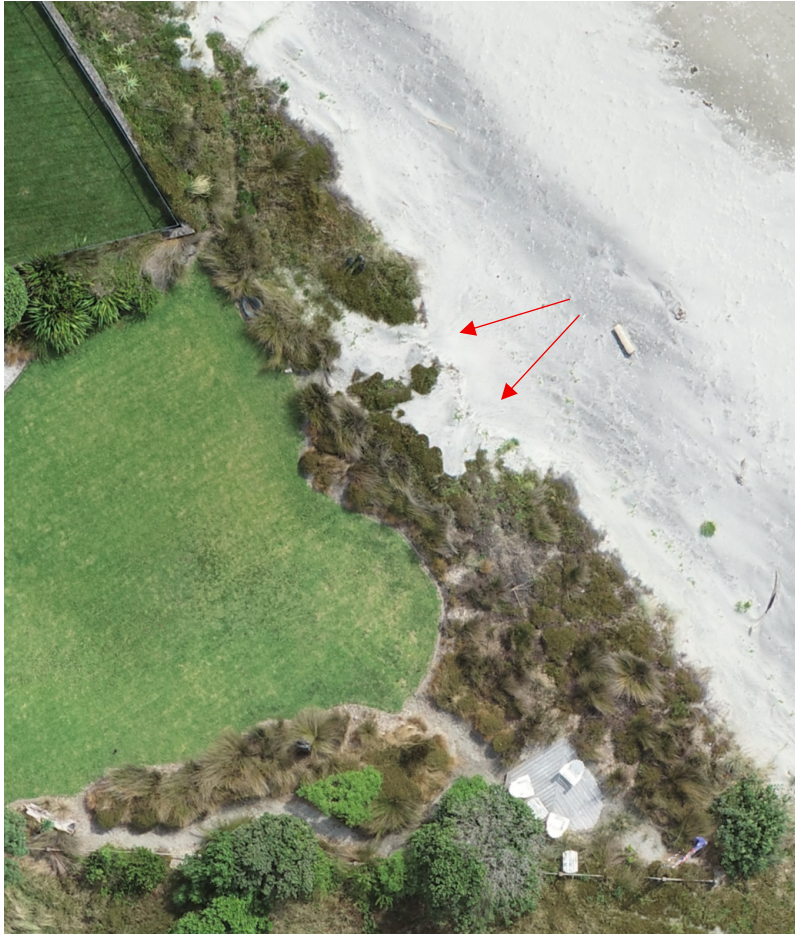
13. Image 4 below shows the extent of the erosion by March 2024, and also shows sand is being blown onto the dune in the affected area, covering some of the plants.

Image 4 (14 March 2024): as the beach recovers, sand has begun to naturally cover some of the planting in the area of concern (red arrows).

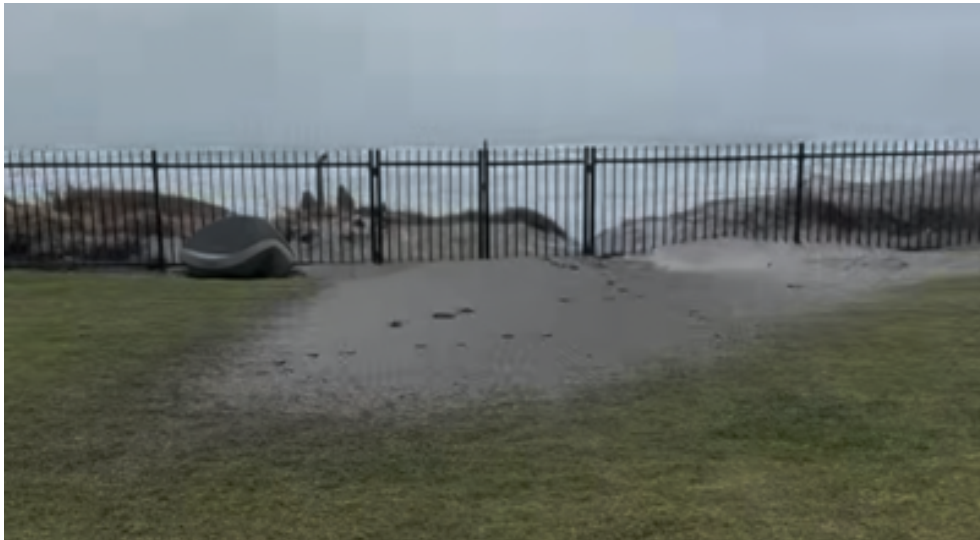
14. Since the width of the dune was significantly reduced by storms in early 2023 and the height of sand on the beach has increased, the residents and 12, 14 and 16 Glen Isla Place have observed frequent occurrences of sand being blown onto the dune plants near their properties, and onto their lawns (see Images 5 and 6 below). Until recently, they had not previously seen this happen.

Image 5 (17 April 2025): showing sand blown over the dune onto the lawn of 12 Glen Isla Place.

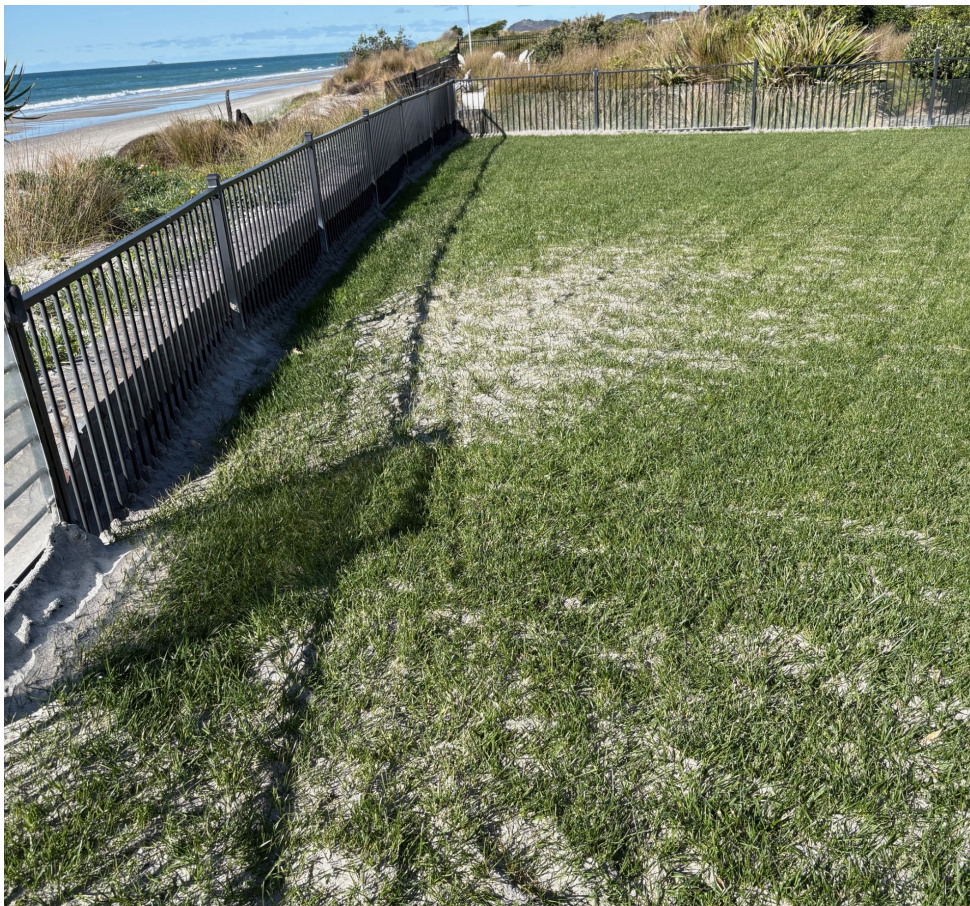
Image 6 (22 July 2025): Wind blown sand on the lawn at 14 Glen Isla Place.

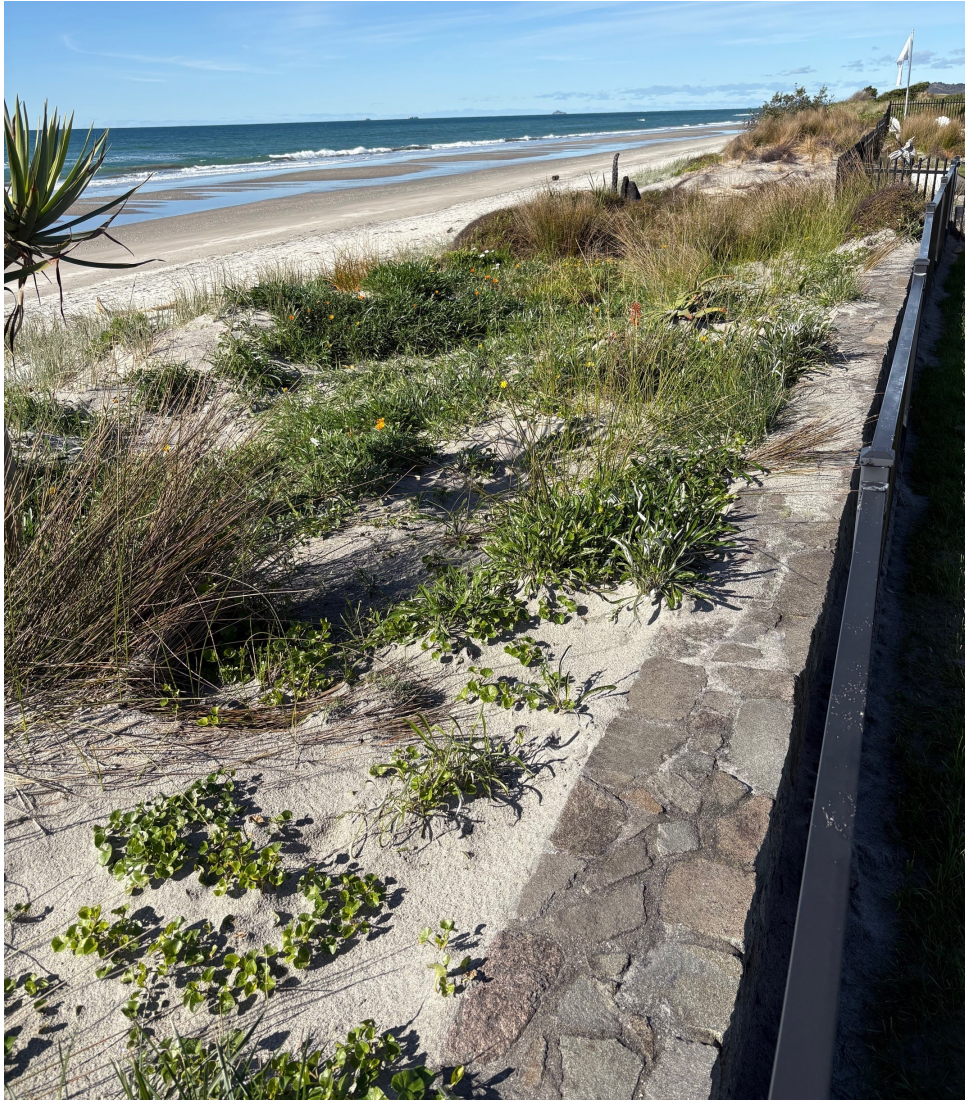
15. There is also wind blown sand covering dune plants seaward of the private property boundary at 14 and 16 Glen Isla Place (see Image 7 below), which is also unusual. Usually the dune is thick with plants, as can be seen in the photos shown in Dr Keesing's evidence such as Figure 8 in that document.

Image 7 (22 July 2025): wind blown sand covering dune plants seaward of 14 Glen Isla Place.

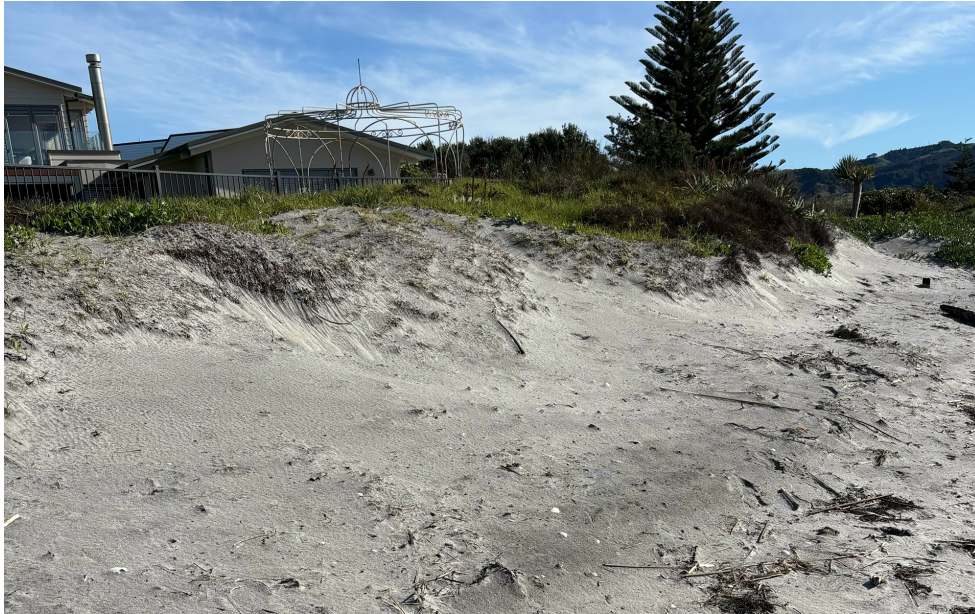
16. In the last few weeks, storms seem to have further damaged the dunes and some of the plants (see Image 8 below).

Image 8 (22 July 2025): plants that appear to have been sand covered and storm damaged in the dune seaward of 16 Glen Isla Place.

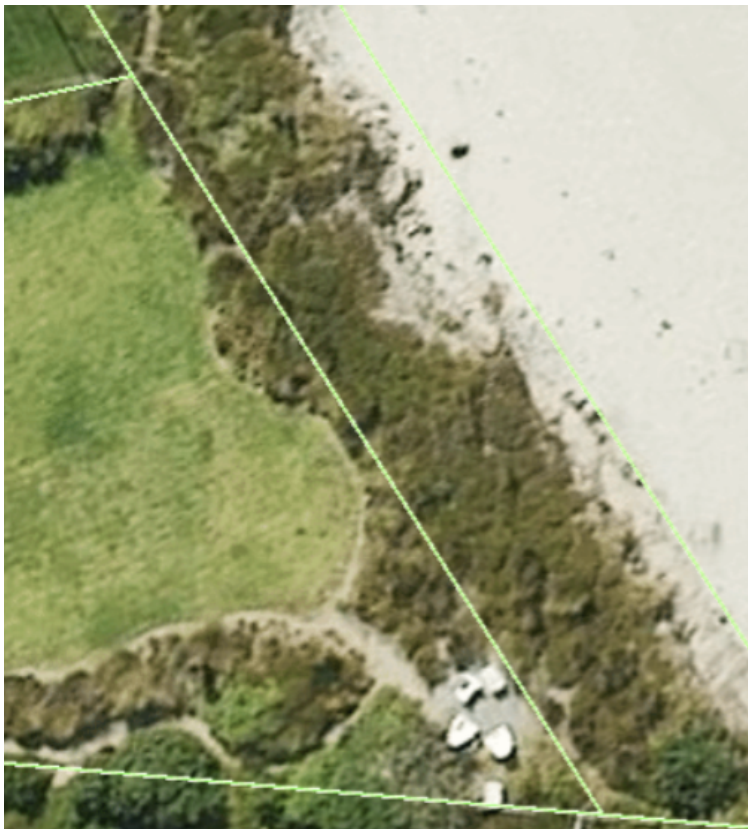
17. Image 9 below shows the location of the seaward boundary of 12 Glen Isla Place. Note that many of the dune plants shown in the red pentagons in images in Dot Watch’s supplemental evidence are on private land.

Image 9 (2023): from the WBOPDC MAPI public maps, shows the seaward boundary of 12 Glen Isla Place.

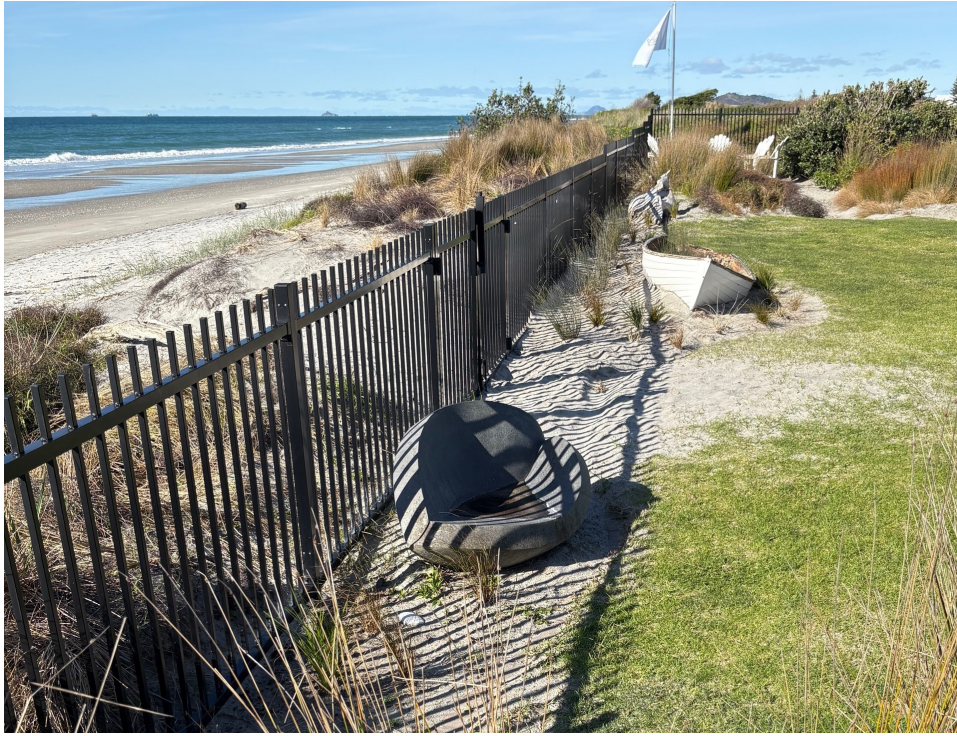
19. The work was carried out between 5 and 12 April 2025, while Mr and Mrs Bason were away from Waihi Beach. Unfortunately, the contractor did not adhere to the agreed methodology, but instead brought in a digger and deposited some of the excavated material onto the dune, covering some plants. Mr Bason was unhappy with what had occurred and required the contractor to return to the site to remove the material covering plants on the dune by hand. That remedial work occurred on 1 May 2025. The completed work with some new planting is shown in Image 10 below.

20. Mr Bason has estimated the area affected by the contractor's actions at around 5 - 6 metres by about 2 metres to the south of the path, with another small area of around 2 metres by 2 metres north of the path. Some plants in those areas have recovered quite well after the remediation work, while some others are still a bit brown, but will hopefully improve in the spring.

Image 10: shows the completed fence and replanting of the affected area inside the property.

21. Mr and Mrs Bason have been in contact with Coast Care and have already re-established some of the native planting that was removed from their own land when the fence was installed, and they intend to carry out more planting on the dune by moving some established native dune plants from their own garden as well as buying some new plants.
