# Catchment Management Plan (CMP)

Eastern Catchments - Te Puke and Small Settlements Catchments  
(Paengaroa, Maketu/Little Waihi and Pukehina)

Client: Western Bay of Plenty District Council (WBOPDC)

**AECOM New Zealand Limited**

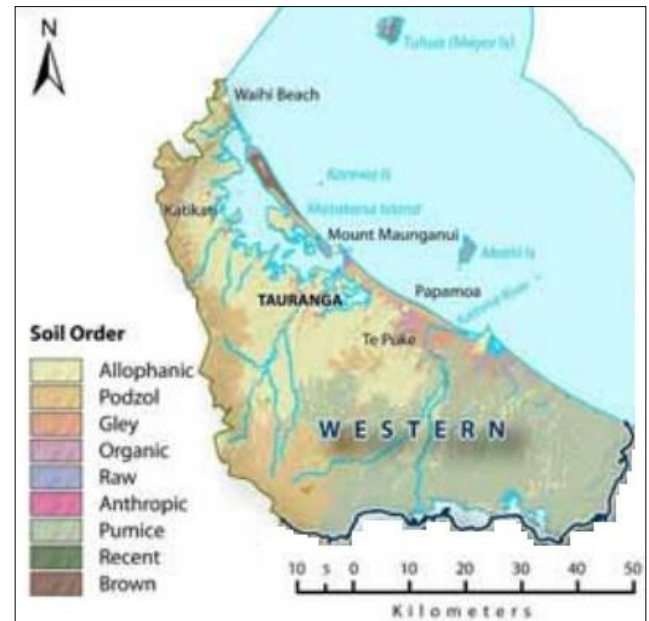
Figure 7 General soil map the WBOPD showing soil orders (Rijkse and Guinto 2010)

There are five main soils types within the Western Bay of Plenty District (Rijkse and Guinto 2010; Thiel-Lardon 2013a), these include (refer to Figure 7):

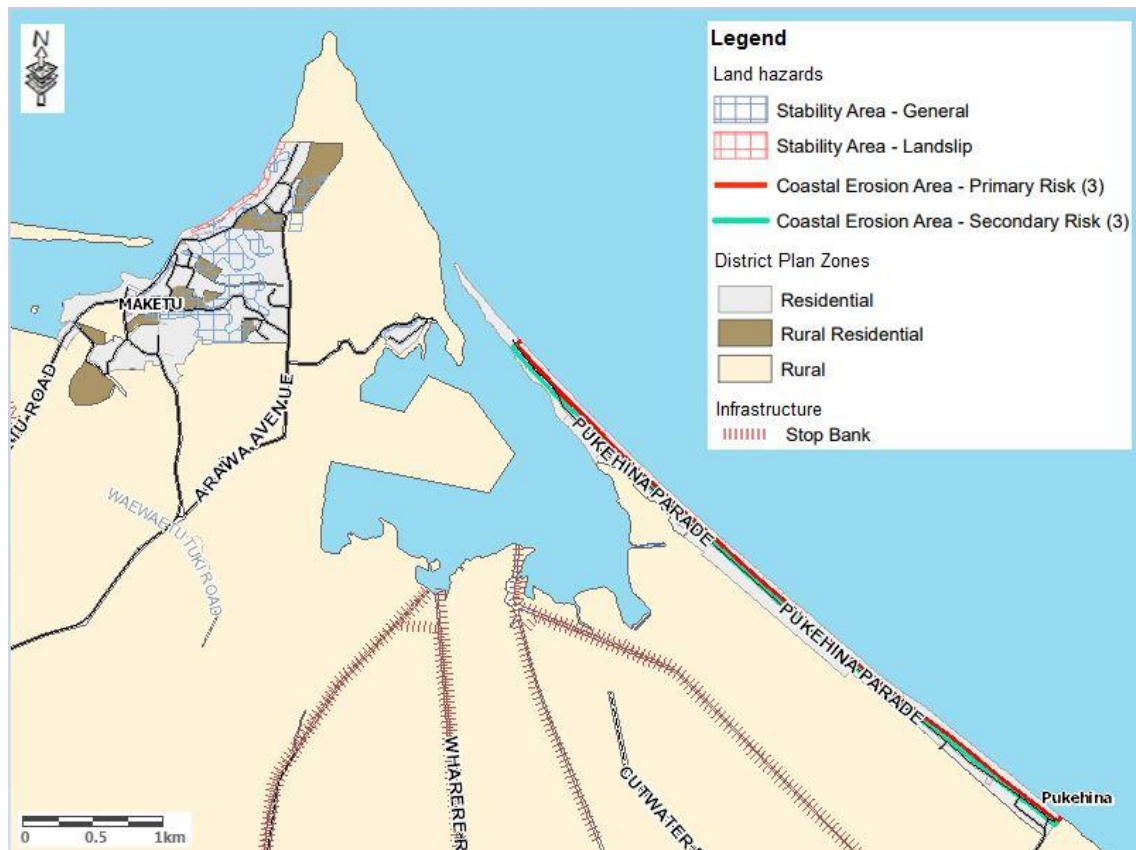
**Figure 8 Land hazards identified in the Maketu/Little Waihi and Pukehina catchments, including associated District Plan zoning (WBOPDC 2017)**

WBOPDC's online geographic information system (GIS) mapping tool, MAPI (WBOPDC 2017), identifies land hazards areas in the Maketu/Little Waihi and Pukehina catchments. Those identified in the Maketu/Little Waihi catchment are associated with landslides and general instability, while hazards identified in Pukehina are associated with coastal erosion (refer to Figure 8).

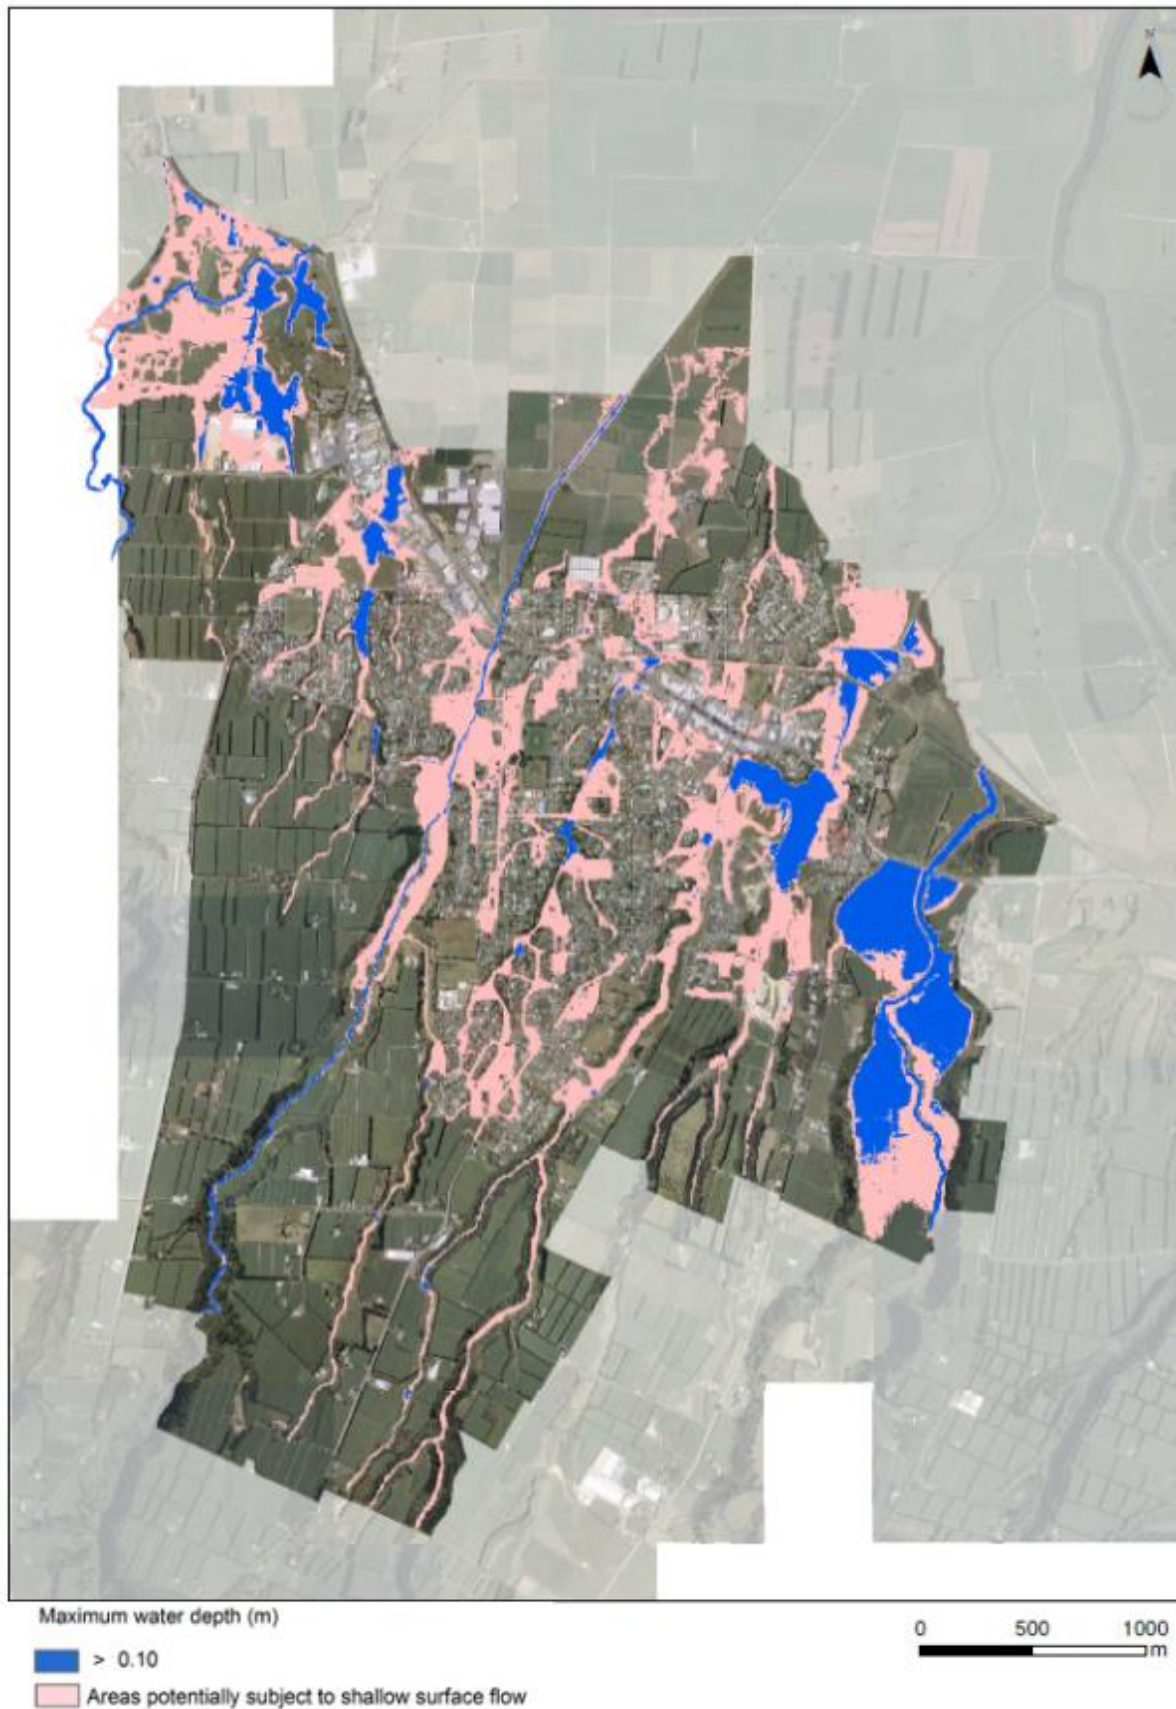
Figure 19 Flood extent for the 50-year ARI, 24-hr duration design nested storm rainfall event (from Opus 2015)

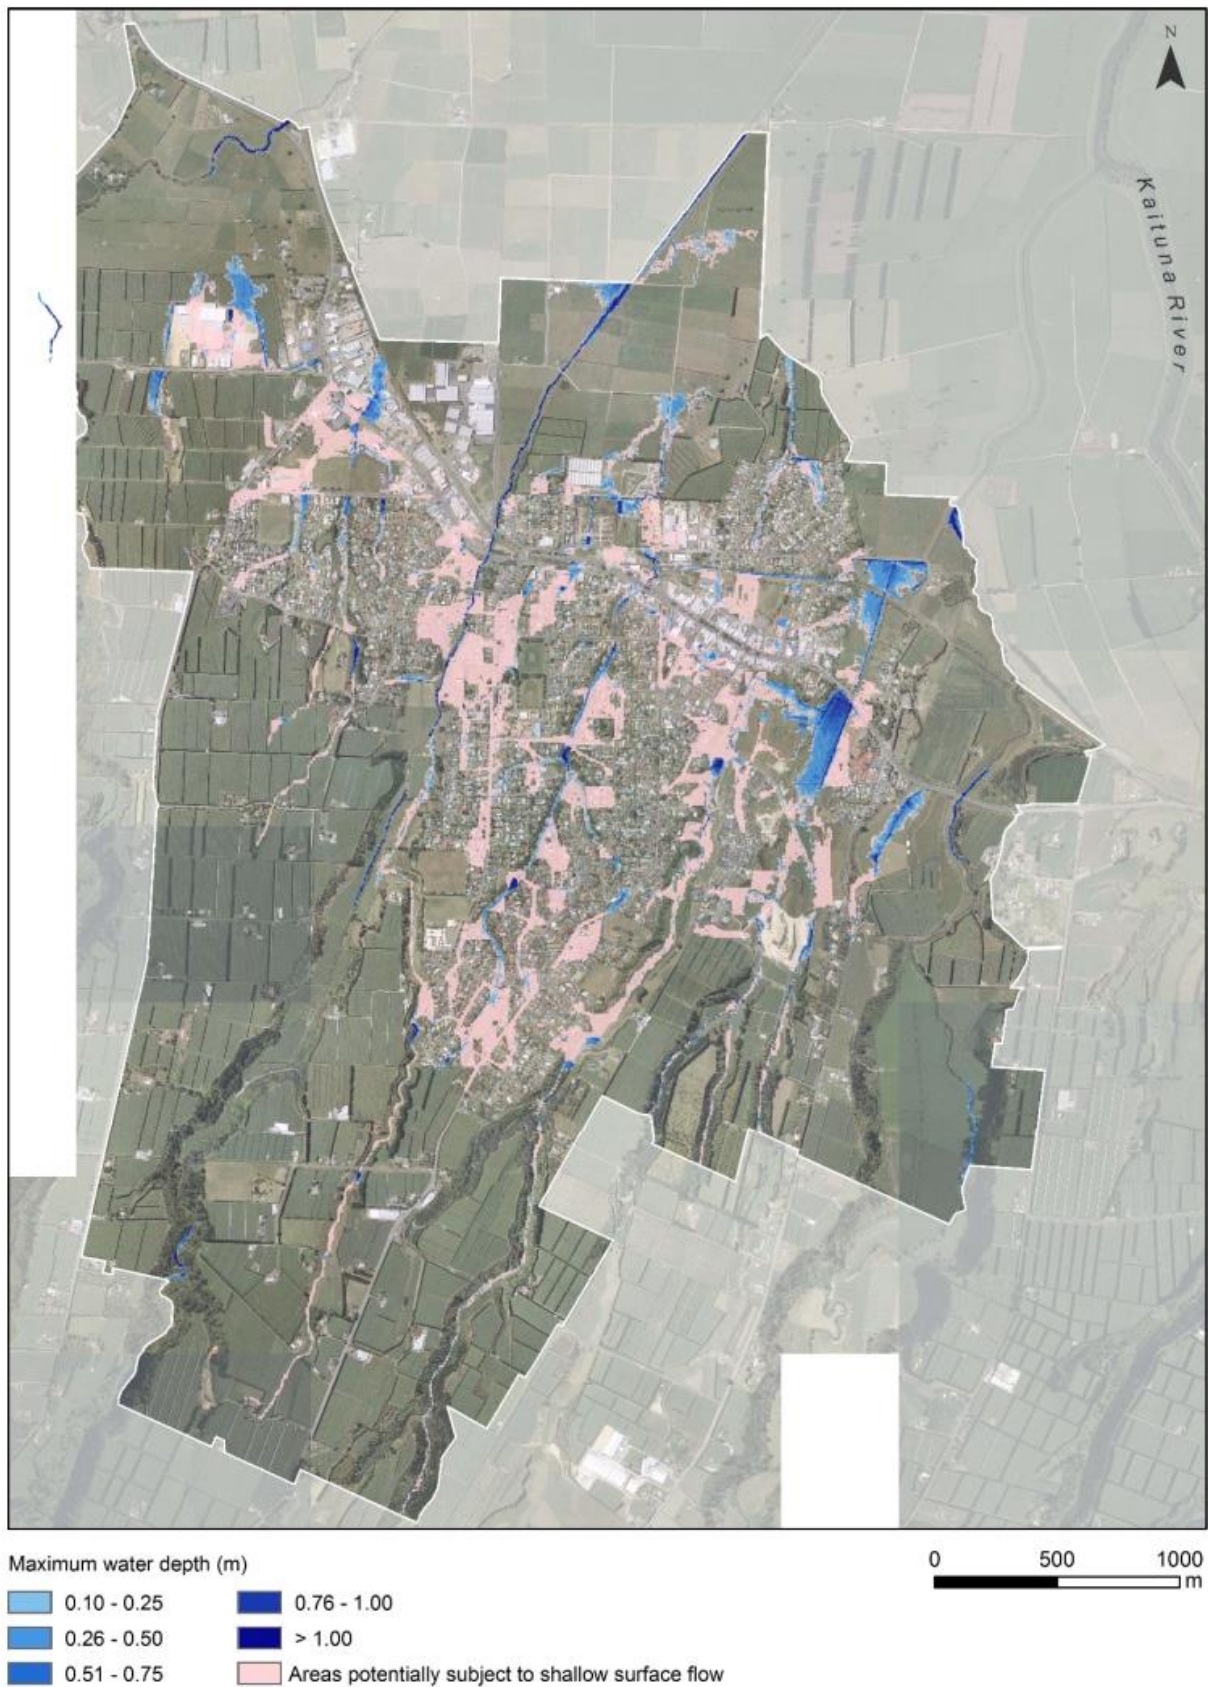
Figure 20 Flood depth for the 50-year ARI, 30-min duration design nested storm rainfall event (from Opus 2014)

As a result of the hydrological and hydraulic modelling, a total number of 275 pipes were identified in the Stage 4 modelling work for upgrading (Opus 2014). In addition, 207 manholes were identified for upgrading in Te Puke catchment (Opus 2014).

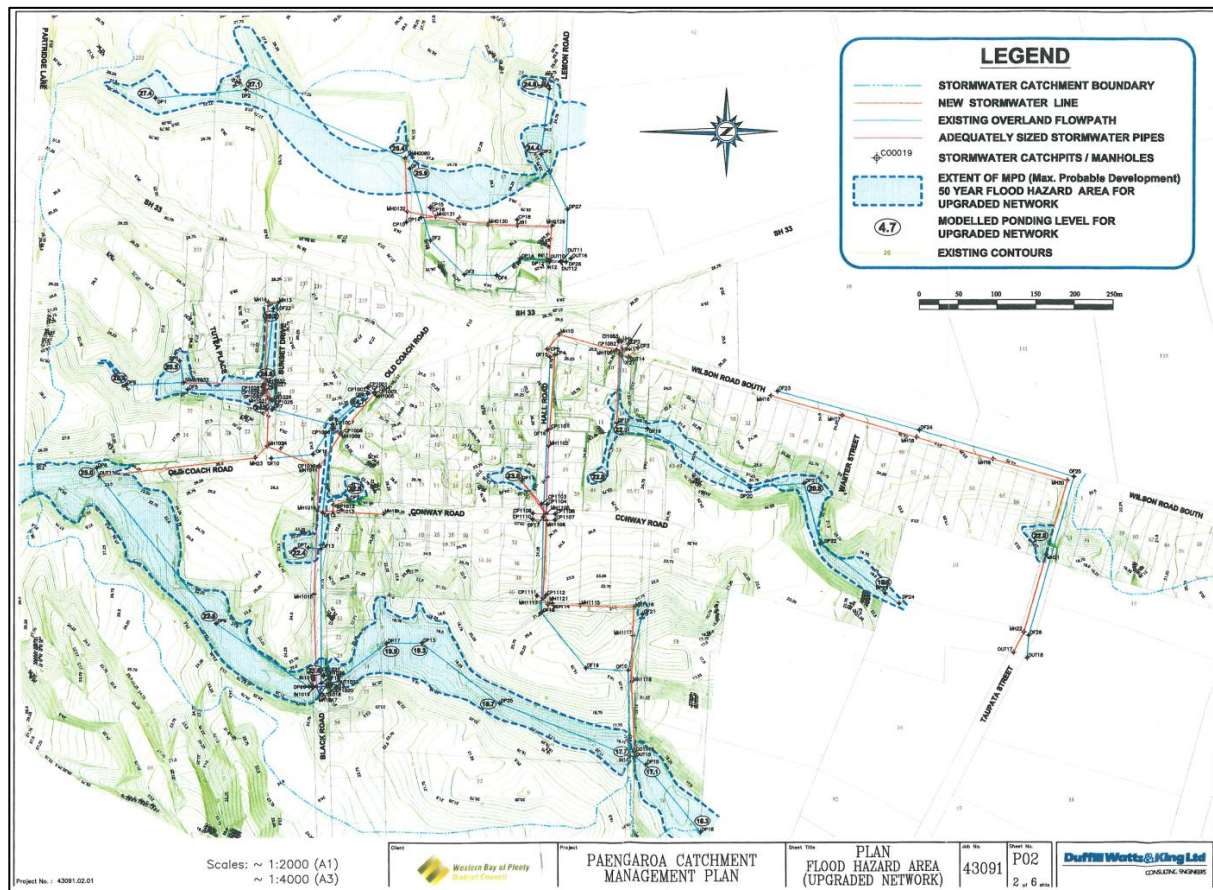
Figure 21 Flood map of Paengaroa Catchment (50-year ARI storm event, figure taken from Duffill Watts 2005)

No specific property or flood depths have been provided in the previous investigations. As an outcome of the network modelling work, stormwater network upgrades were recommended. The recommended network upgrades were based on maximum probable development scenario based on WBOPDC's Code of Practice and District Plan constraints.

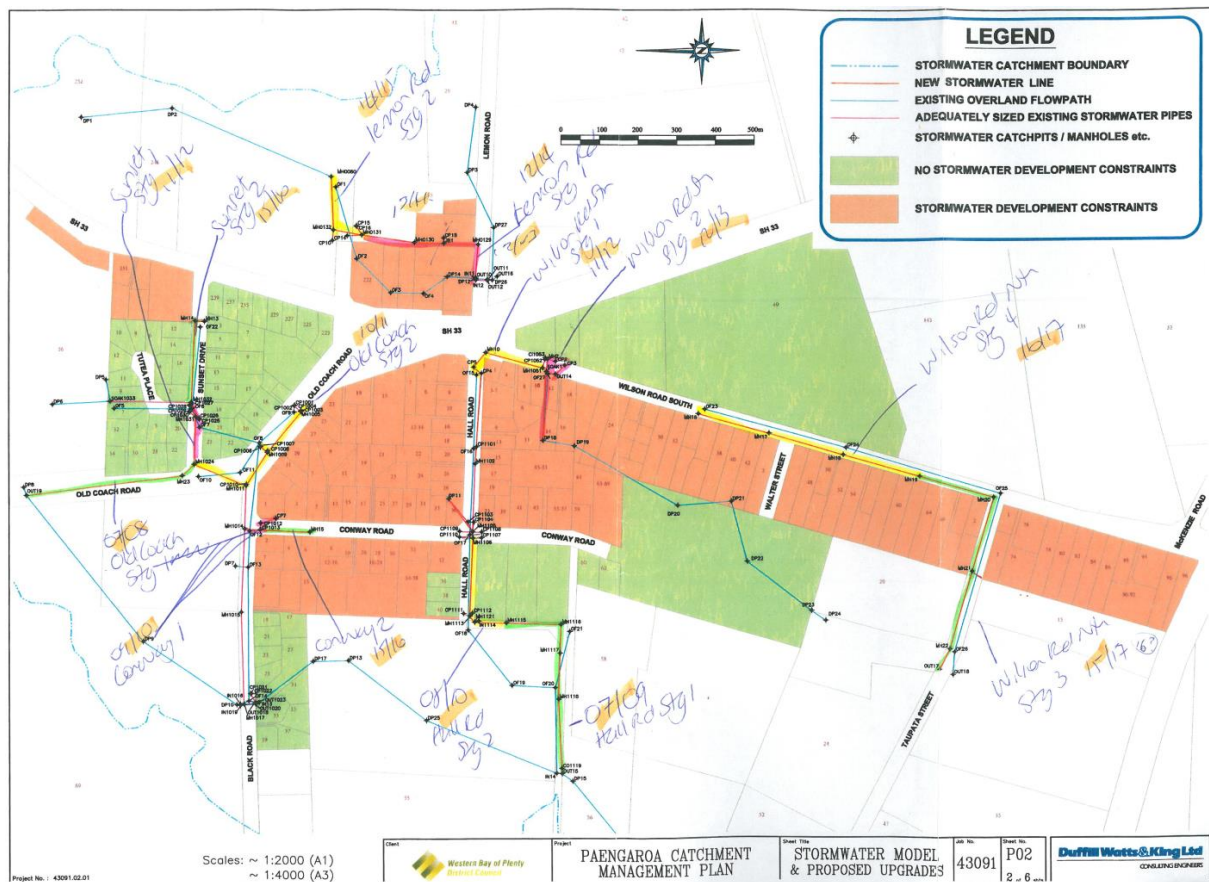
Figure 22 Location of stormwater network upgrade projects within Paengaroa Catchment (Duffill Watts 2005)

These stormwater upgrades were partially completed between 2012 and 2014. Further work is to be undertaken between 2026 and 2034 (i.e. Halls Rd Stage 1 and Stage 2 upgrade).

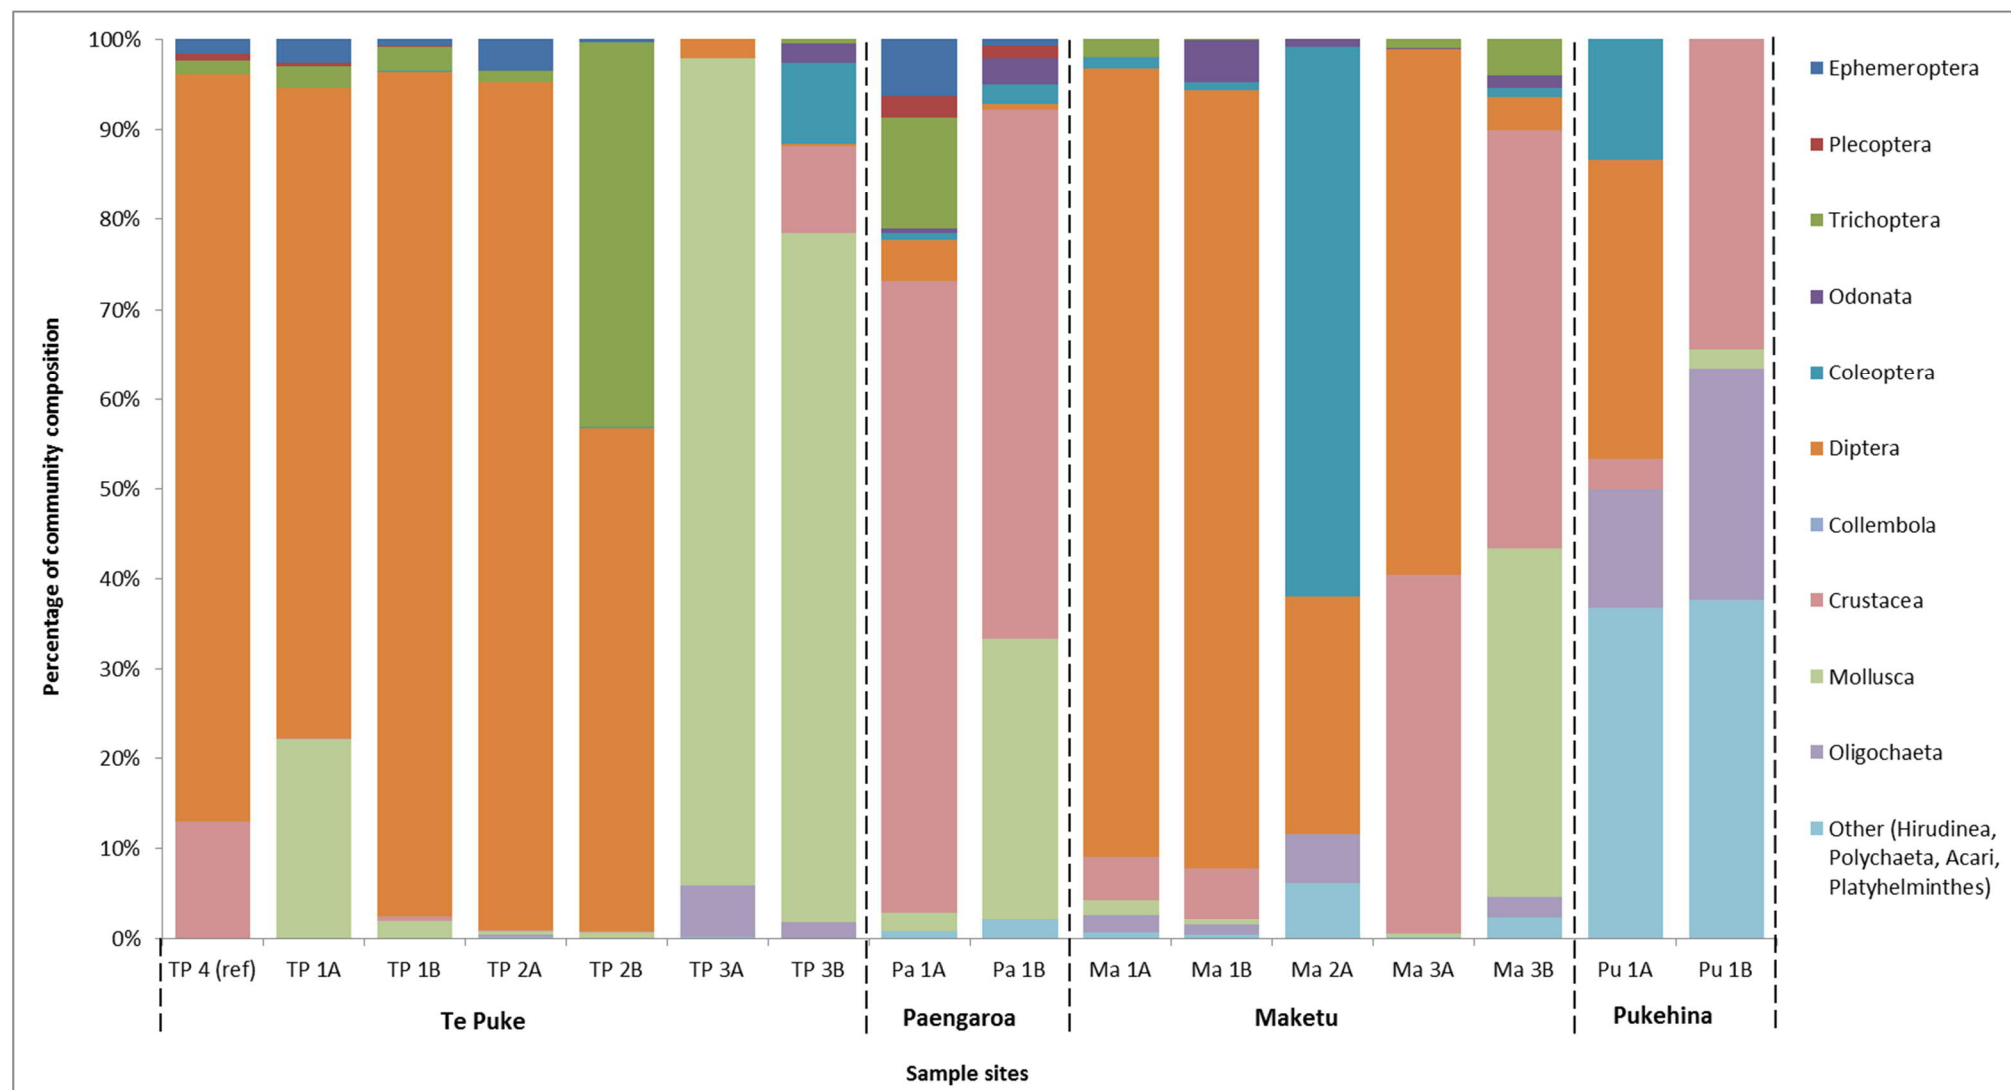
**Figure 1 Macroinvertebrate community composition (%) recorded in 2018 at sample sites in WBOPDC Eastern Catchments**

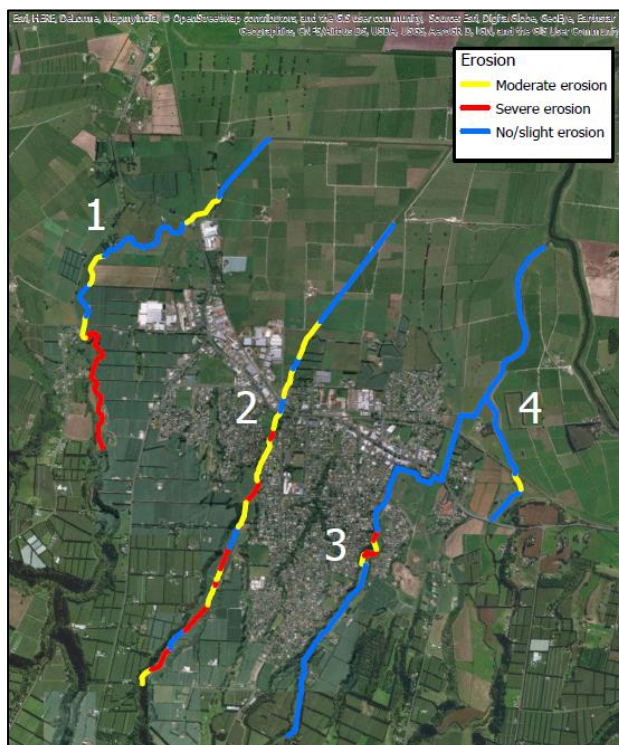
Figure 1 - Map showing stream bank erosion of streams surveyed in the Te Puke Catchment. 1 - Raparapahoe Stream. 2 - Ohineangaanga Stream. 3 - Cannell Farm Drive Waterway. 4 - Waiari River.

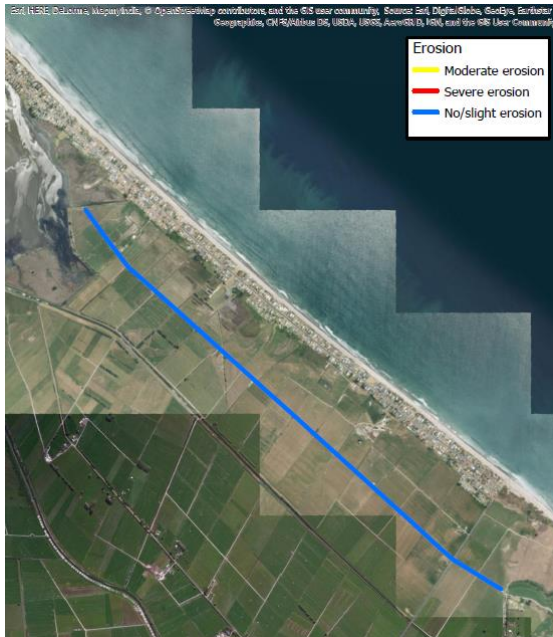
Figure 3. Map showing stream bank erosion of the unnamed canal in the Pukehina Catchment.

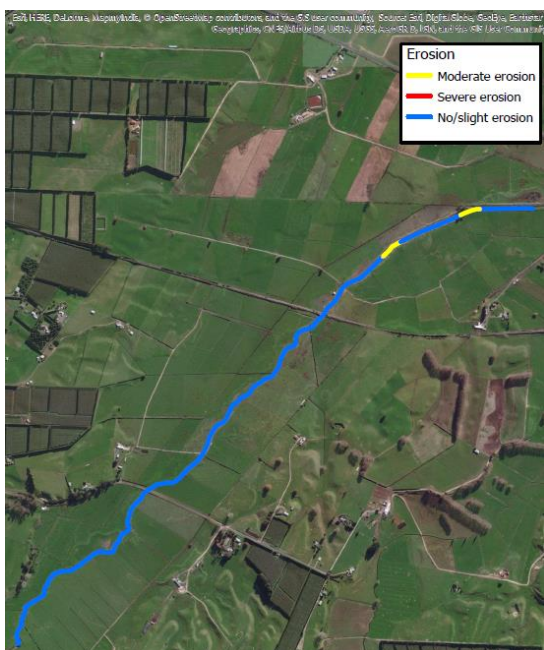
Figure 4. Map showing stream bank erosion of Pokopoko Stream in the Paengaroa Catchment.

One stream, Pokopoko Stream, was surveyed for this catchment. The stream bank of the surveyed reach was largely homogenous, with 'slight to no erosion'. Small areas of 'Moderate' erosion were observed in the lower survey reach.
- **Maketu/Little Waihi:**

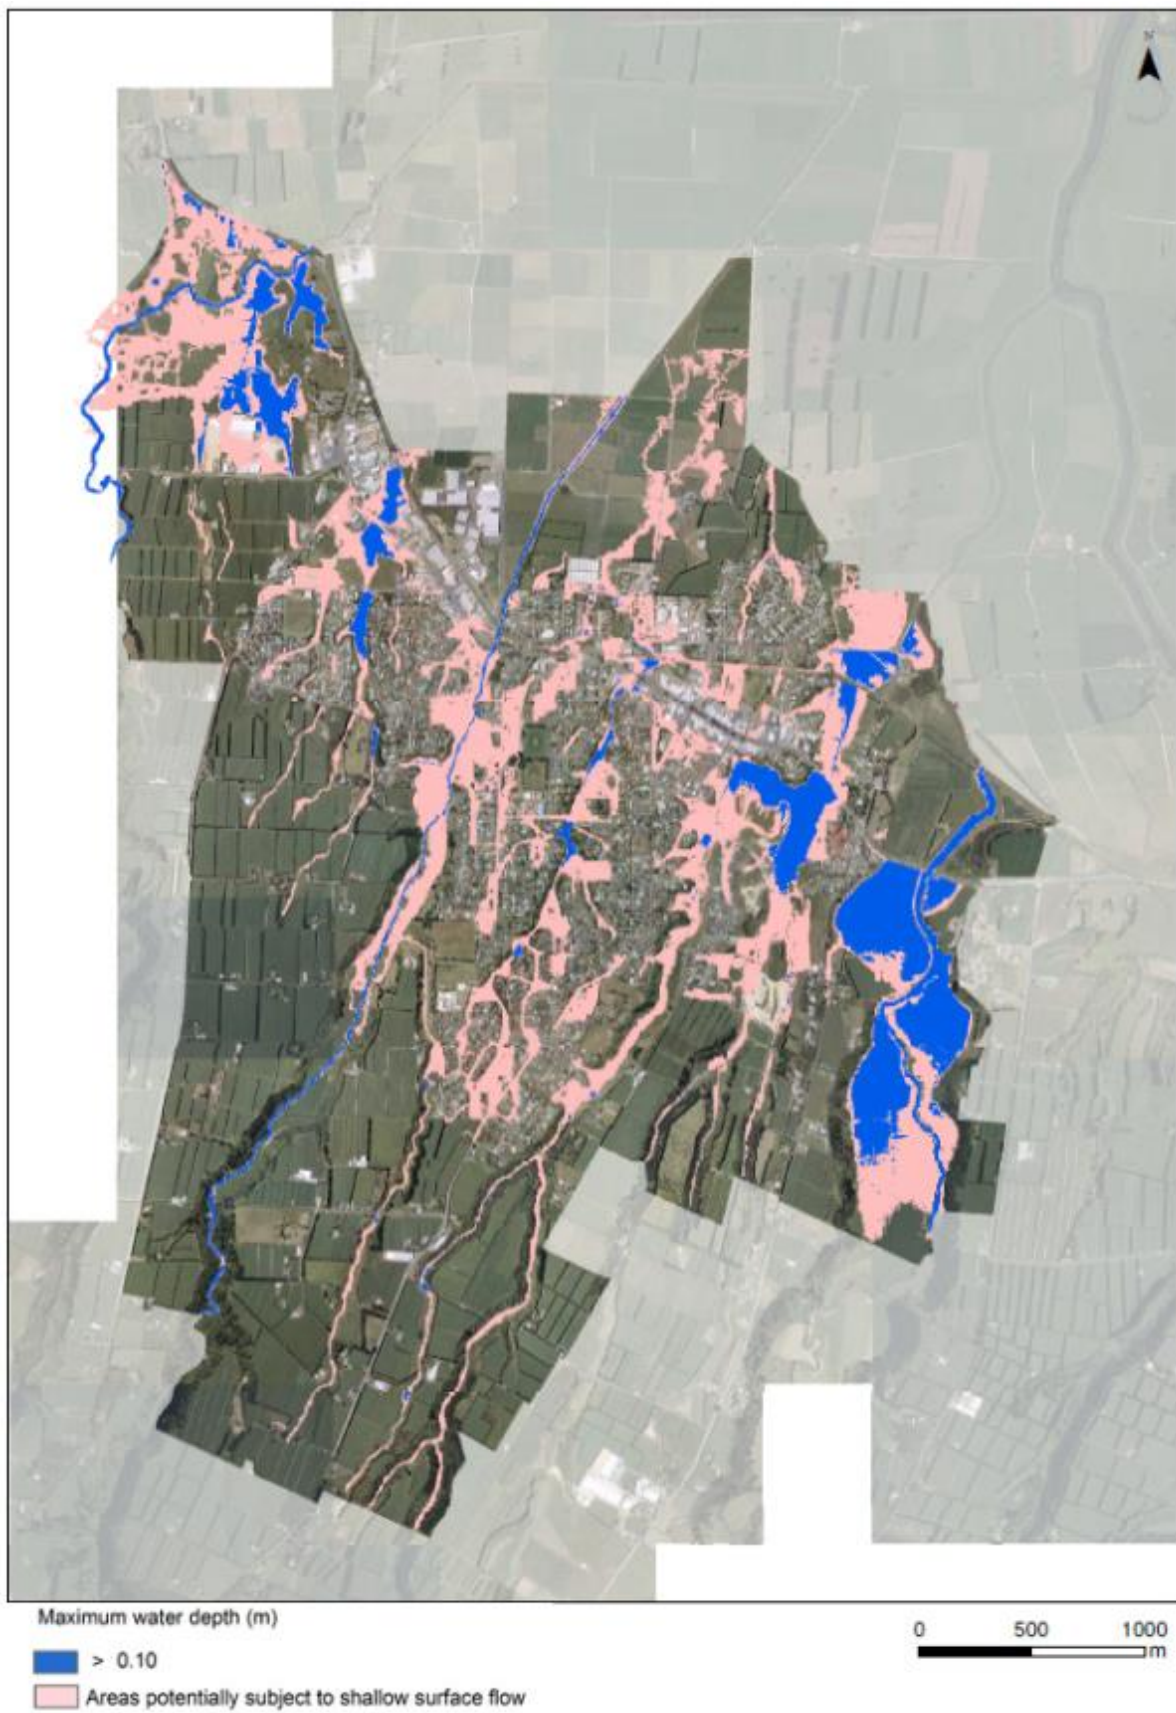
Figure F-2 Te Puke Flood depth for the 50-year ARI, 30-min duration design nested storm rainfall event (from Opus 2014)

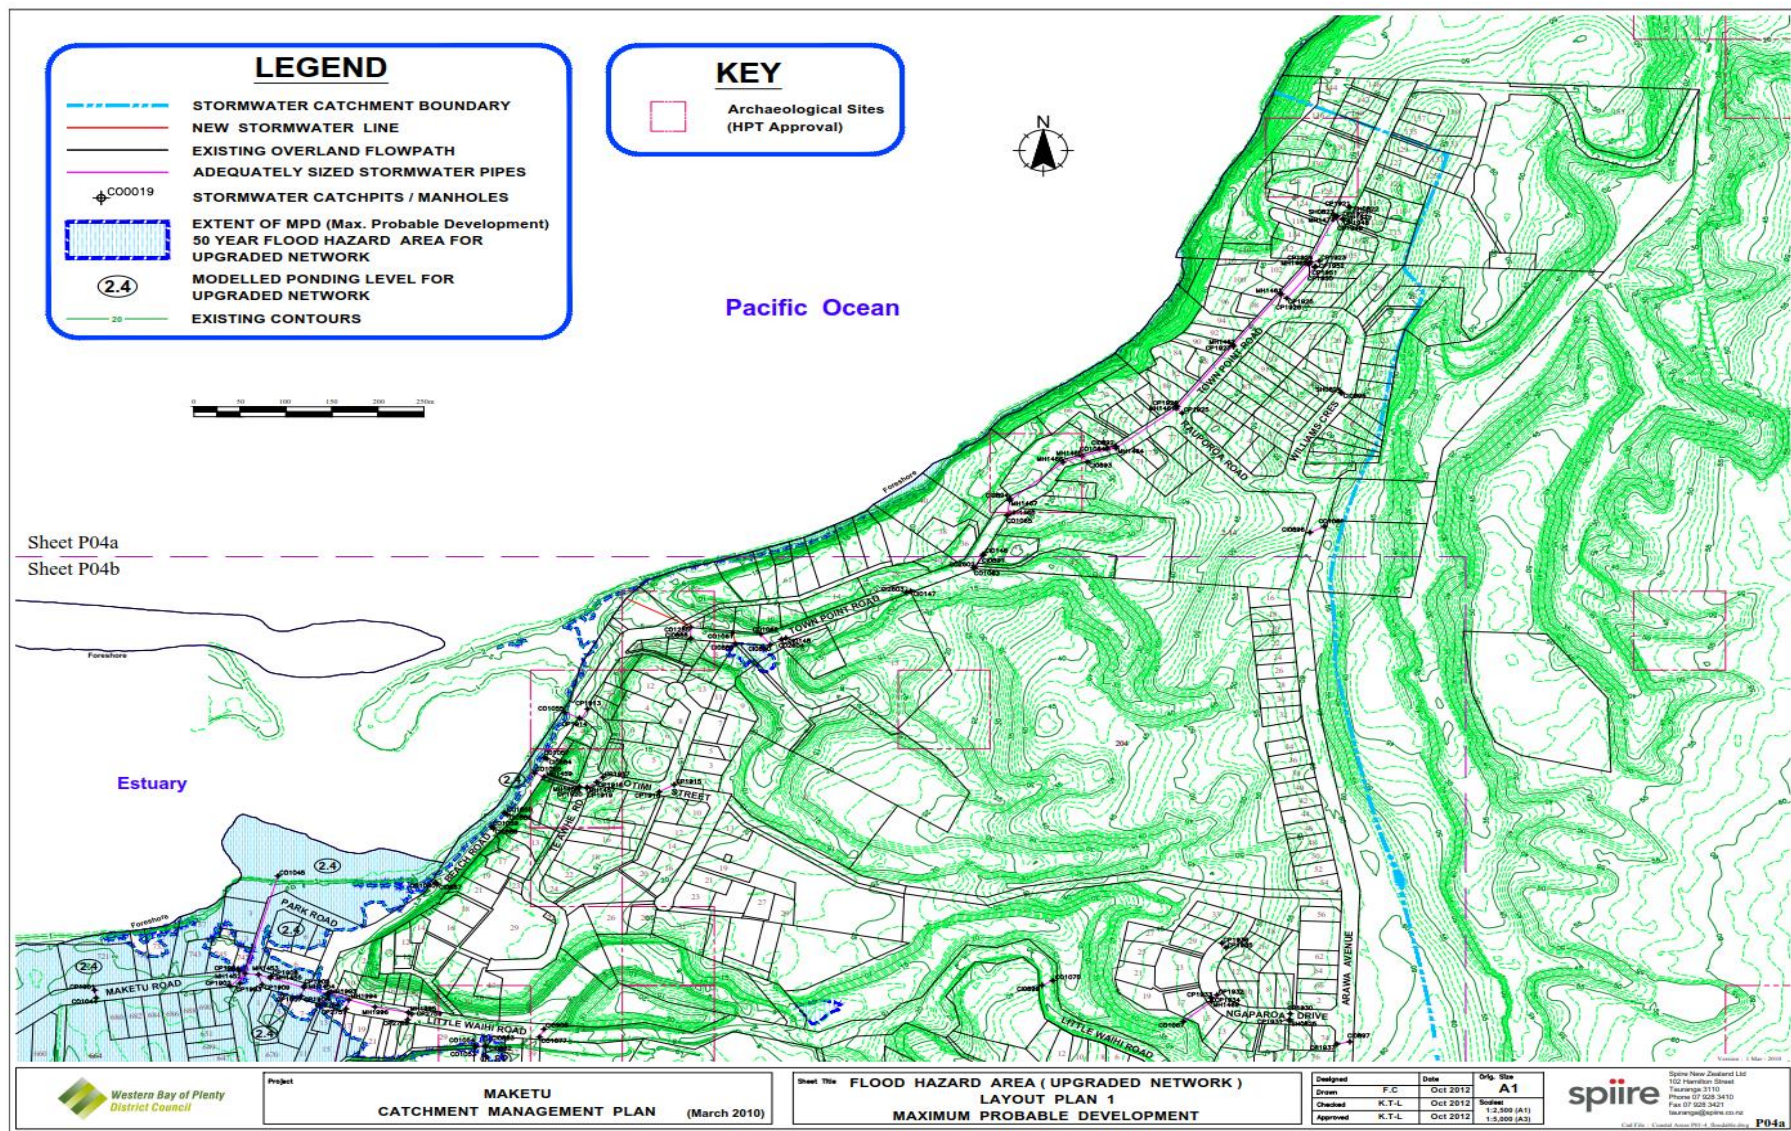
Figure F-6 Flood map (2) of Maketu Catchment (50-year ARI storm event, figure taken from PMS 2013)

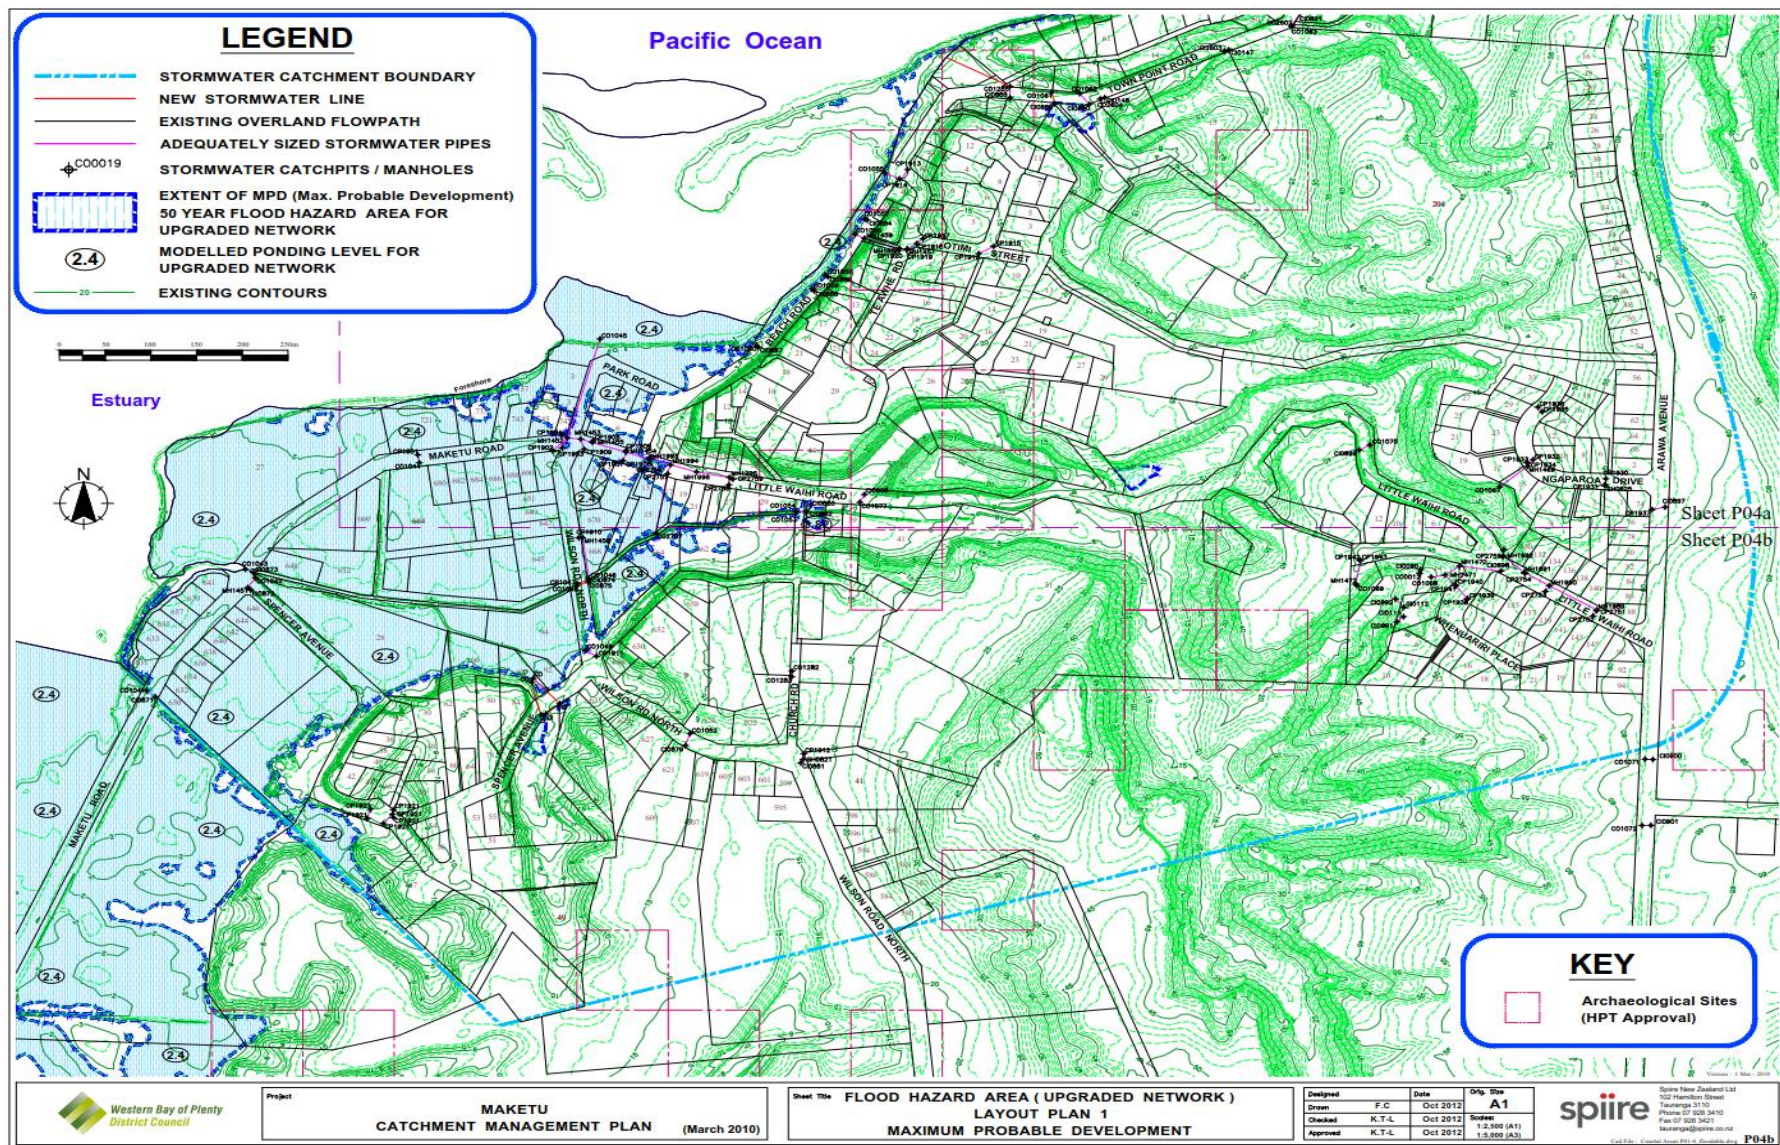
Figure F-7 Flood map (1) of Pukehina Catchment (50-year ARI storm event, figure taken from PMS 2013)

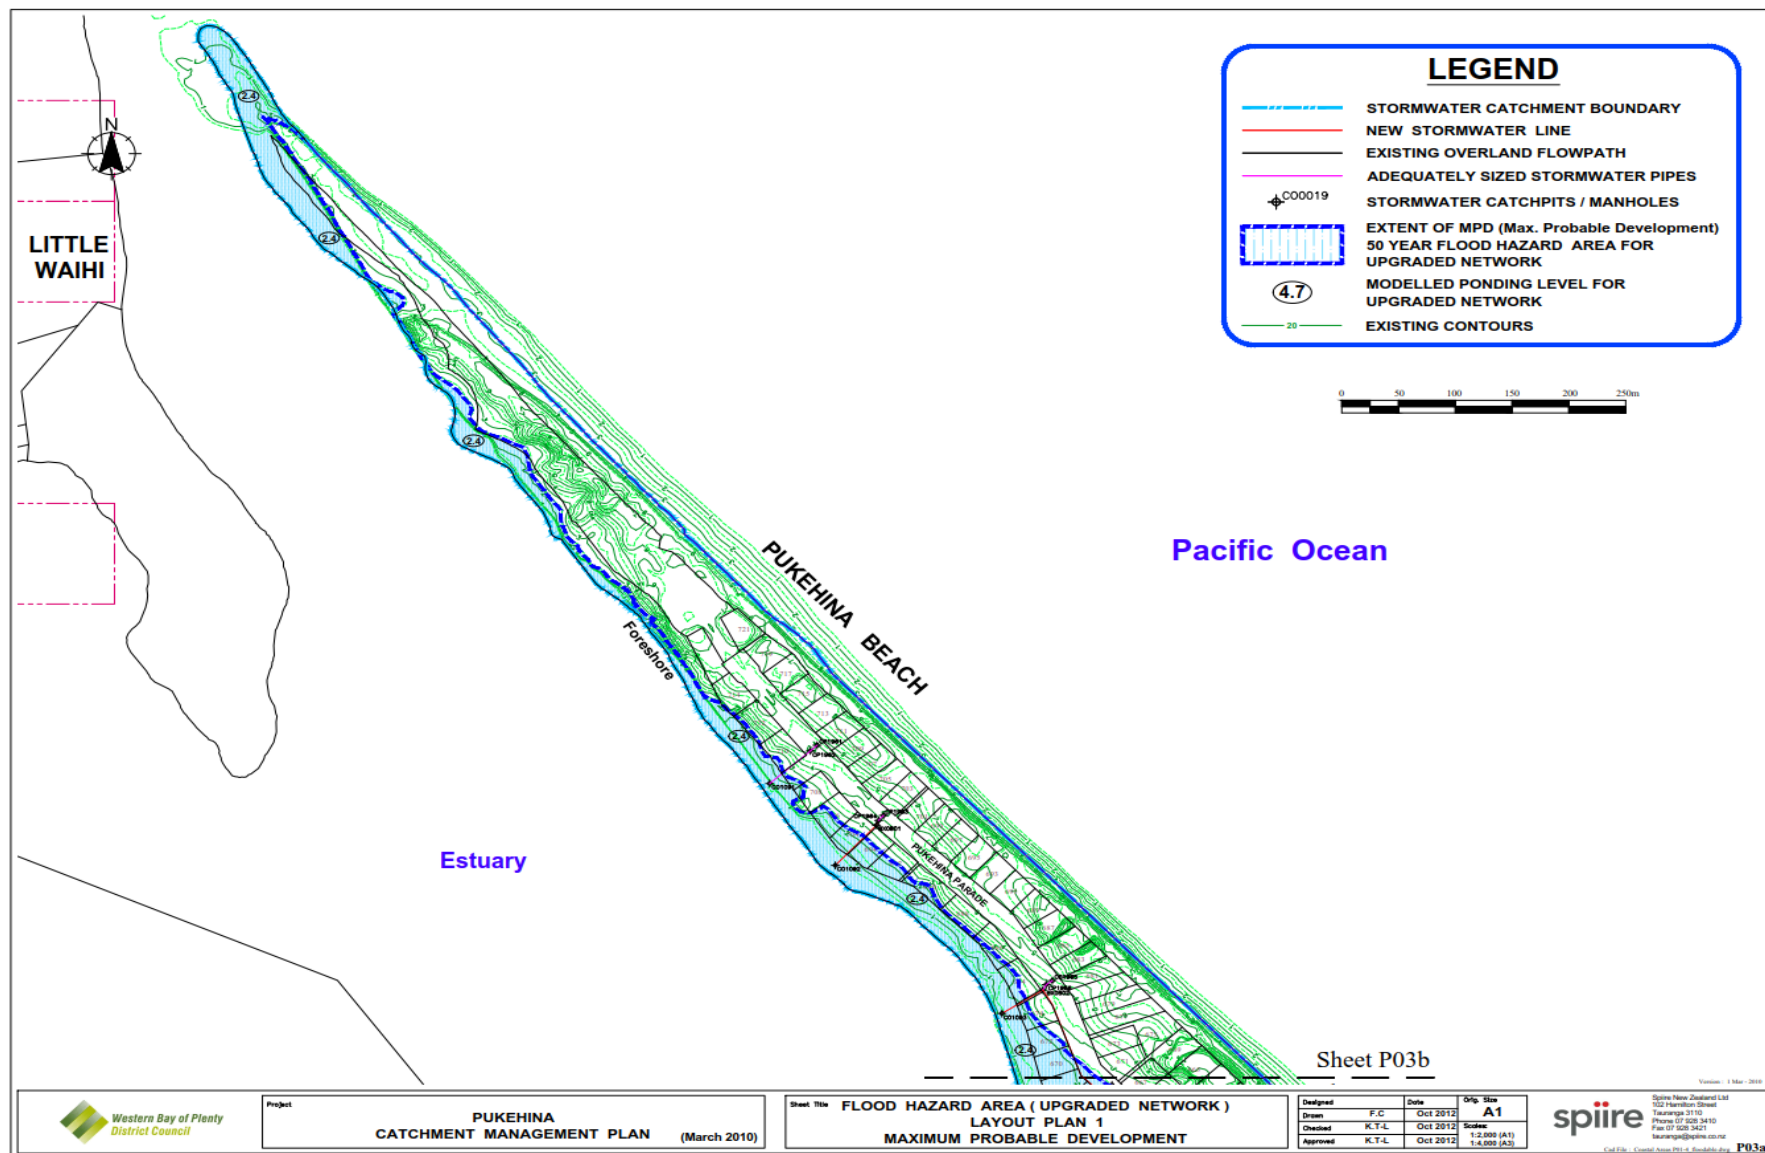
Figure F-8 Flood map (2) of Pukehina Catchment (50-year ARI storm event, figure taken from PMS 2013)

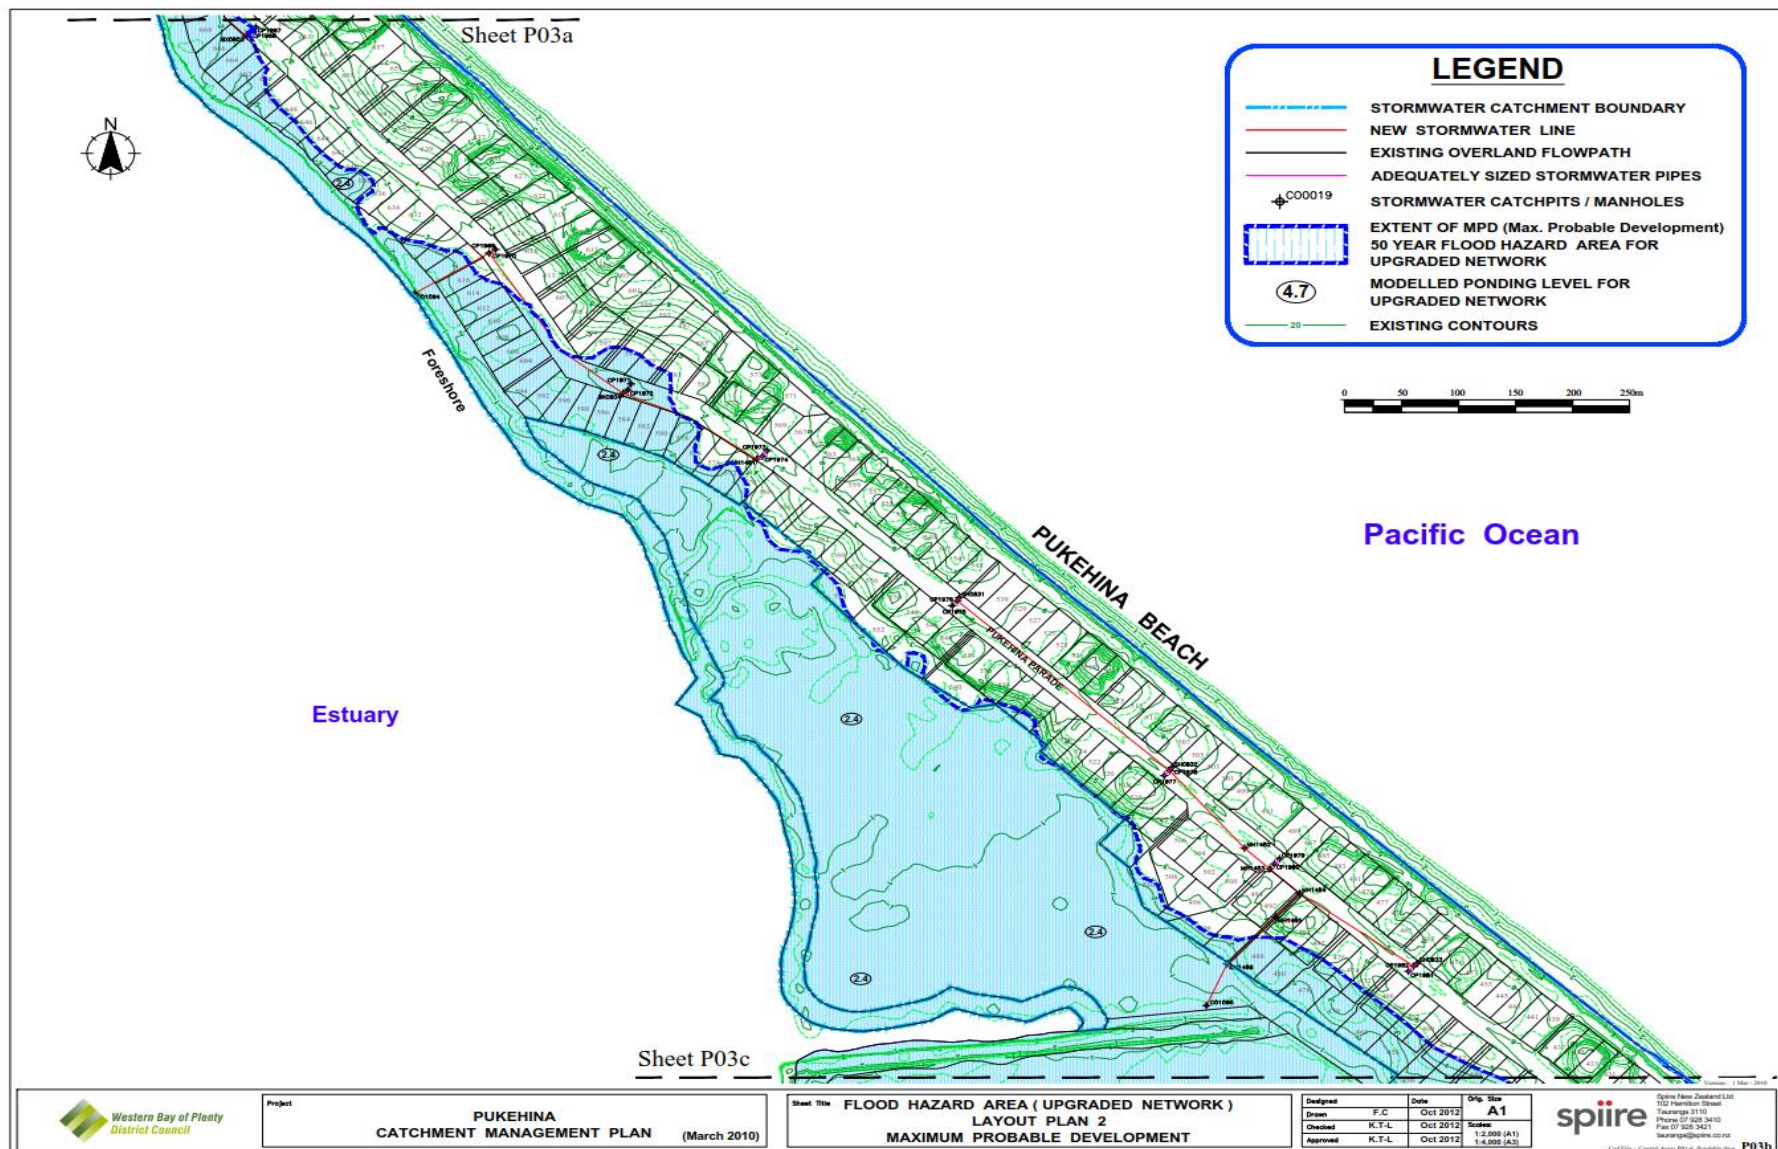
Figure F-9 Flood map (3) of Pukehina Catchment (50-year ARI storm event, figure taken from PMS 2013)

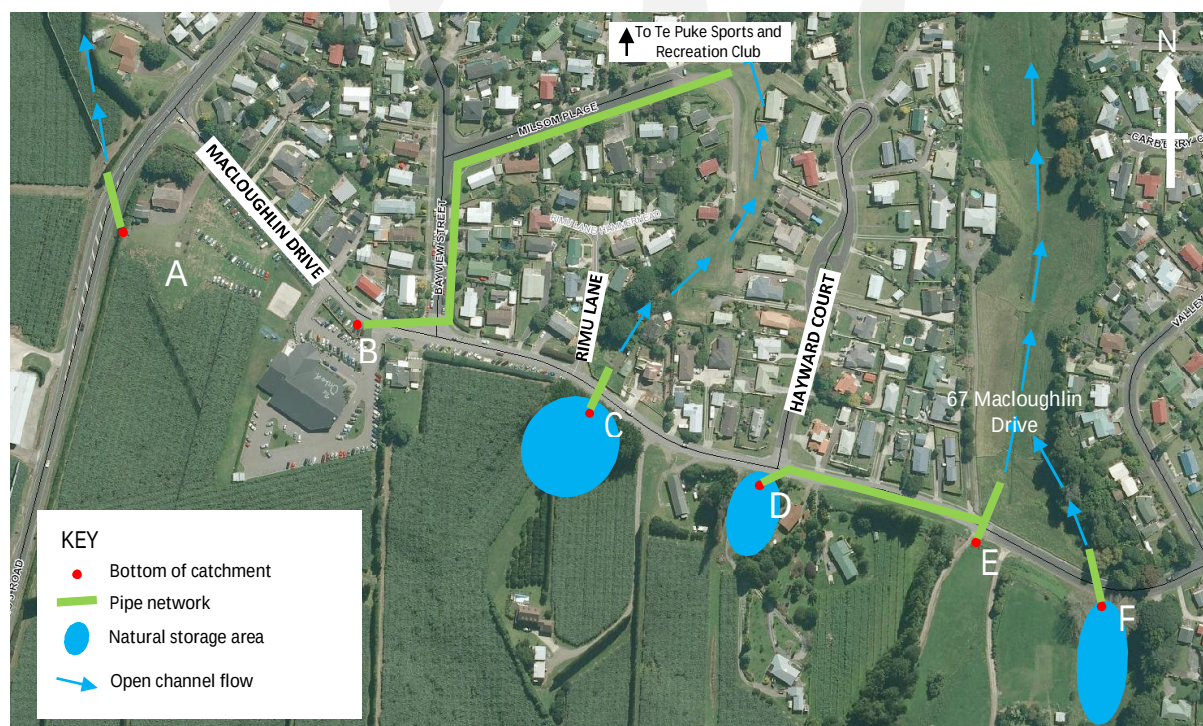
Figure 5: Existing stormwater infrastructure
