# Catchment Management Plan (CMP)

Eastern Catchments - Te Puke and Small Settlements Catchments  
(Paengaroa, Maketu/Little Waihi and Pukehina)

Client: Western Bay of Plenty District Council (WBOPDC)

**AECOM New Zealand Limited**

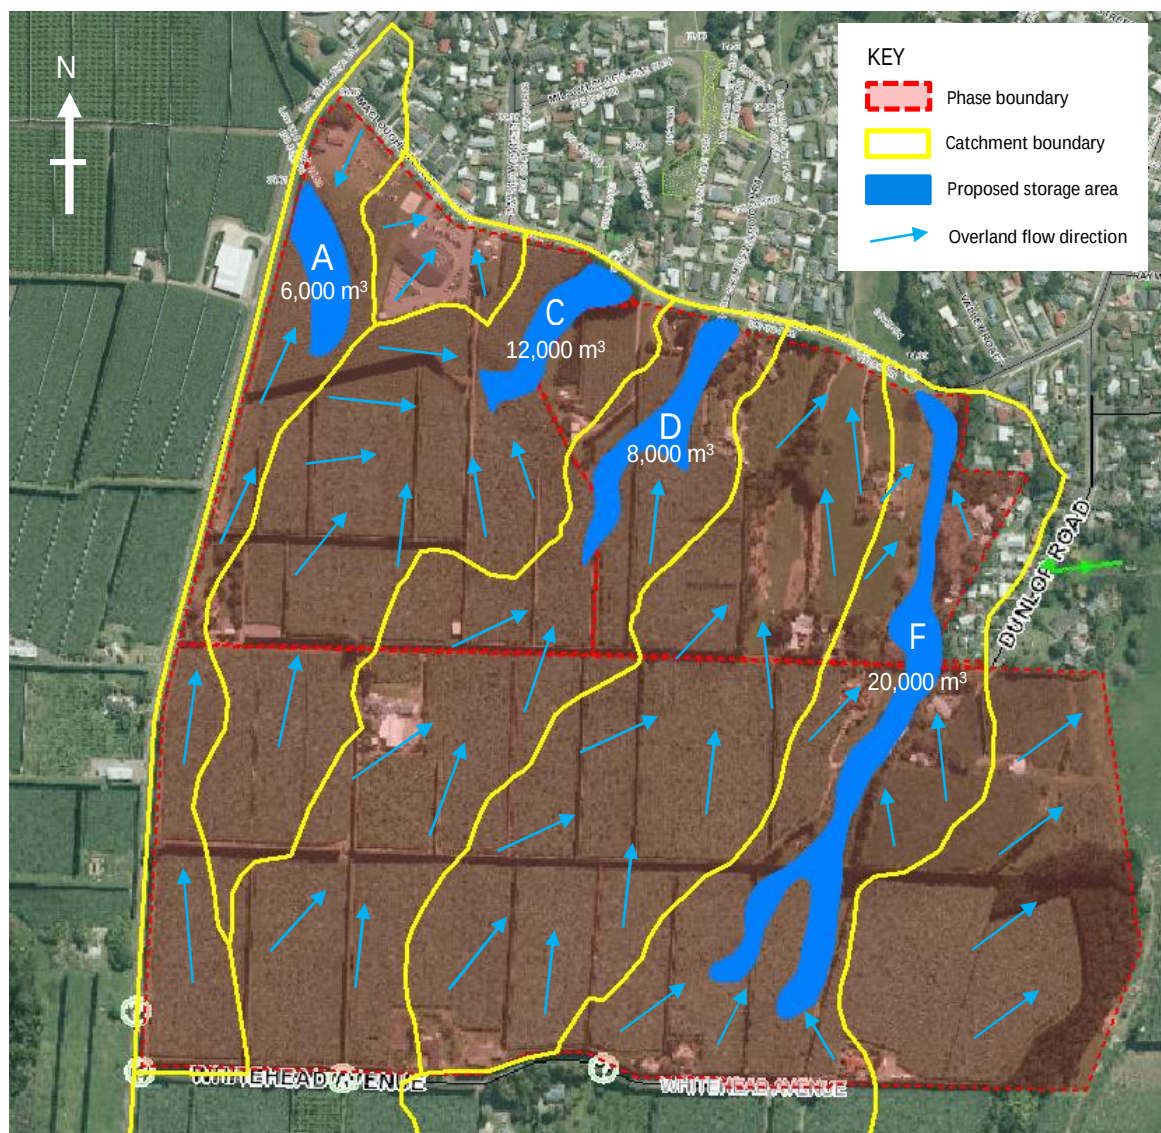
Figure 6: Proposed storage area location and extents
