OPERATIONS AND MONITORING COMMITTEE

OP21
Thursday, 15 August 2019
Council Chambers
Barkes Corner, Tauranga
9.30am

Prepared by Beca Limited

5 July 2019

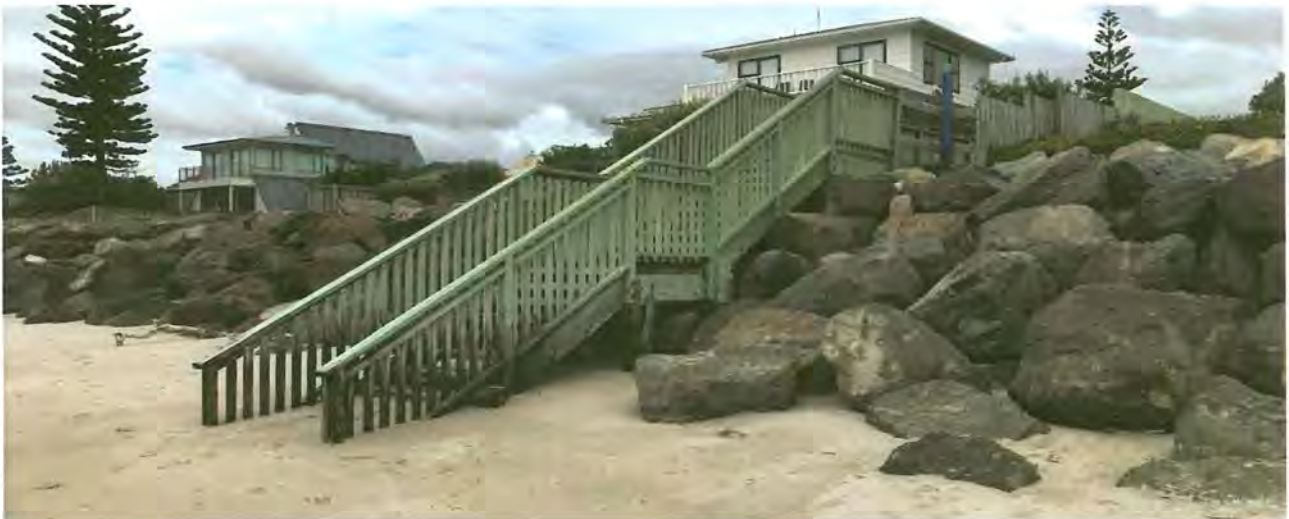
Figure 3 – Seawall showing accretion at seawall toe and a public access structure over the wall

There are formalised public access points to the beach, with substantial access structures, constructed at intervals along the length of the seawall (Figure 3).

At the date of the inspection the beach appeared to be in an accretional state – refer to Figure 3. There were no instances of scouring at the seawall toe, though it should be noted that sand migration is seasonal and movement of sand to offshore bars would be expected in winter months or during storm events. This seasonal sand movement was confirmed by Kelvin Hill (WBoPDC) who noted that the toe of rock armoring is sometimes exposed during winter months.

Smaller-sized rock approximately between 0.3 - 0.4m Ø was observed on the crest section which would be outside the lower limits of the riprap grading. Such rocks, which are not well interlocked, would be unstable in wave overtopping conditions.

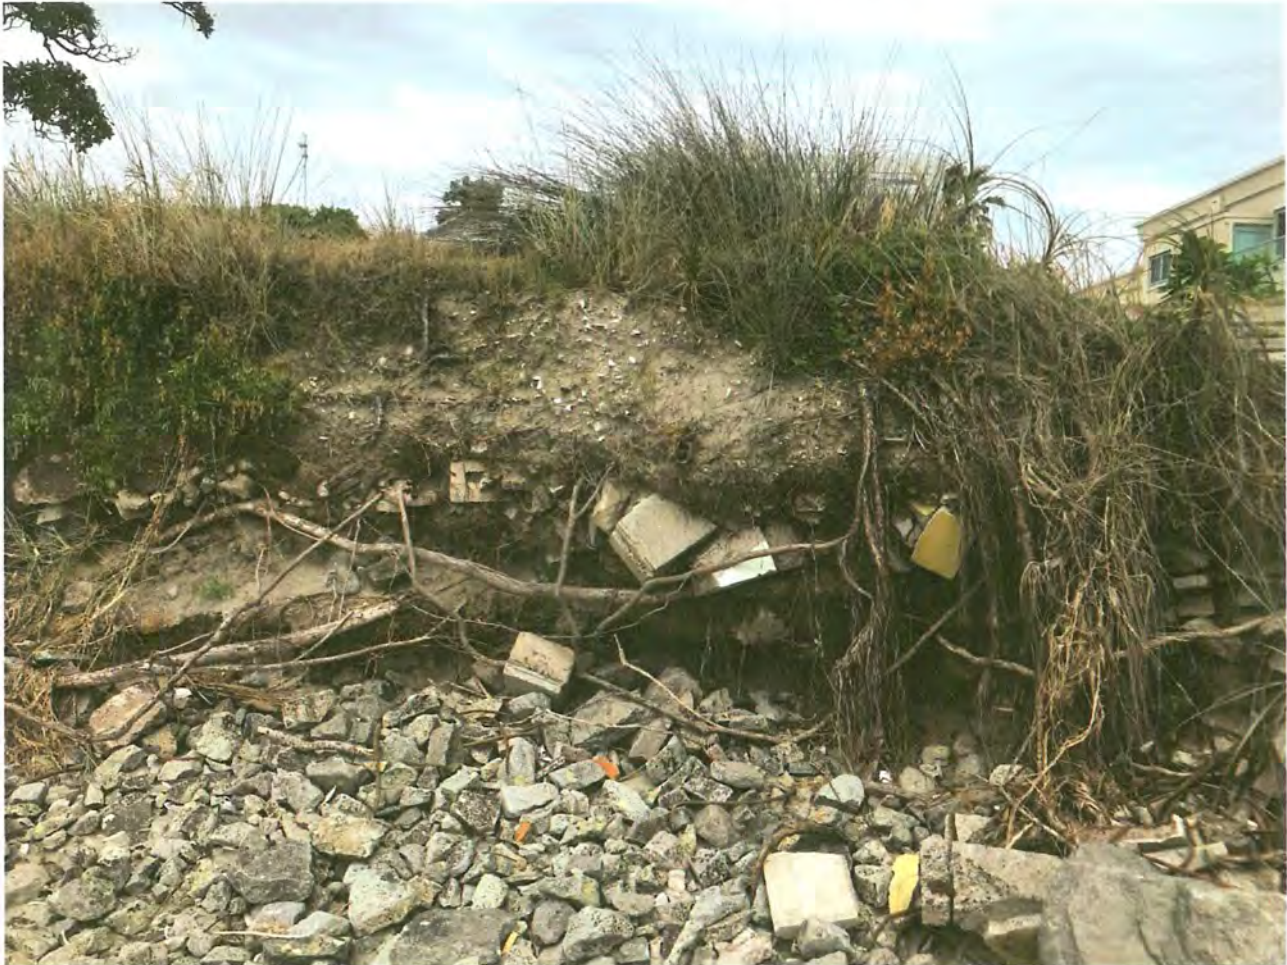
Figure 6 – Vertical bank littered with buried construction debris (Section A-A)

The bank slope is generally vertical and approximately 1.8 – 2.2m high, with sporadic inclusion of buried construction debris (Figure 6). The top of the bank line meanders inside the property boundary in many cases and the crest line shows active areas of erosion.

From 2011-2013 there was regular beach profile monitoring. This indicated that the dune embankment had a slope of approximately 1V:1H during 2011-13. Although no profile measurements were taken as part of the site visit, the dune material is observed to have eroded to a vertical face.

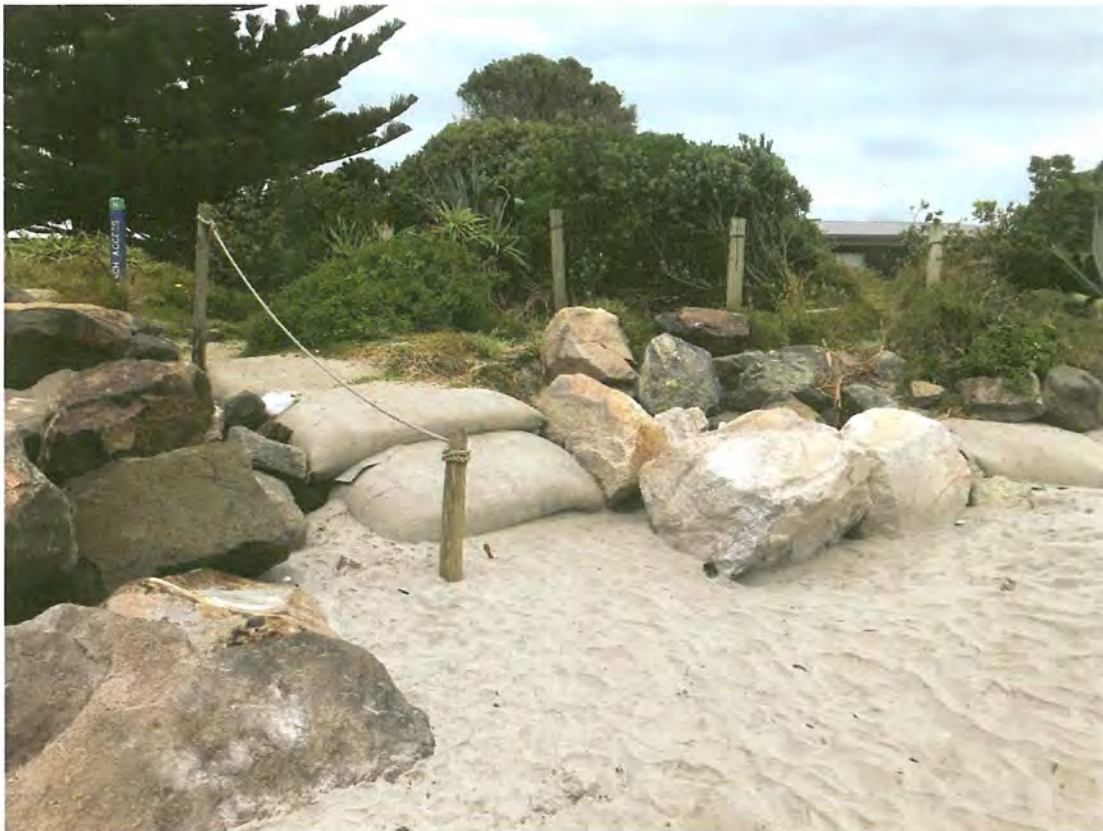
Figure 7 - Northern Seawall Northern Termination

The northern seawall termination at the northernmost end (refer to Figure 7) does not currently have an adequate transition to the dune system. There is also a walkway located at the transition formed by sand bags (Figure 7). Minor erosion is observed at the rock/ dune interface and there are only scattered rocks at this location. The rock should be replaced in this location to protect against potential outflanking and vegetated sand placed over the buried rock in this location. It is possible for these minor works to be undertaken as maintenance works in accordance with condition 10.1 of the resource consent¹.

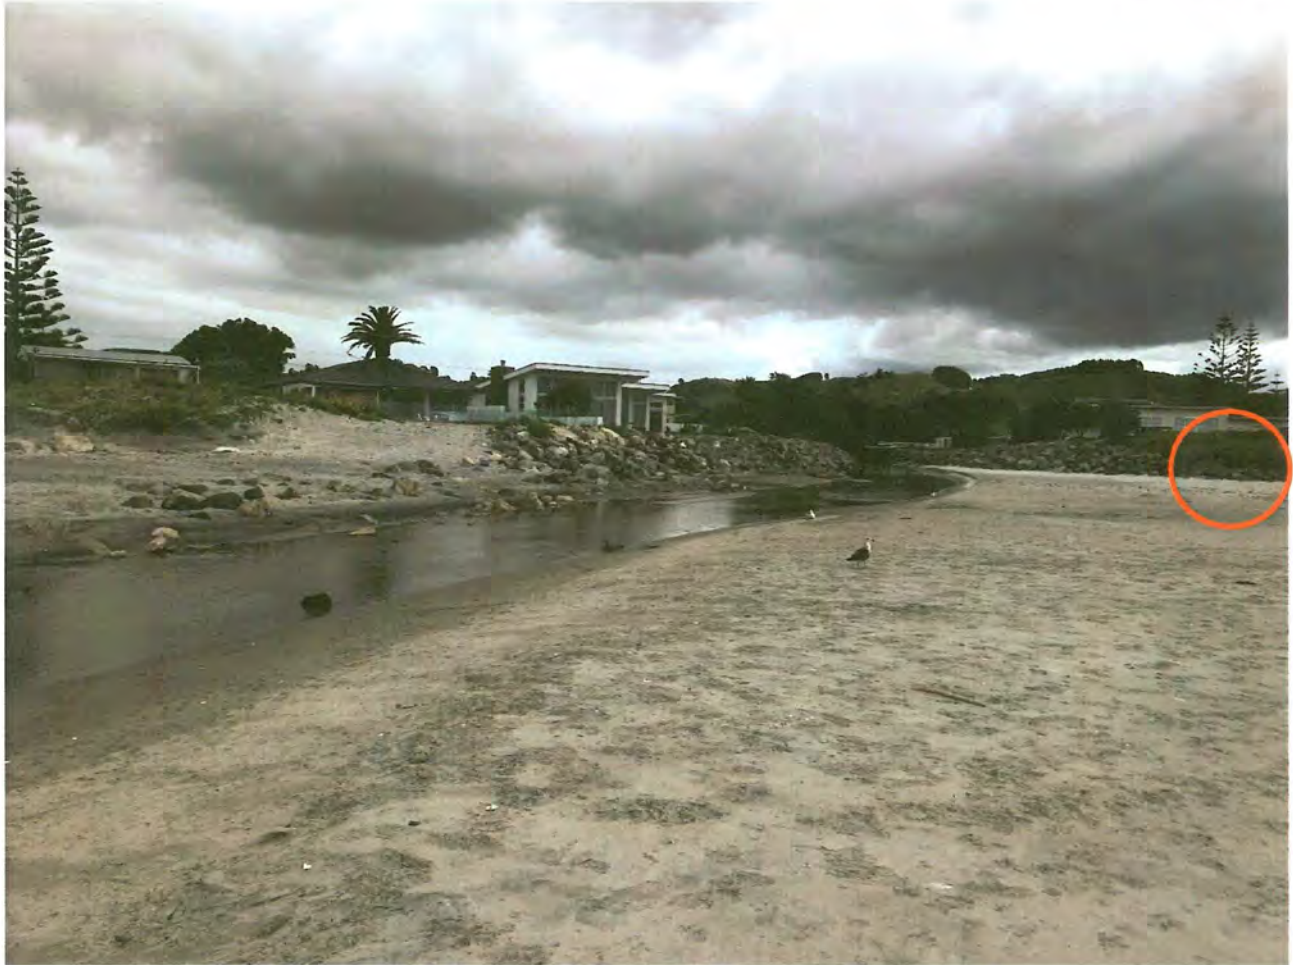
Figure 8 – Two mile creek showing rock training walls and northern seawall transition (red circle)

The northern seawall transitions into the Two Mile Creek training wall structure at its southern end with some rocks and a well vegetated dune area behind which provides continuous protection of the properties behind in this area (Figure 8).

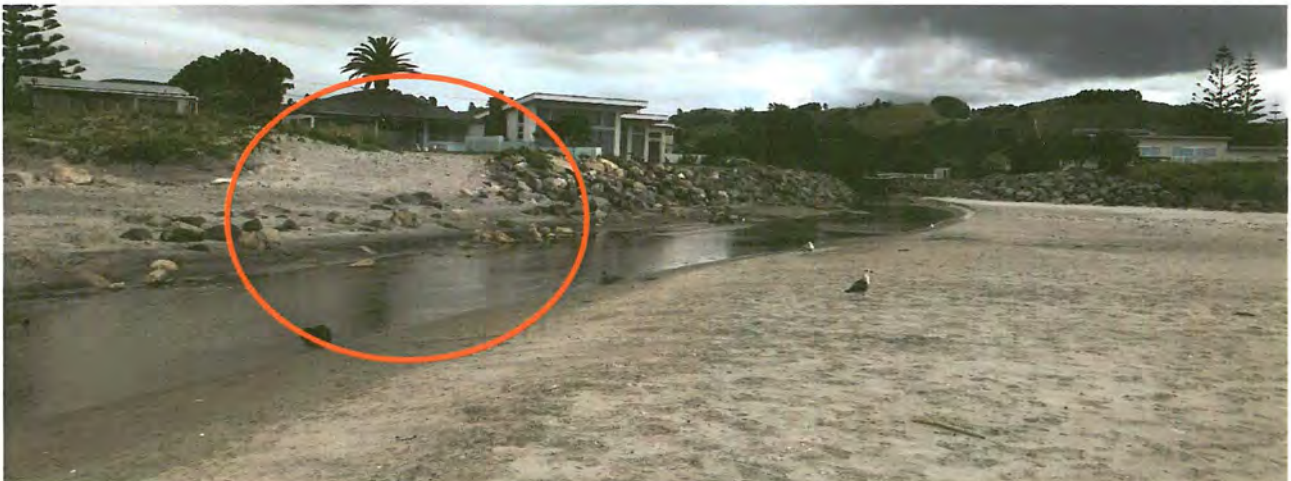
Figure 10 - Beach Access and Dune Tie-In (red circle)

At the termination of the southern rock training groyne (refer to Figure 10) there is an unvegetated sand bank approximately 20m in length which appears to be used as a pedestrian accessway or small boat ramp onto the beach. There is no vegetated dune in this location and this means this area may be particularly susceptible to erosion in the future. Vegetation in this area will assist in stabilising the dune and so WBOPDC may consider planting as a priority in this location.

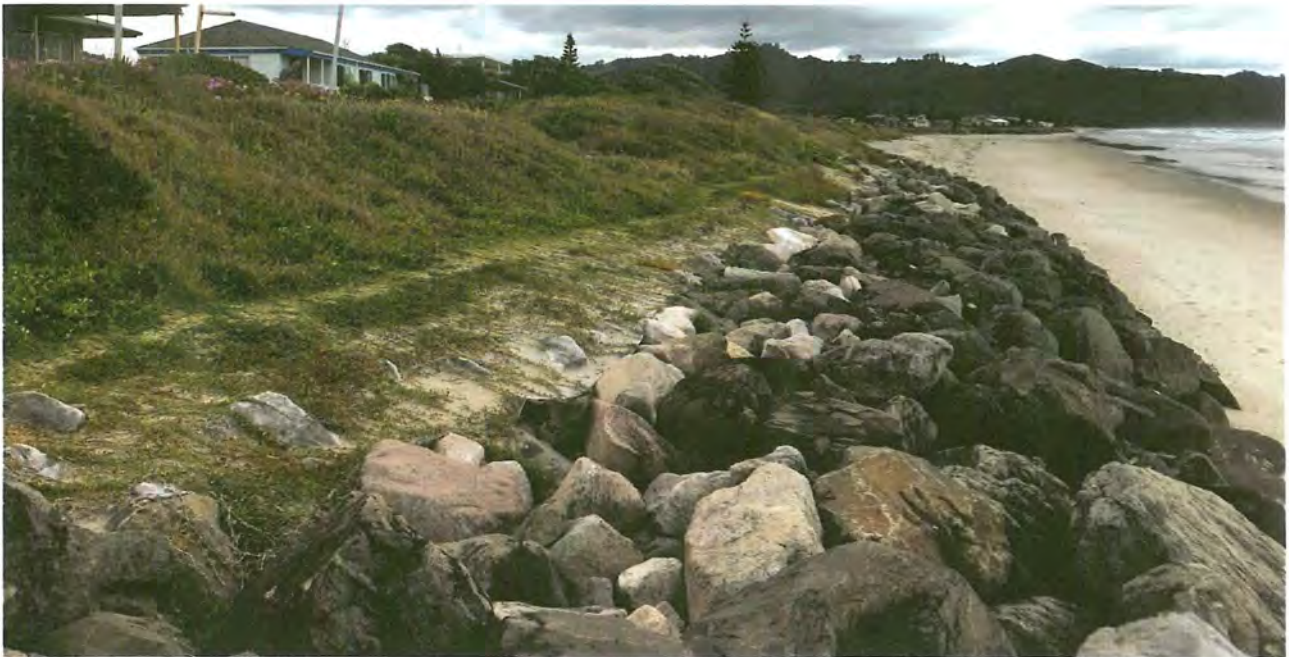
Figure 11 - Pedestrian Walkway Parallel to Seawall Crest (Section F-F)

The rock armour appears to be stable and the average rock size diameter is 1.0m Ø. There are no signs of erosion at the crest. There is a minor quantity of small rock on the seawall crest which is undersize for typical riprap grading. There is a pedestrian thoroughfare running parallel and adjacent to the crest of the seawall – refer to Figure 11.

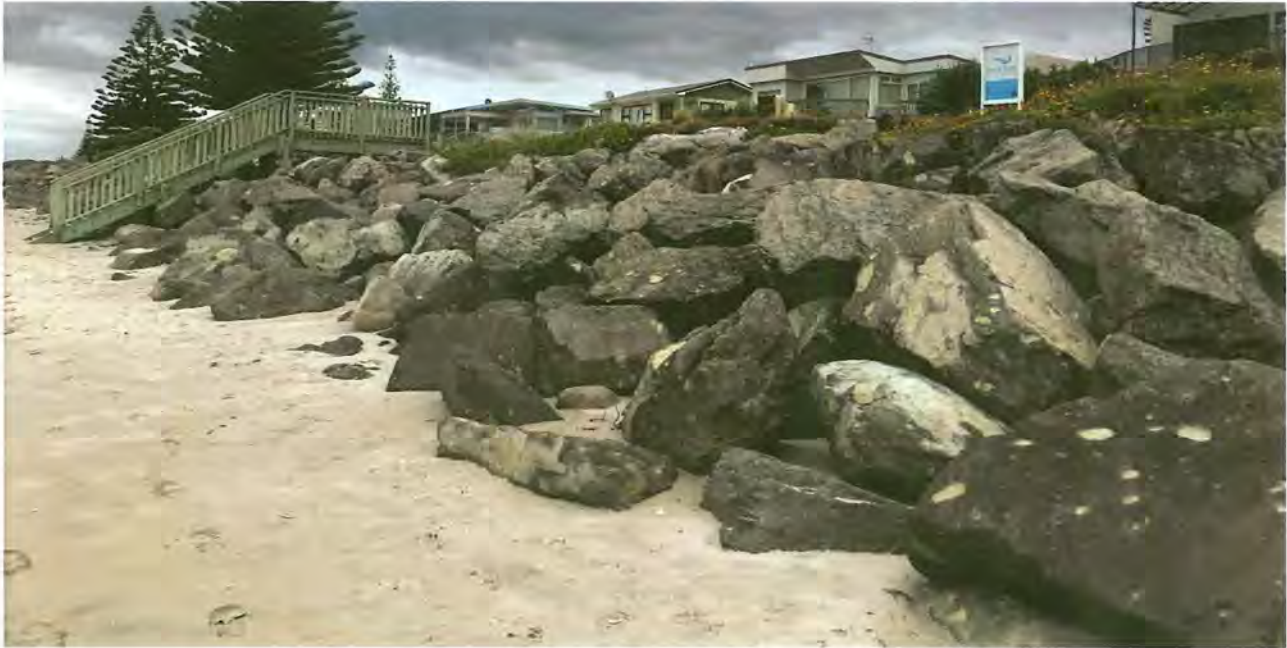
Figure 12 – Seawall Condition and Slope (Section C-C)

Figure 12 in the fore area of the photo shows a zone where rock interlocking and placement could be improved.

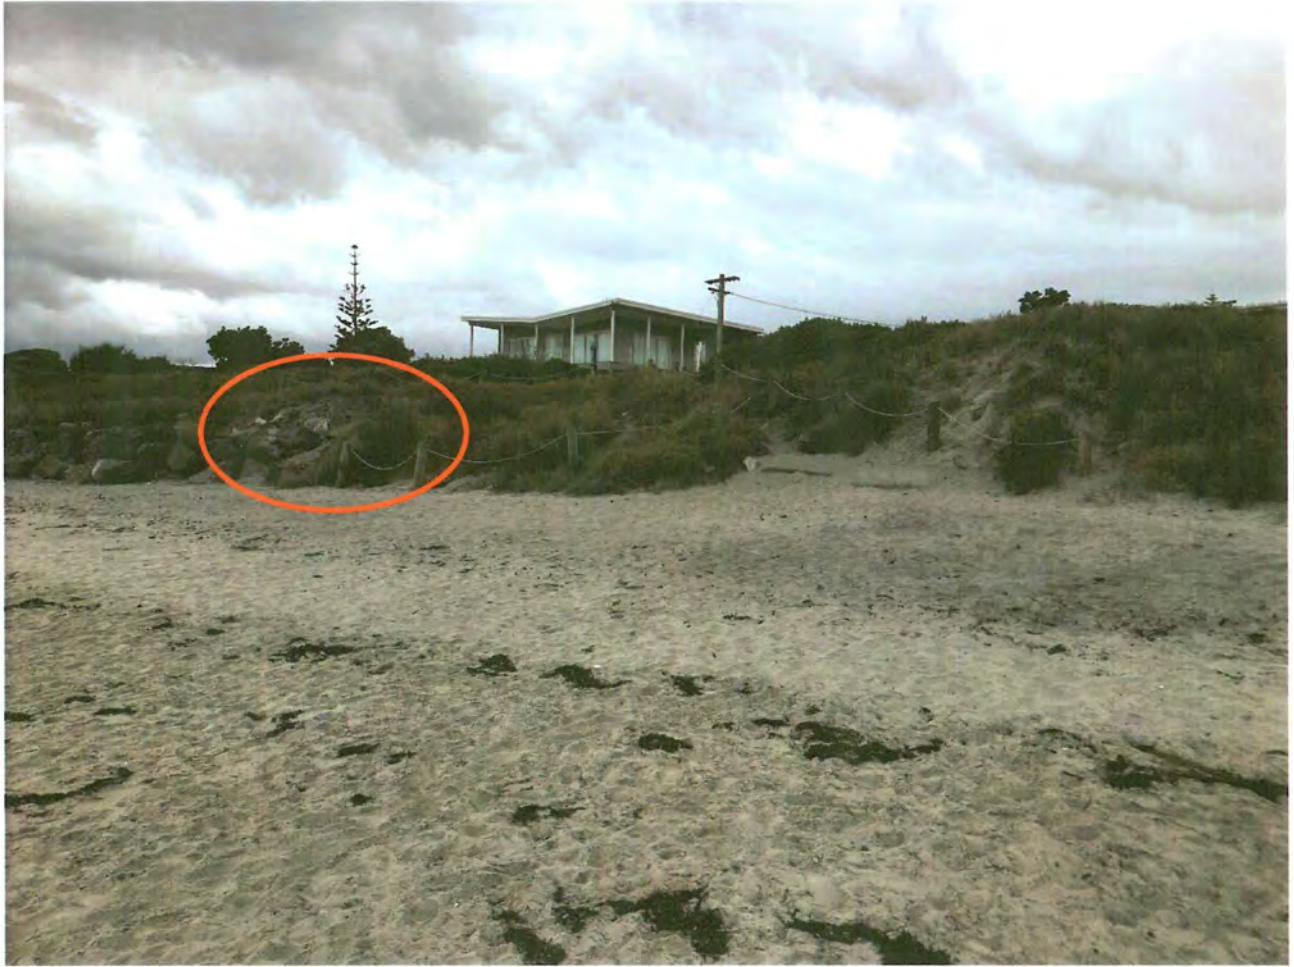
Figure 13a - Northern Termination of the Southern Seawall (red circle shows minor end effect erosion)

The terminations (both northern and southern) of the southern seawall are not well constructed (Figure 13a and Figure 13b). There is minor end effect erosion observed at the northern termination (Figure 13a) and more significant end effect erosion at the southern end (Figure 13b). Seawall terminations will always need maintaining and natural beach processes may continue to result in recession of the dune profile outside the seawall zone.

Maintenance Works: The end wall effect experienced on both the southern and northern seawalls needs to be addressed. The report from Beca provides engineering solutions to manage this and staff will look to undertake these repairs during this financial year.

5. Modify the existing seawall. This would be for the purpose of minimising end effect erosion and would consist of constructing end wall transitions at the southern and northern seawall termination points. This upgrade item can be undertaken independently or in conjunction with patch repairs (option 1). A suggested preliminary engineering design for the more significant end effect erosion at the southern termination of the southern seawall is provided in Appendix D. Any modifications to the existing seawall structure that are in line with the originally consented structure may be considered within the existing resource consent and therefore potentially not require a variation or new consent from the Regional Council³.

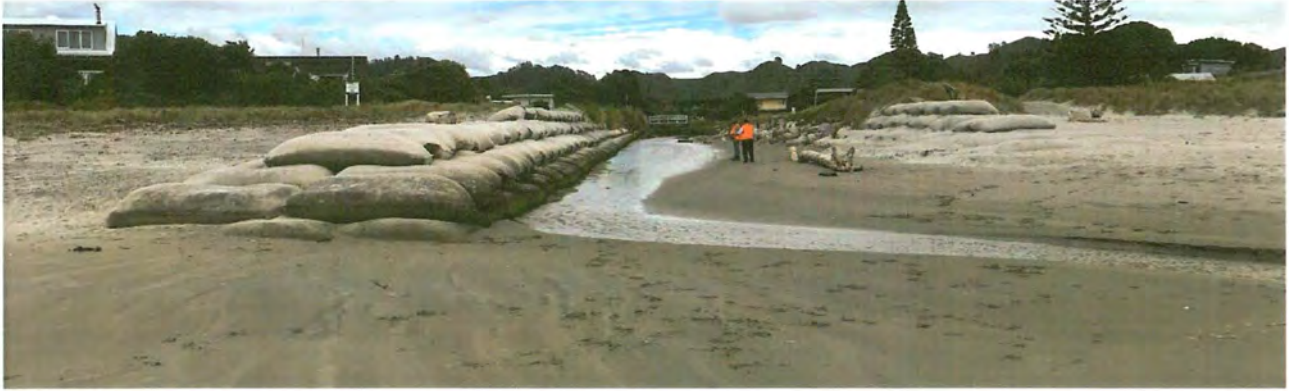
Figure 15 - Three-mile Creek Mouth

There is also apparent sand build up either side of the training walls providing localised increased beach volumes that provide an increased erosion buffer for the backshore area (Figures 15 and 16). This accumulation is not unexpected particularly over moderate time scales for shorelines that are dynamically stable with close to zero net littoral drift. In these situations sediment accumulates either side of the walls until it is bypassed, either over the top of the walls or around the seaward toe of the training walls. The sediment volumes accumulated either side of the training walls are likely to be highly dynamic during short term storm events, ranging from sedimentation to lee side erosion. Sediment deposited in between the training walls is either scoured during creek discharge events and deposited at the lower beach or, during periods of low flow where there is insufficient sediment transport potential, sediment is likely to accumulate requiring ongoing removal. WBOPDC have a resource consent to undertake this periodic removal of sand and this will need to continue to keep a channel open for the creek. The durability (life) for geosynthetic material can be expected to be 20-30 years. Damage to bags from sharp objects (particularly through vandalism) will necessitate replacement of the affected bags periodically to maintain groyne integrity.

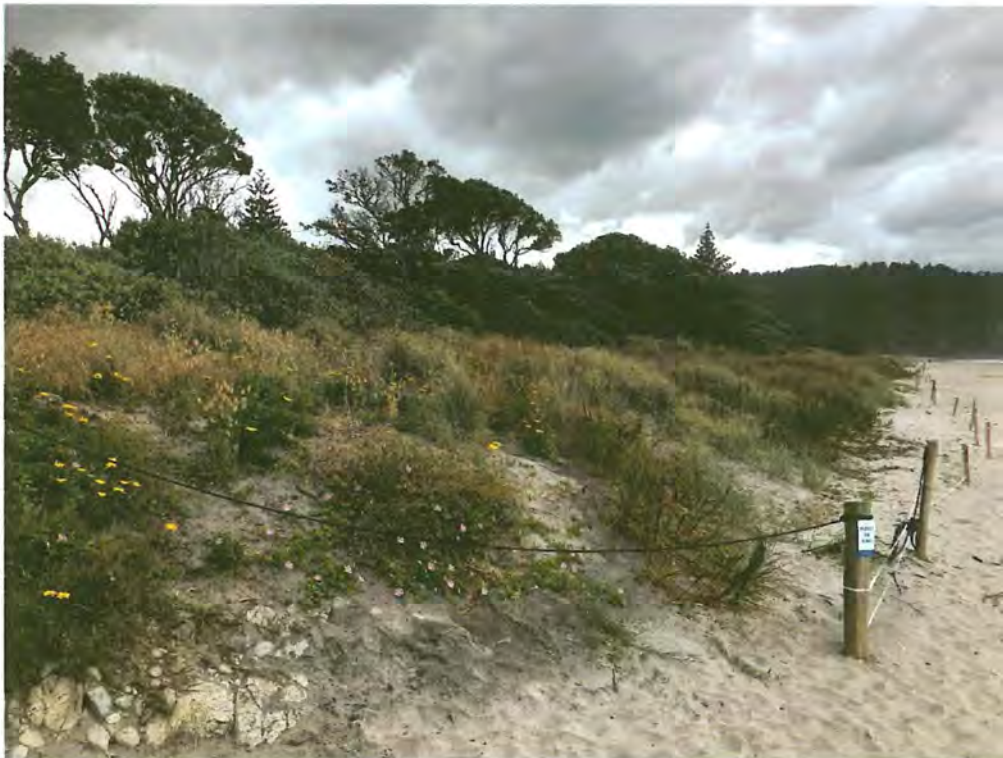
Figure 17 - Barrier Dune Adjacent Coronation Park – View North

The dune system adjacent Coronation Park is functioning well – refer to Figure 17 and Figure 18. The barrier dune is planted and trapping windblown sand thereby supplementing the dune. The park area behind the barrier dune is likely to be an old marsh or swamp remnant. There appears to be adequate berm width between the high tide contour and the dune. A post and rope fence with signage warns people not to enter and damage the planted dune area.

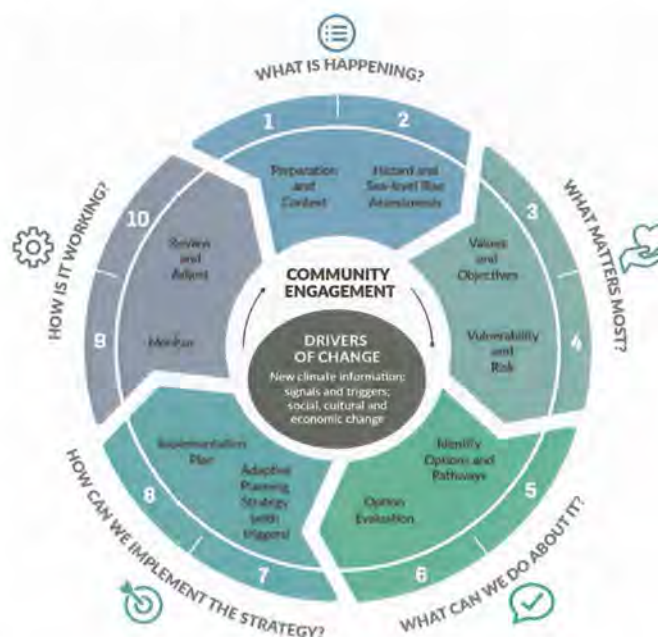
Figure 19: Coastal Hazard Decision Cycle (Source: MfE, 2017)

The best practice decision framework for the dynamic adaptive pathways includes 5 steps and 10 subheadings as shown in Figure 19 below:

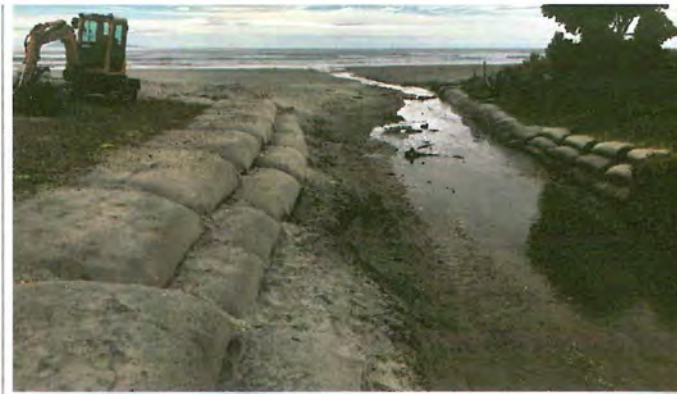
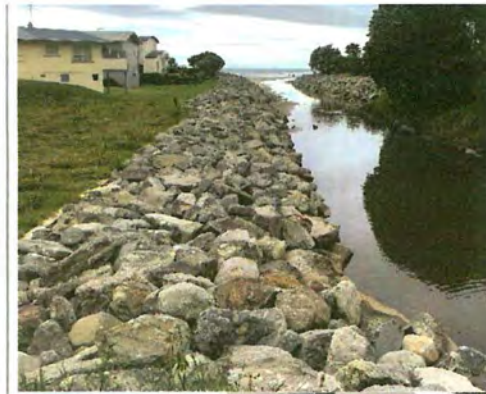
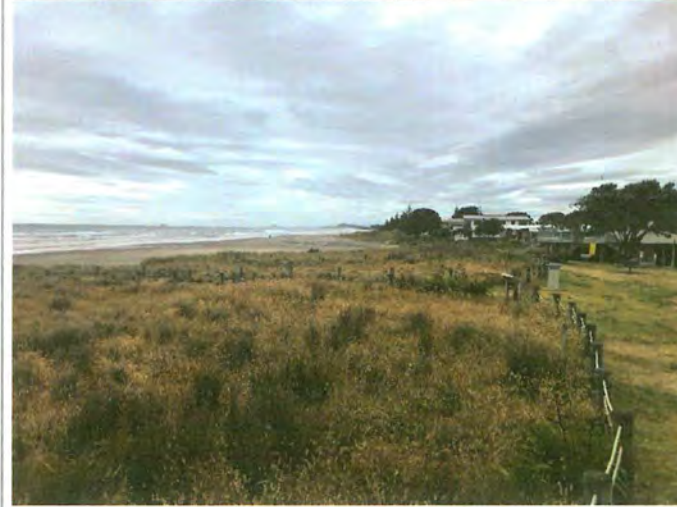
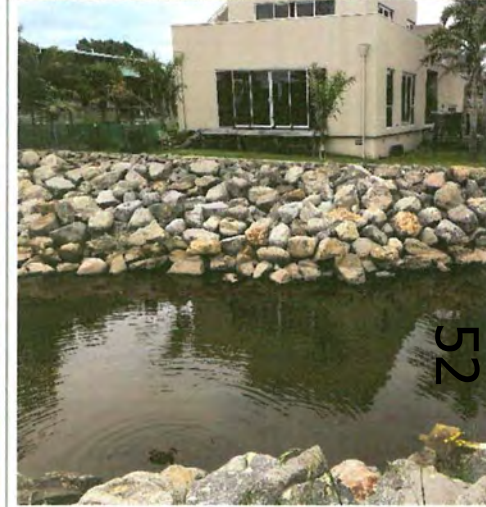
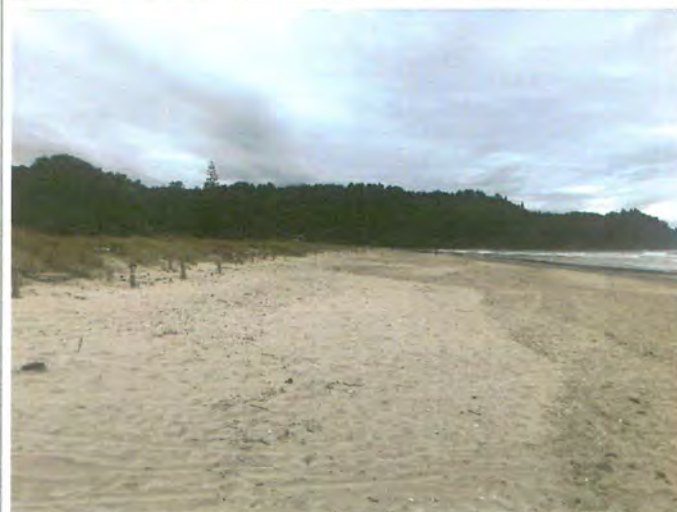
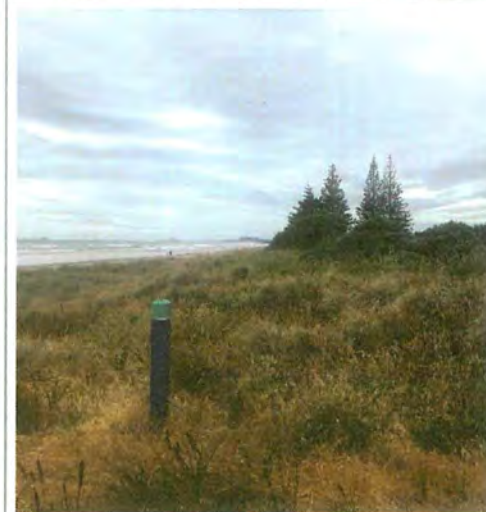
- › High-tide line varies, yet dune enhancement remains consistent along the beach (Left column of photos)
- › Crest of dune buffer is densely vegetated, however exposed dunes at beachline are sparser.
- › Dune fence lines are not well maintained, allowing foot traffic to pass through easily.

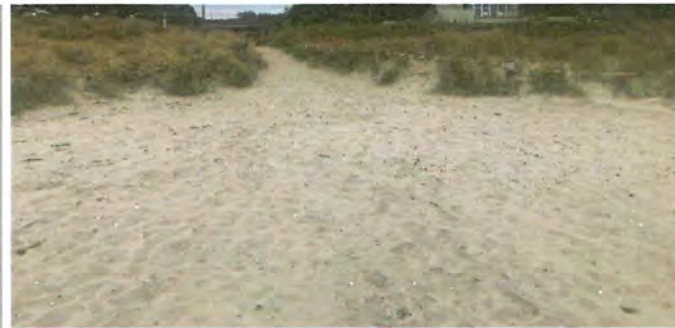
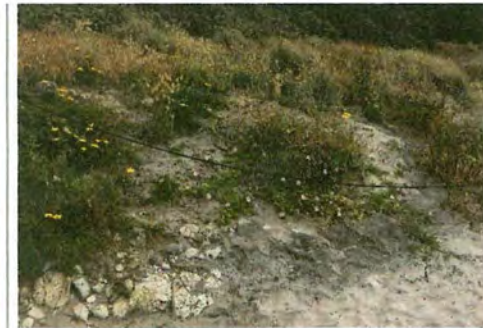
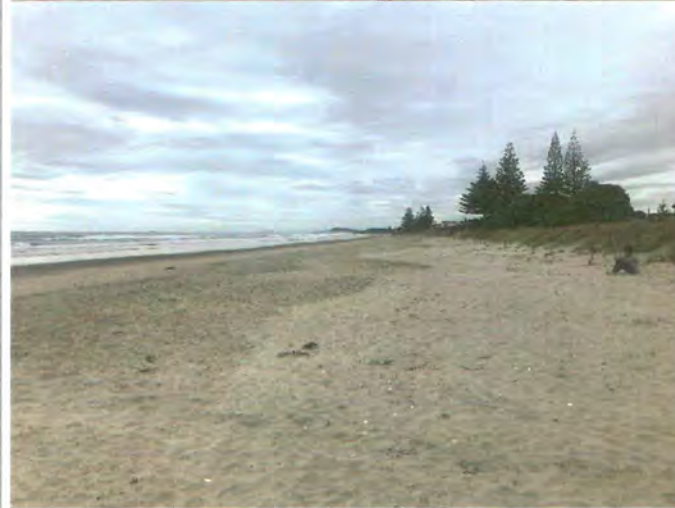
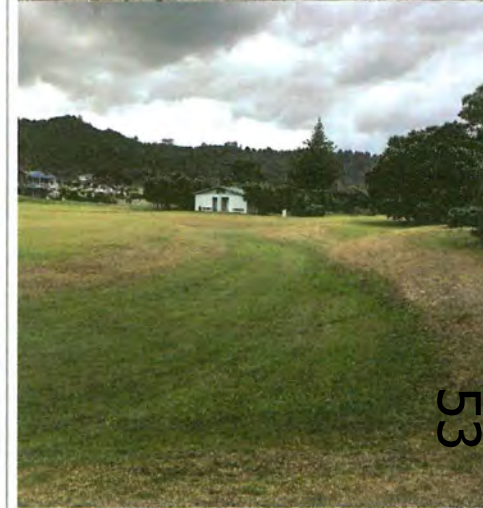
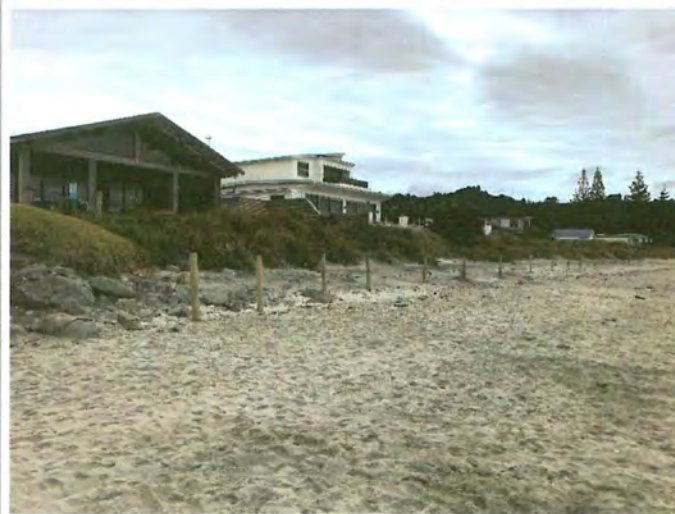
- Café is newly established (last three years approximately). Noted that the building footprint extends to neighbouring fence line.
- Council park neighbouring Flat White is benched at a different level. Sporadic placement of large boulders that provide little to no protection for local scour in this area. Scattered boulders located around staircase piles.
- Steep bank section that is vegetated. High water mark is ~10m from the toe of bank.

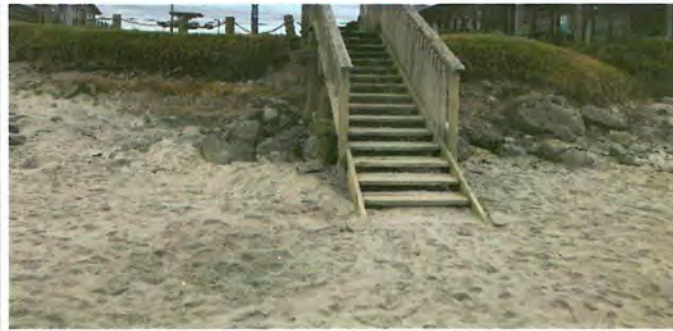
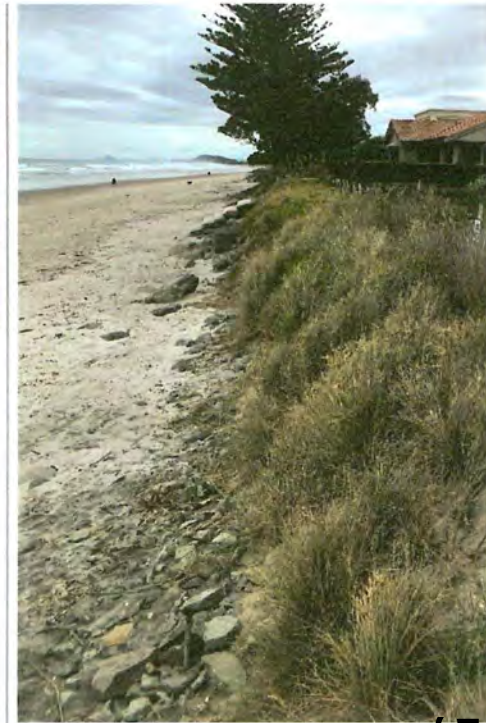
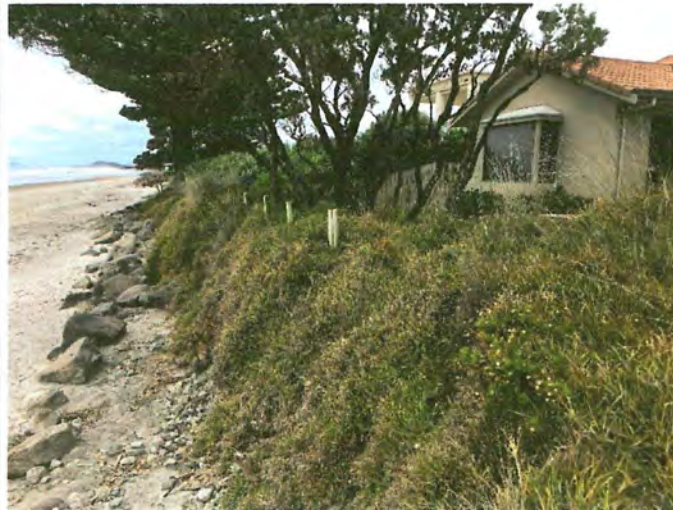
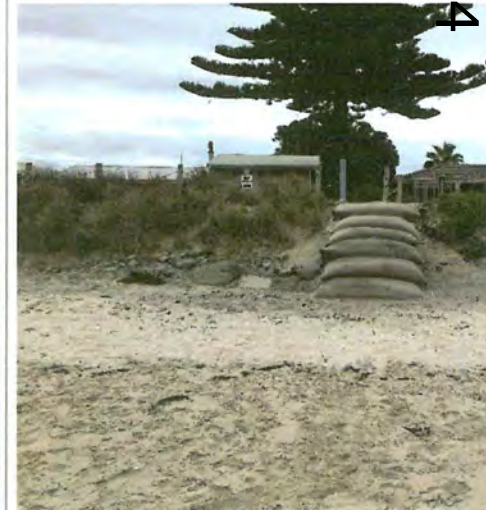
- Timber posts indicate approximate property boundary. ~1.5m from the crest of the bank.
- Bank height approximately ~1.8m to the toe. 100mm - 500mm diameter stones and leftover construction debris line the toe.
- ElcoRock sandbags used for beach access.
- Active erosion occurring at banks.

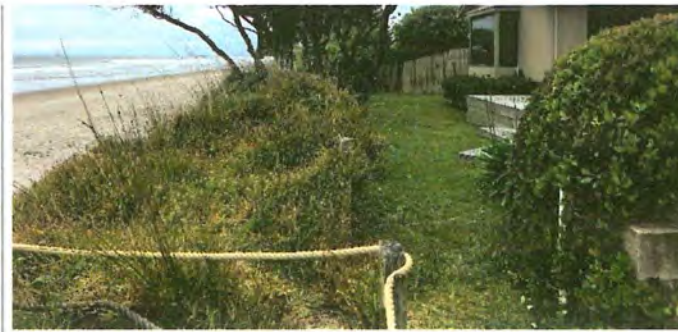
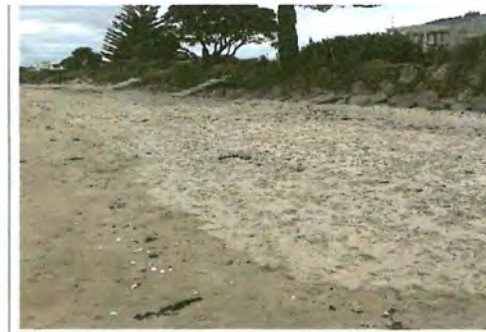
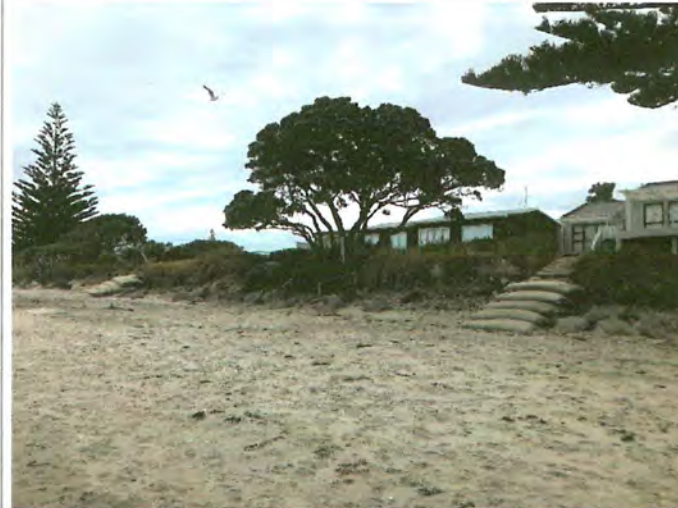
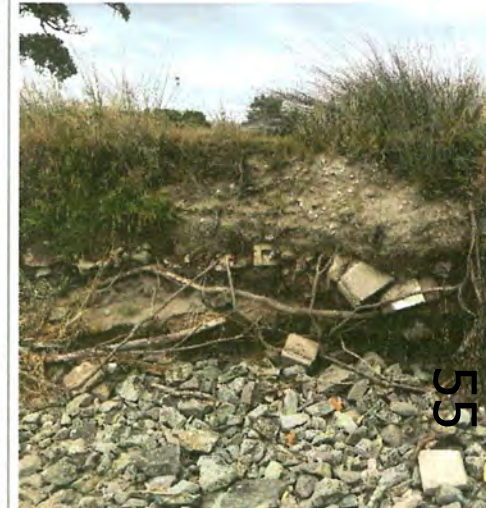
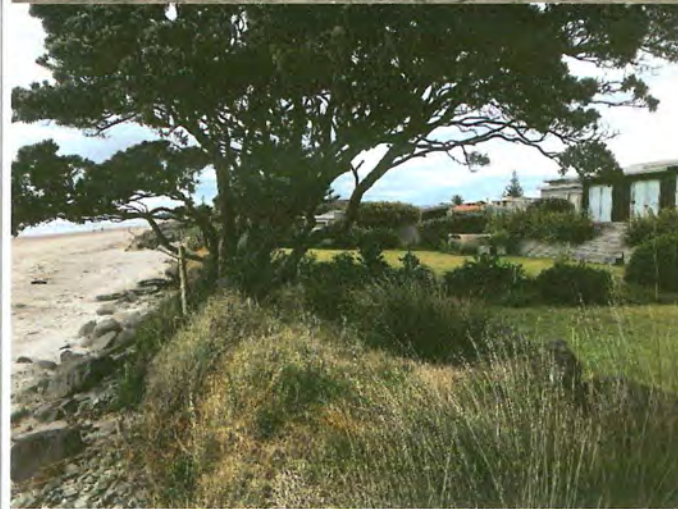
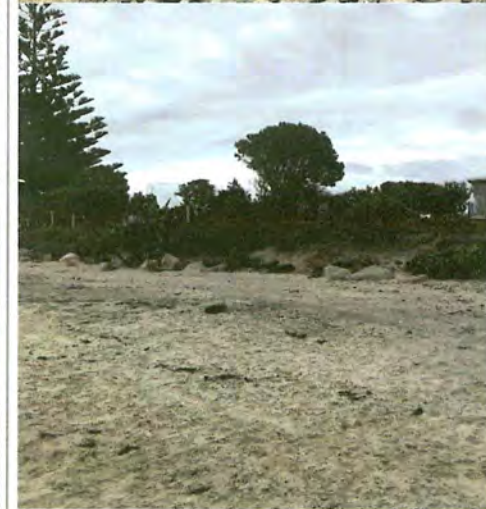
- › More ElcoRock accessways. Scour on either side of the accessways are more prominent in these locations.
- › Property boundary line is present at the crest of embankment.
- › Significant amount of construction debris exposed within bank. Debris has dislodged from the embankment and collected at the toe.

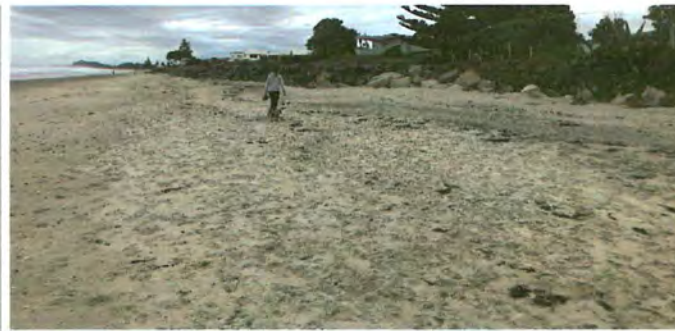
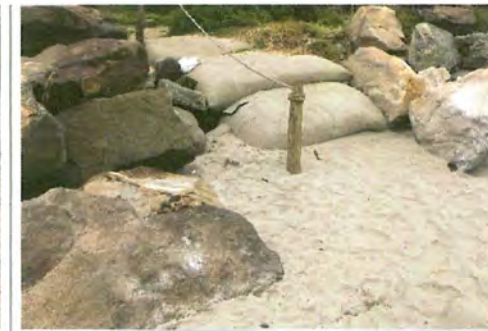
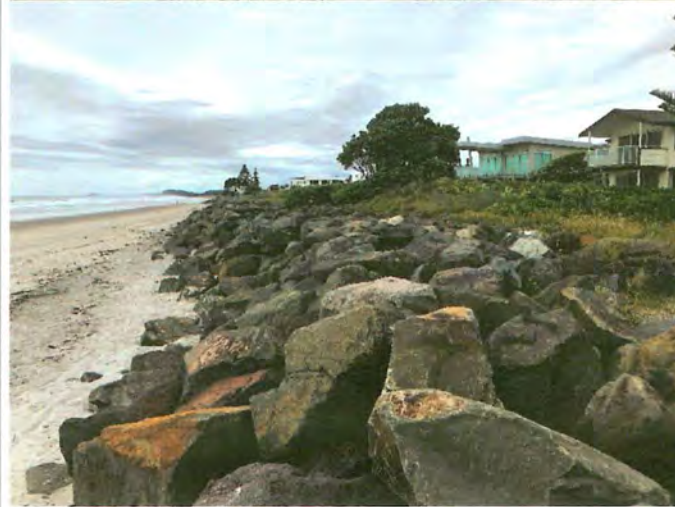
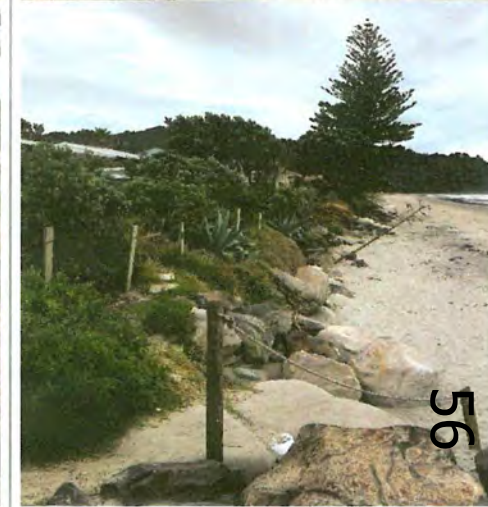
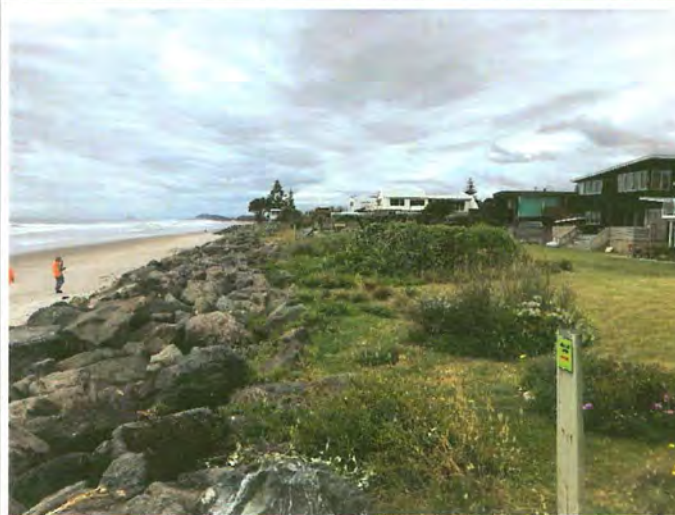
- › Crest edge of seawall to property boundary is significant here. ~5-10m.
- › Use of similar-sized slab rock to bench private accessways common along this section due to crest length.
- › Sand accretion showing at base of seawall.
- › Highwater mark often reaches toe of seawall at this section.

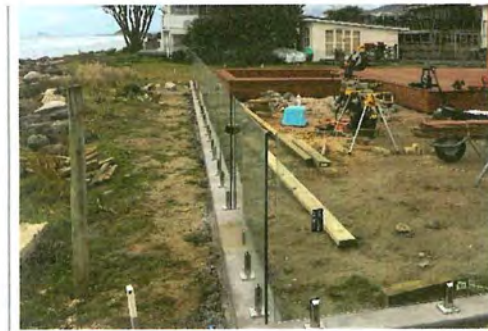
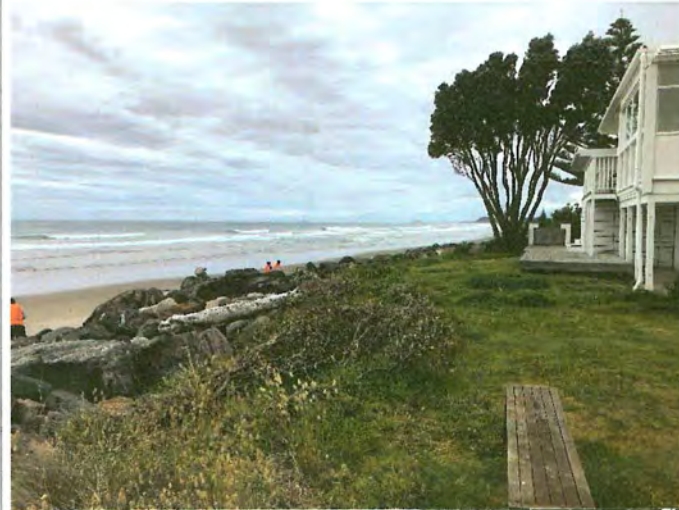
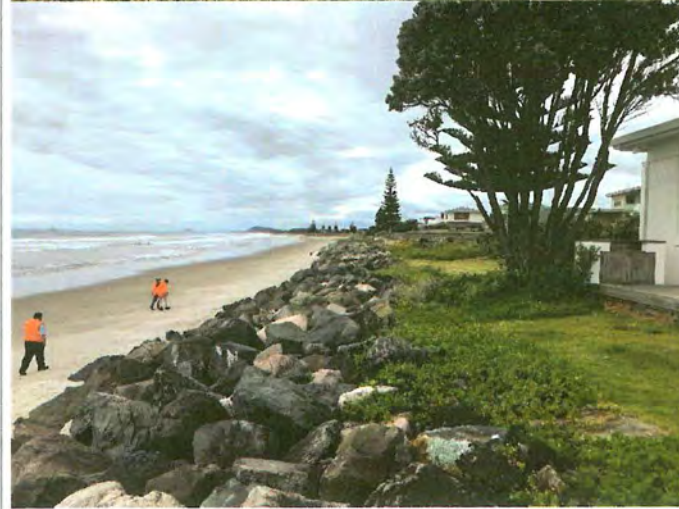
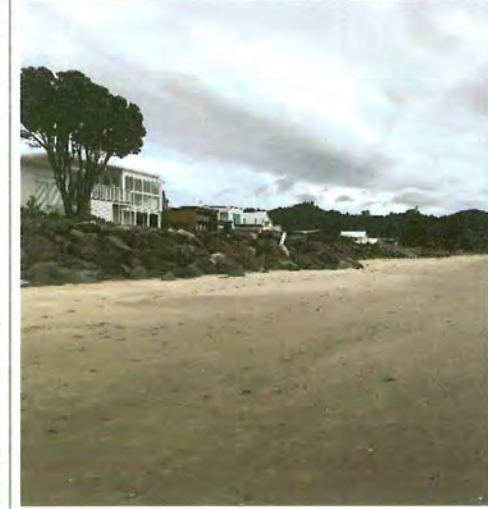
- Section located at property under-construction. Includes tabled seawall access, and a large offset of house from seaside boundary.
- Approximately ~1.0m from fence to beginning of seawall.

- › House is constructed extremely close to edge of dune.
- › Accretion of sand visible at seawall base.
- › Noted that the sand recession during winter months reduces to the toe edge of seawall in this section.

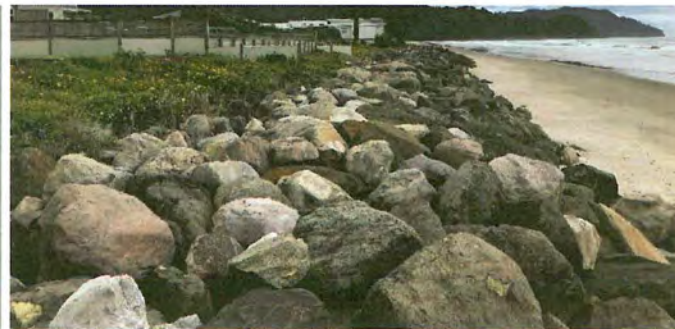
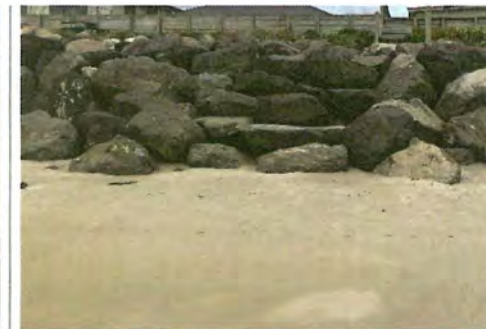
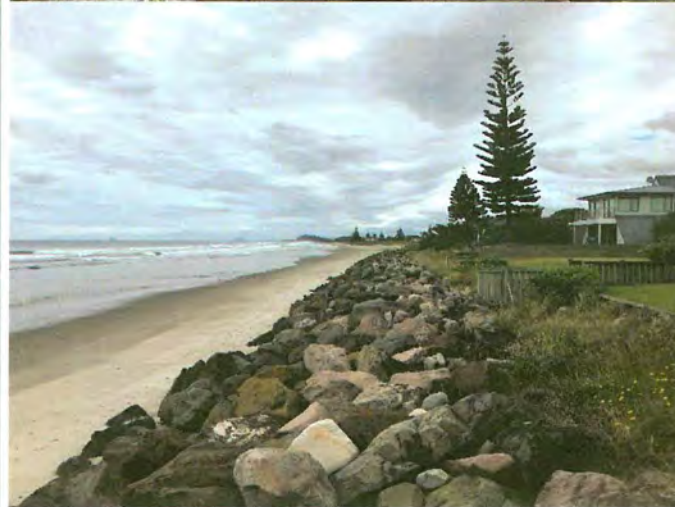
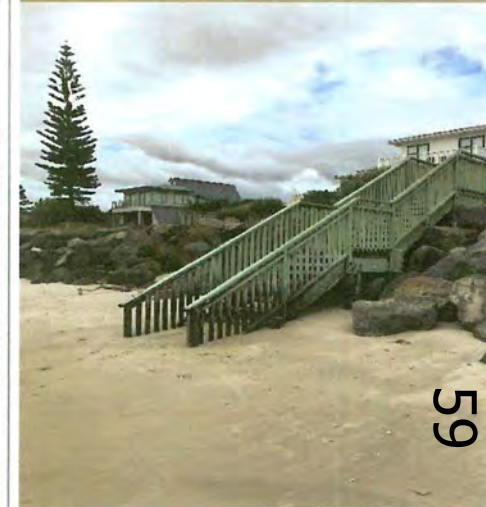
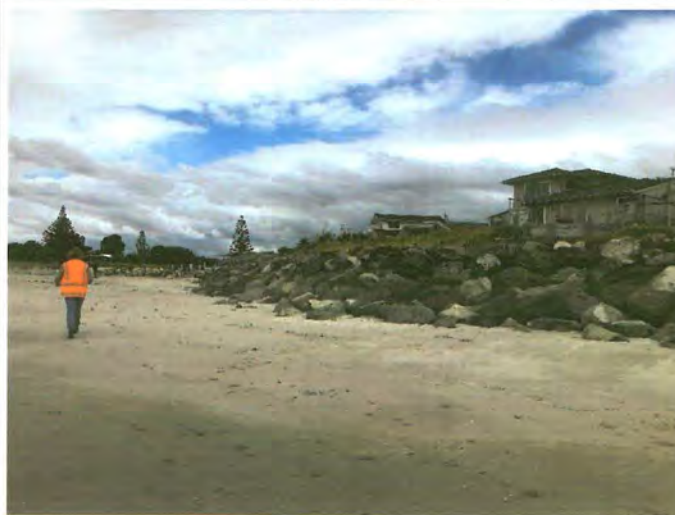
- Noting the encroachment of seawall into several properties. Very close to building footprints.
- Conversation with Chris who owns 1 Edinburgh St. Talked about the wetland and how the creek functions. During storm conditions, wave overtops seawall and is near finished floor level of house.
- Currently, the creek outlet is following the training wall groyne, and is exiting straight out to ocean.
- Area at termination of southern training groynes appears to be used for public and boat access.
- Dunes south of creek appear to be well secured and flourishing.

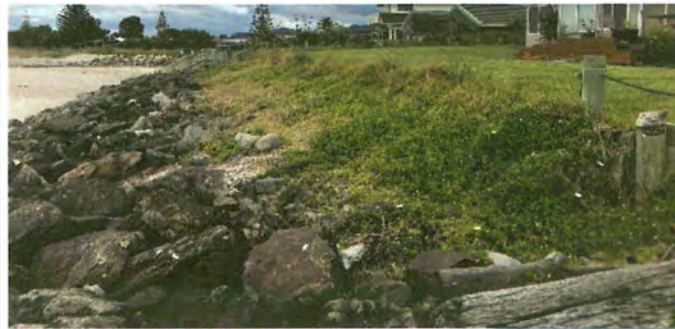
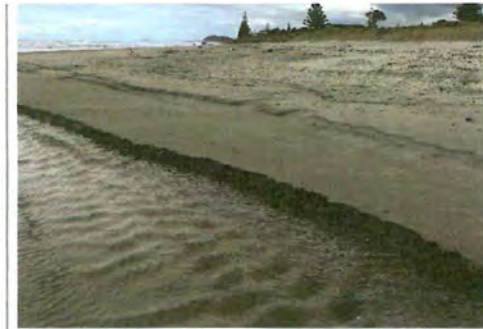
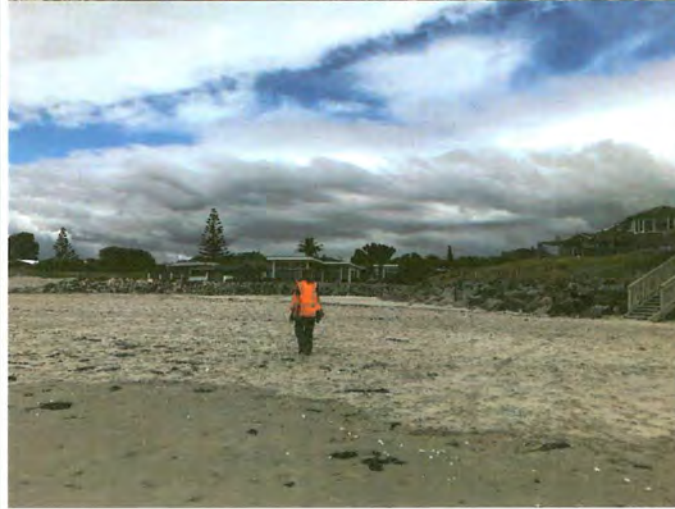
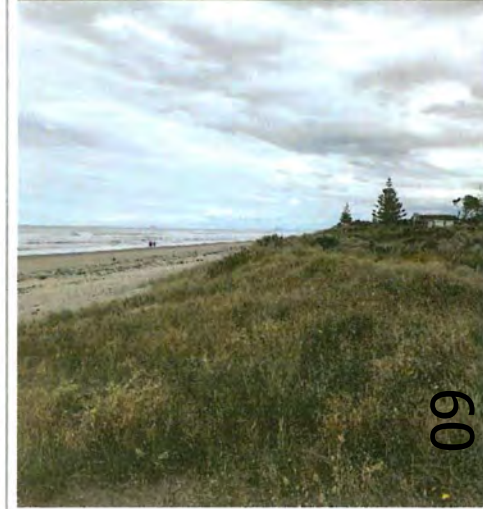
- › At commencement of southern seawall, pedestrians are walking over the dune, displacing sand and exposing geotextile.
- › Height of dune buffer is notably higher than more northern sections.
- › Highwater mark appears to return to $\sim +10\text{m}$ outside of seawall toe.

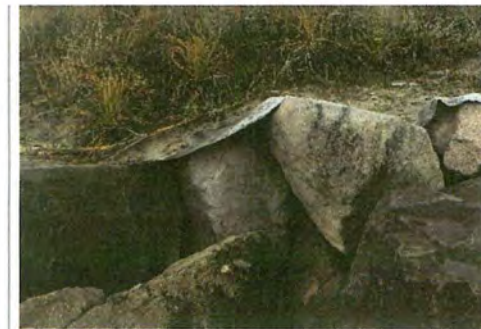
- Rock seawall terminates at existing private boat ramp.
- Concrete ramp surface has cracks.
