OPERATIONS AND MONITORING COMMITTEE

OP21
Thursday, 15 August 2019
Council Chambers
Barkes Corner, Tauranga
9.30am

Prepared by Beca Limited

5 July 2019

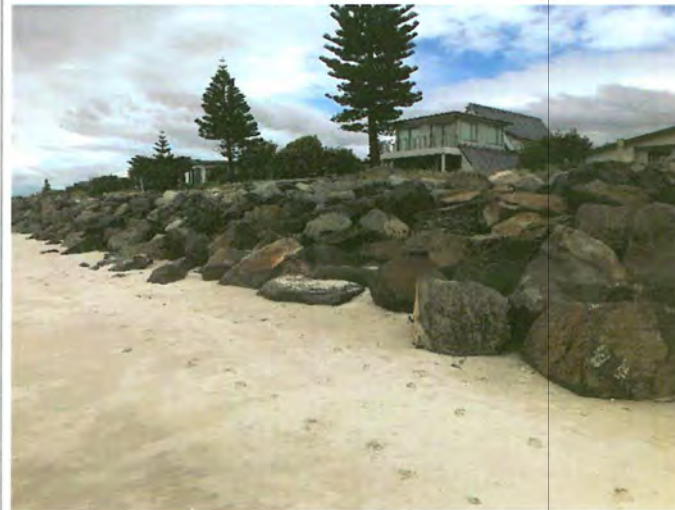
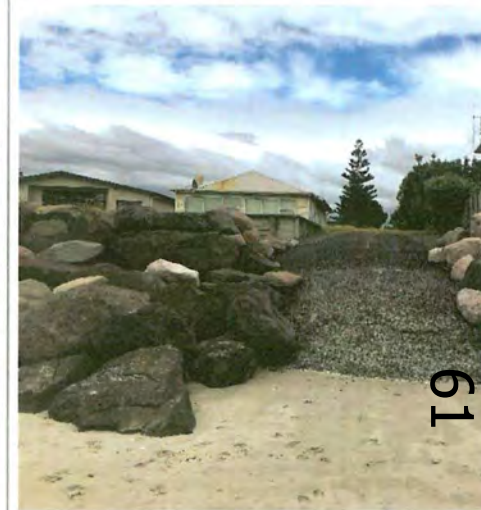
- Section measurements taken ~15m south of access staircase (RH column photos). Access 21.
- Properties positioned a substantial distance from beginning of seawall. Pedestrian thoroughfare parallel to top of seawall.

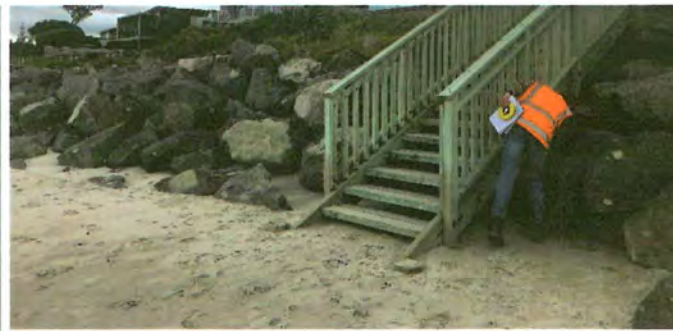
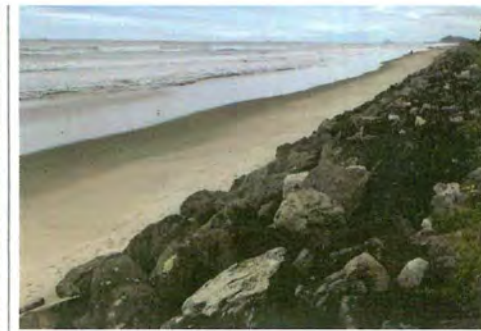
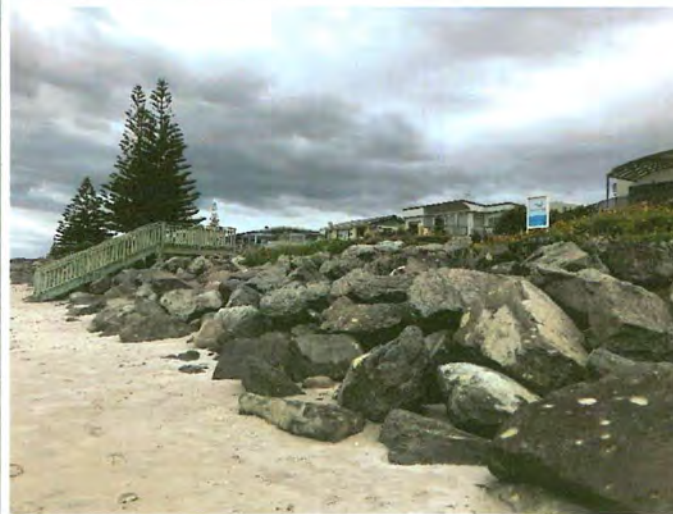
- Section measurements taken ~15m south of access staircase (RH column photos).
- Properties positioned a substantial distance from beginning of seawall. Pedestrian thoroughfare parallel to top of seawall.

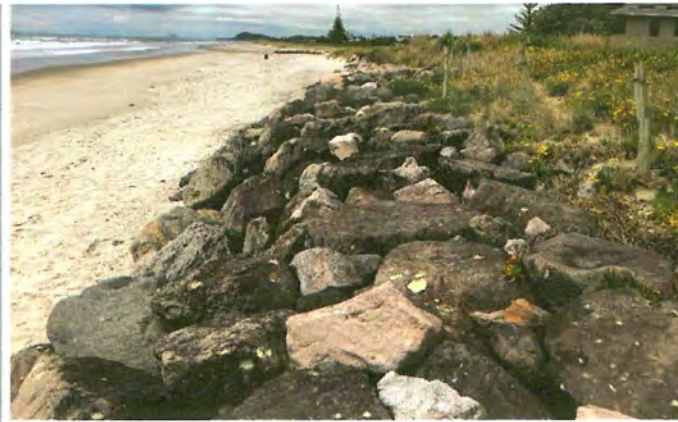
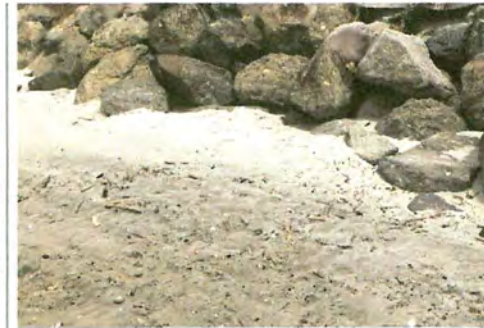
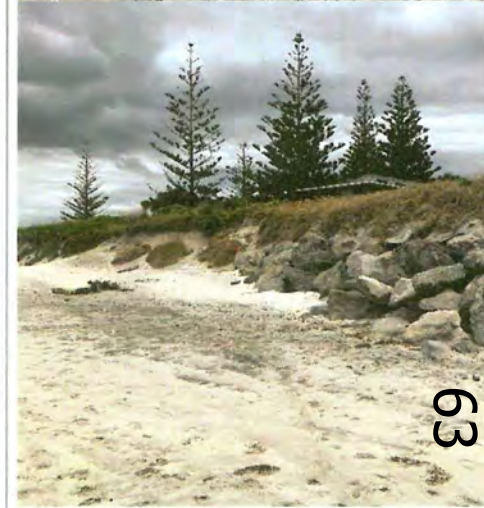
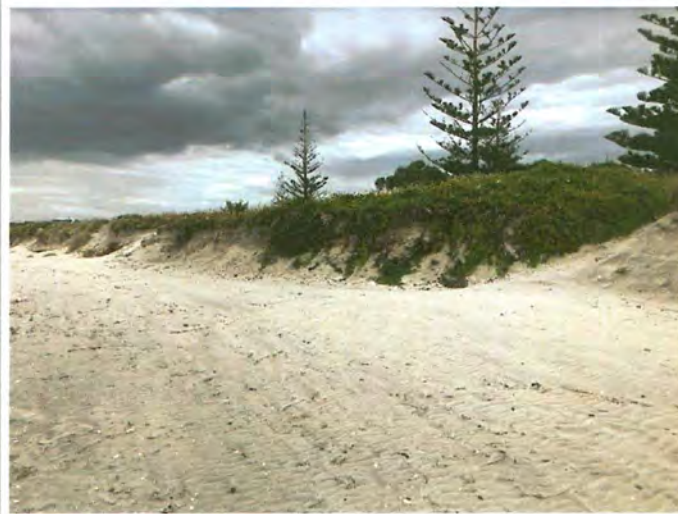
- › Lead up to Three-Mile Creek – bank erosion occurring.
- › Banks are approximately ~2.2m high.
- › Access north of the creek has dunes which are notably inland from the elcorock wall.

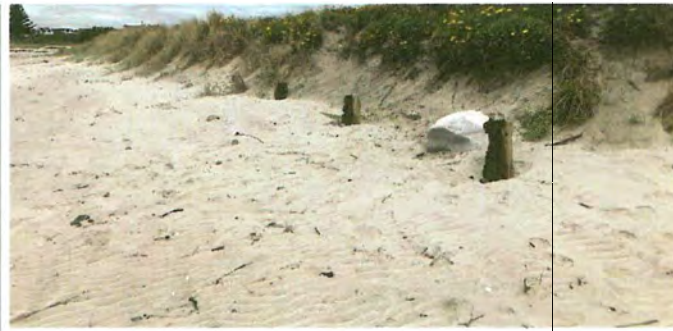
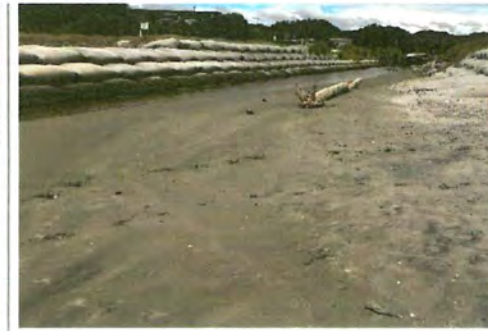
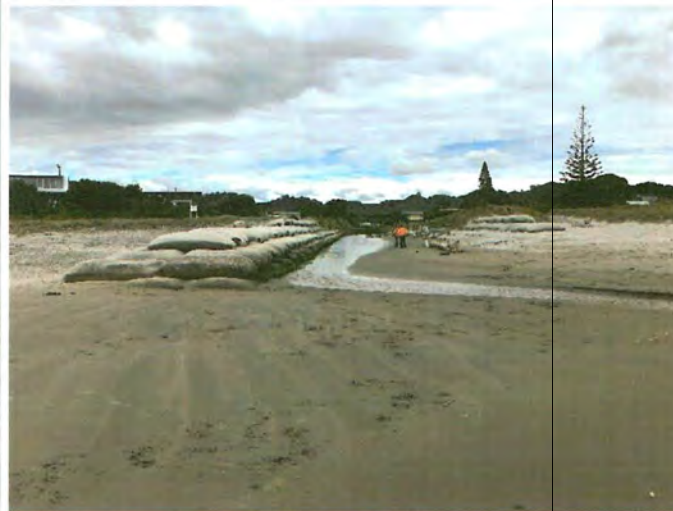
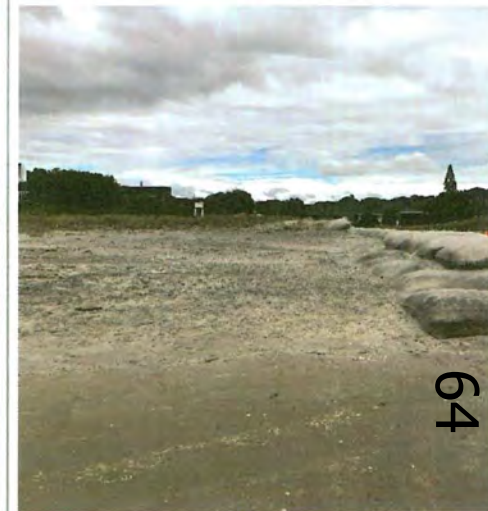
- › Northern sea section ElcoRock bank is keyed in and is trapping sand.
- › The channel of the creek favours the southern embankment. There are some minor remedial works to the bags on the southern side also, close to current water level.
- › Sand has built up to the top layer of the ElcoRock bags on the southern groyne.
