DETAILED SITE INVESTIGATION

PENCARROW ESTATE,
1491 STATE HIGHWAY 2, PONGAKAWA

Prepared For: Momentum Planning and Design Limited

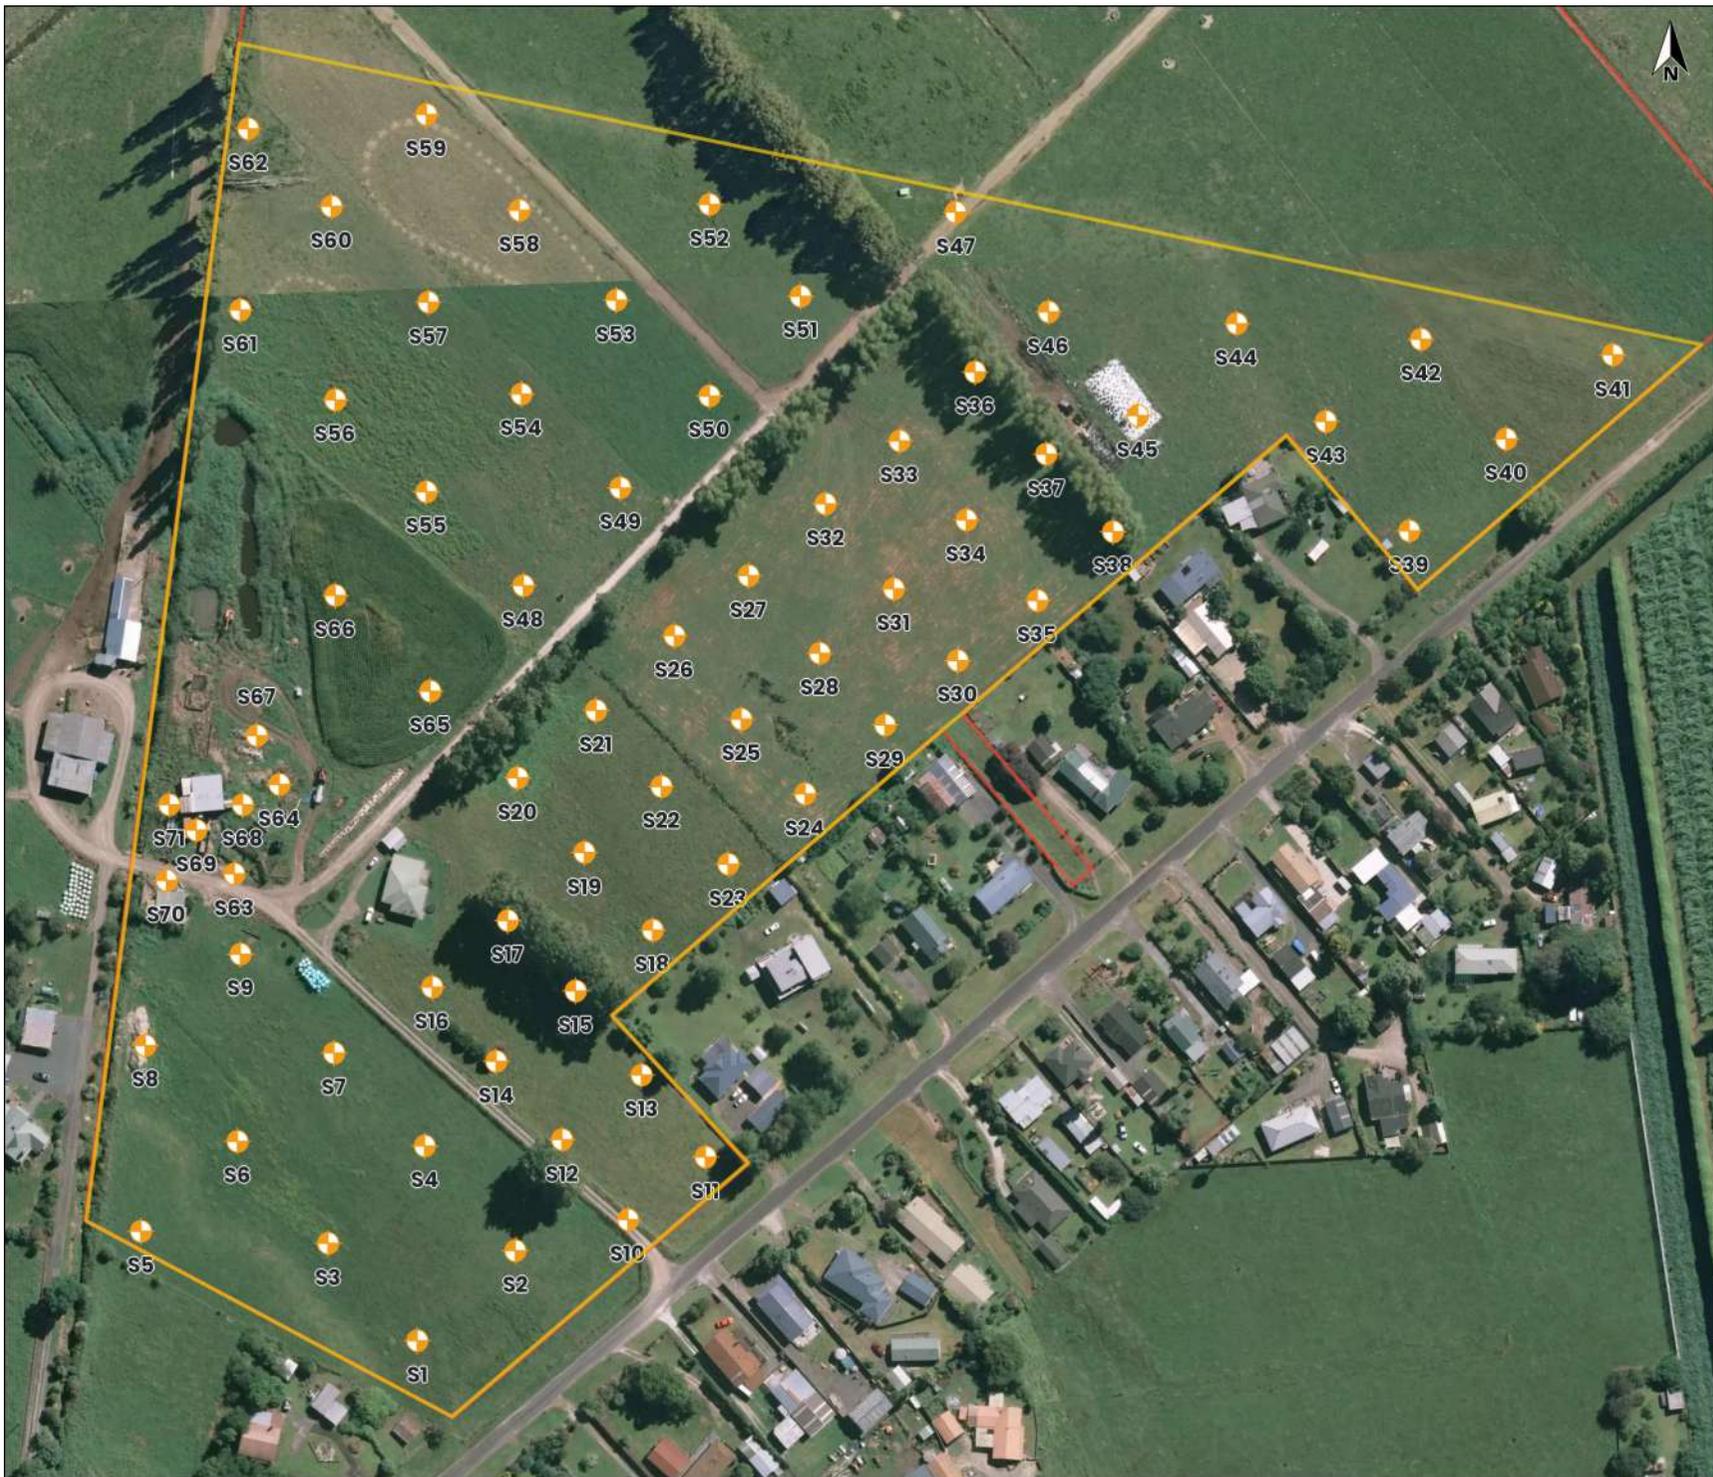
- Surface samples (0-0.1 m below ground level (bgl)) were collected from a total of 71 locations (refer Figure 2). The number of locations is in general accordance with Ministry for the Environment Contaminated Land Management Guidelines No. 5 (revised 2021).
- Soil sampling was undertaken using a stainless-steel hand auger. Soil samples were collected directly from the hand auger using disposable nitrile gloves and placed in a laboratory supplied glass jar for sample analytical purposes.
- Collection of quality control samples as per Section 7.6.
- Where re-useable sampling equipment was used, this equipment was decontaminated prior to collection of another sample.
- Soil samples were collected in the appropriate sample jars, stored and transported in chilled containers in accordance with IANZ laboratory requirements.
