**PENCARROW ESTATE**

**1491 STATE HIGHWAY 2, PONGAKAWA**

**GEOTECHNICAL INVESTIGATION REPORT FOR PLAN CHANGE**

TGA2021-0096AC Rev 0

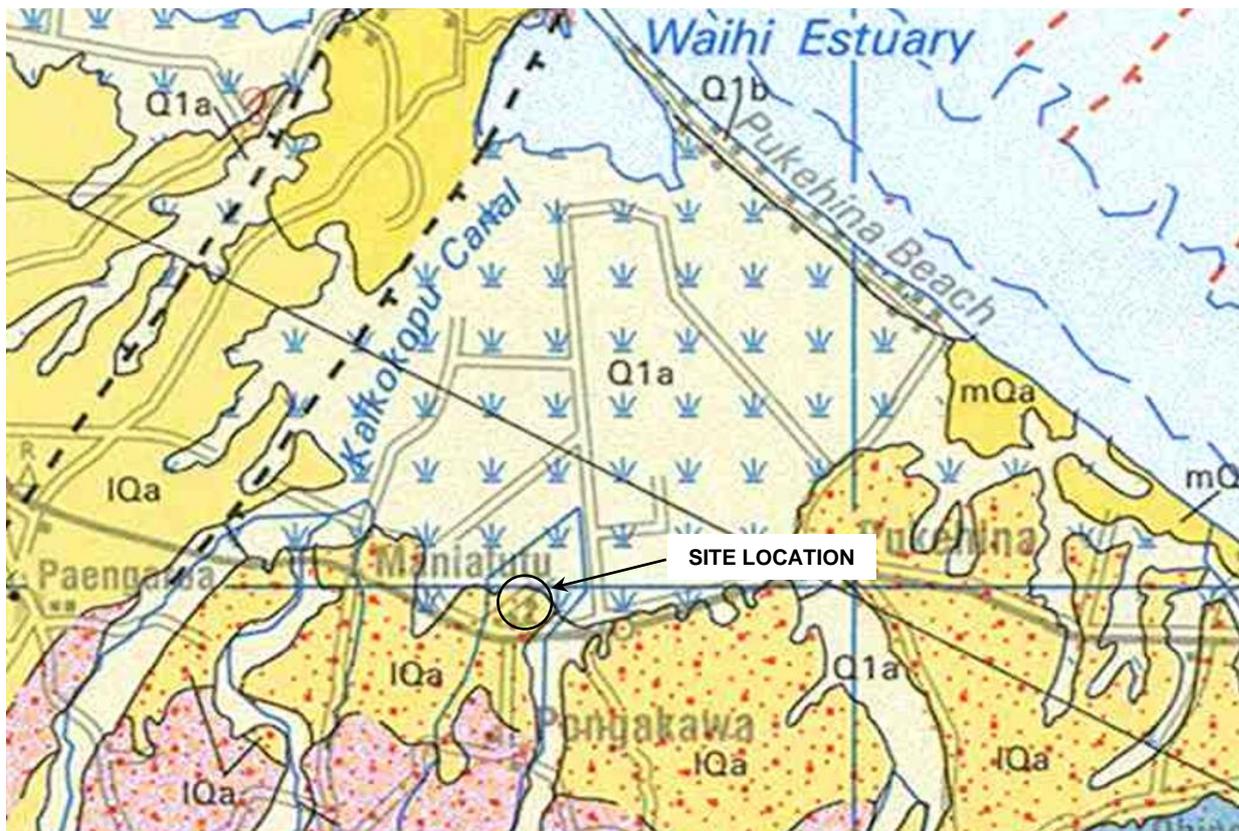
Figure 2: Regional Geology (Leonard and Begg 2010)

The published geological map<sup>4</sup> depicts the regional geology for the area as comprising Pleistocene alluvium consisting of variably degraded terraces dominated by pumiceous soils (Tauranga Group- IQa), as illustrated in Figure 2 below. To the north and west of the site, swamp deposits comprising dark brown to black peat, organic-rich mud, silt and sand (Tauranga Group- Q1a) are anticipated.

The ground conditions encountered and inferred from the investigation were generally consistent with the published geology for the area and can be generalised according to the following subsurface sequences.

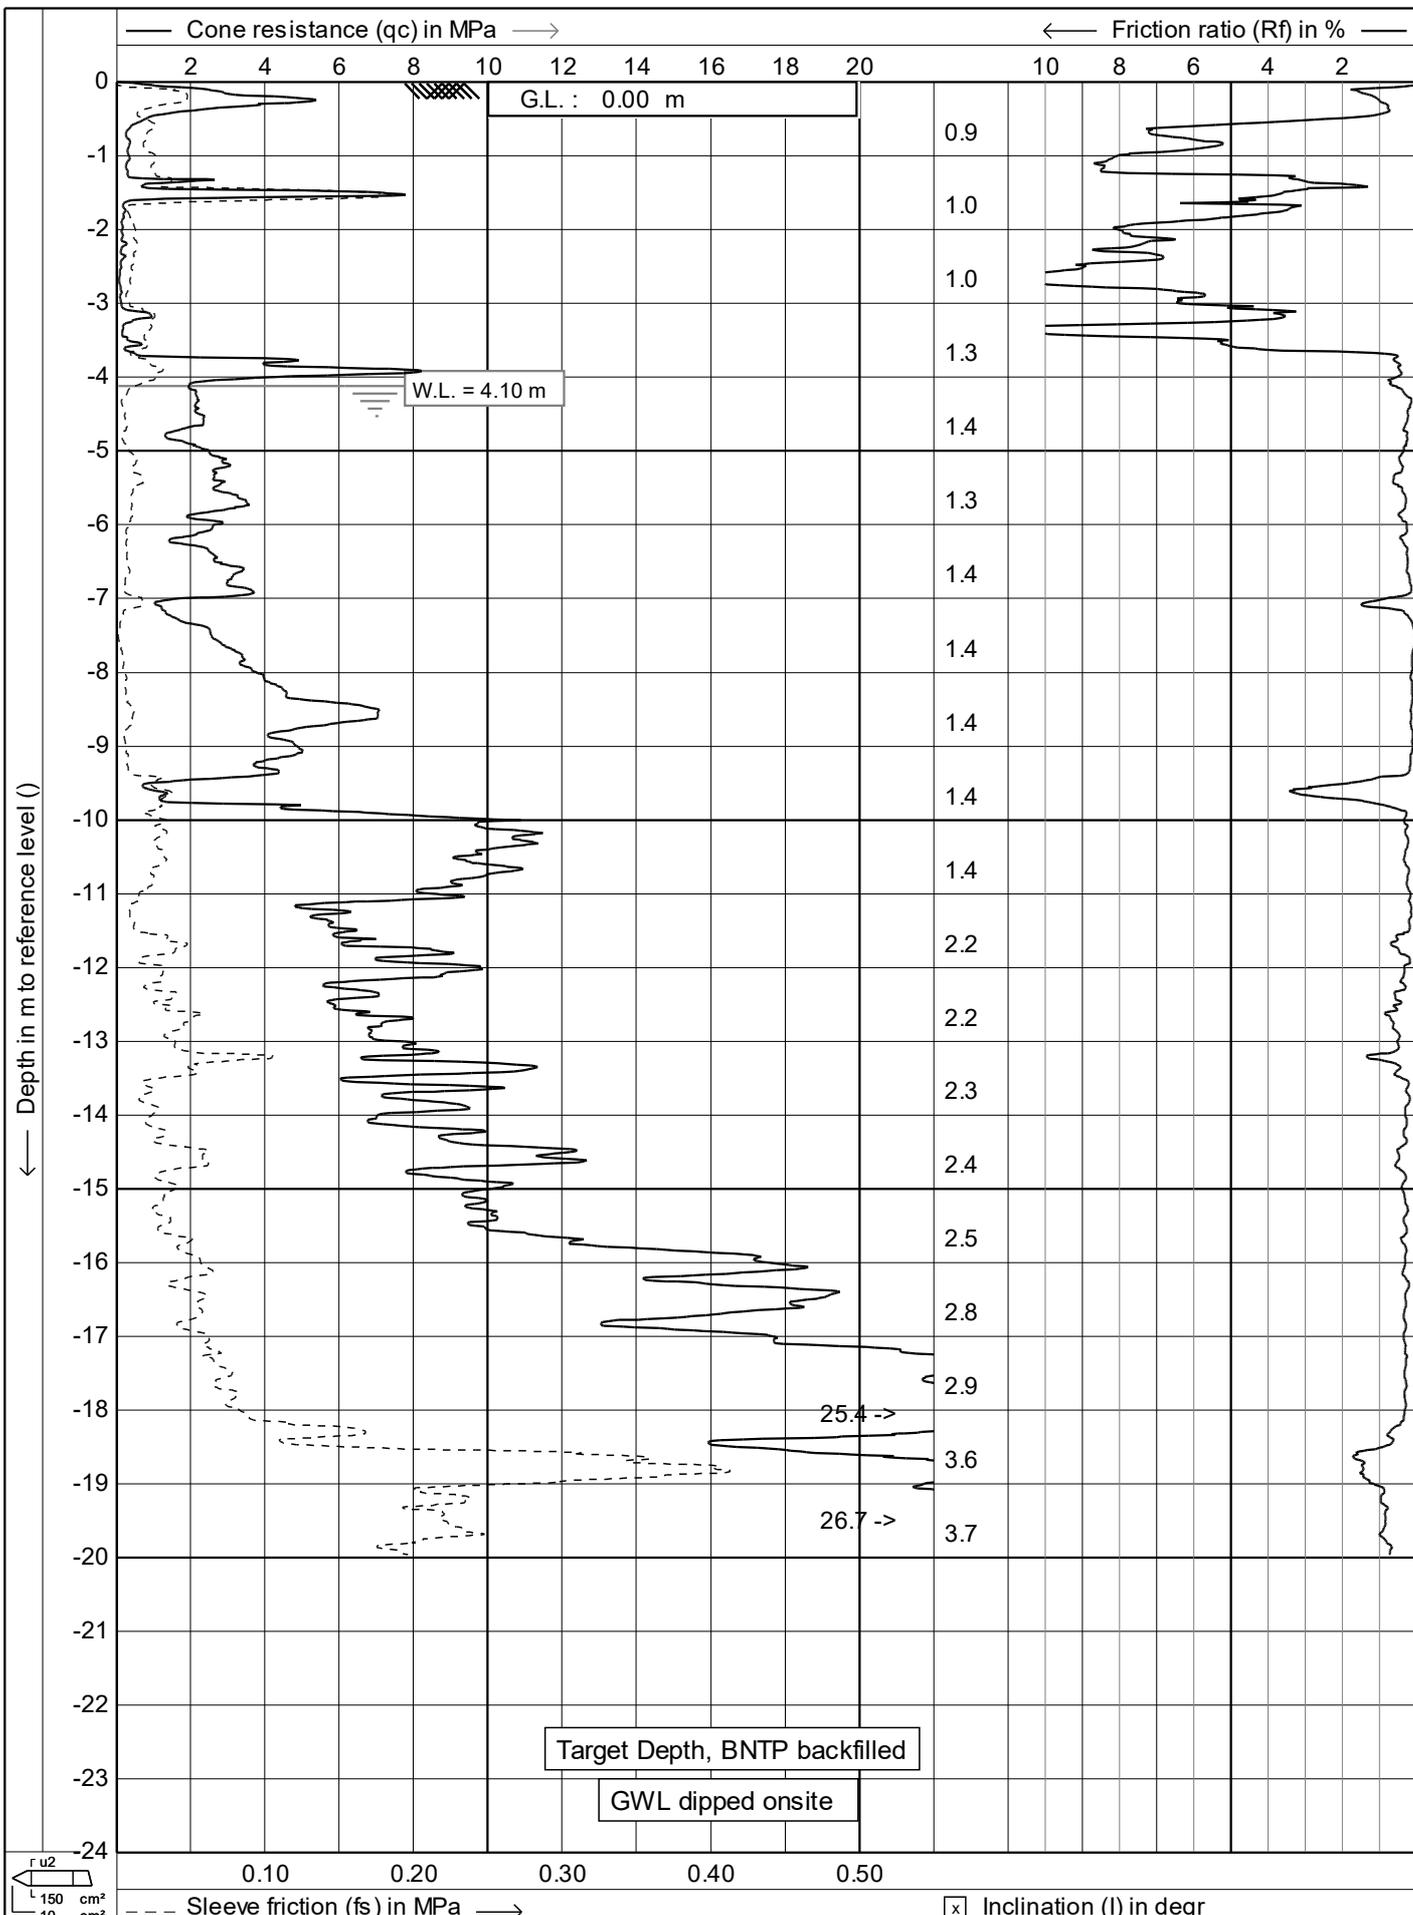
Date : **18/01/2022**  
 Cone no. : **C10CFIP.C17803**  
 Project no. : **05CMW099**  
 CPT no. : **01**

Test according A.S.T.M Standard D 5778-12  
 Project : **Site Investigations**  
 Location: **1491 Arawa Rd Pongakawa**  
 Position: **0, 0**

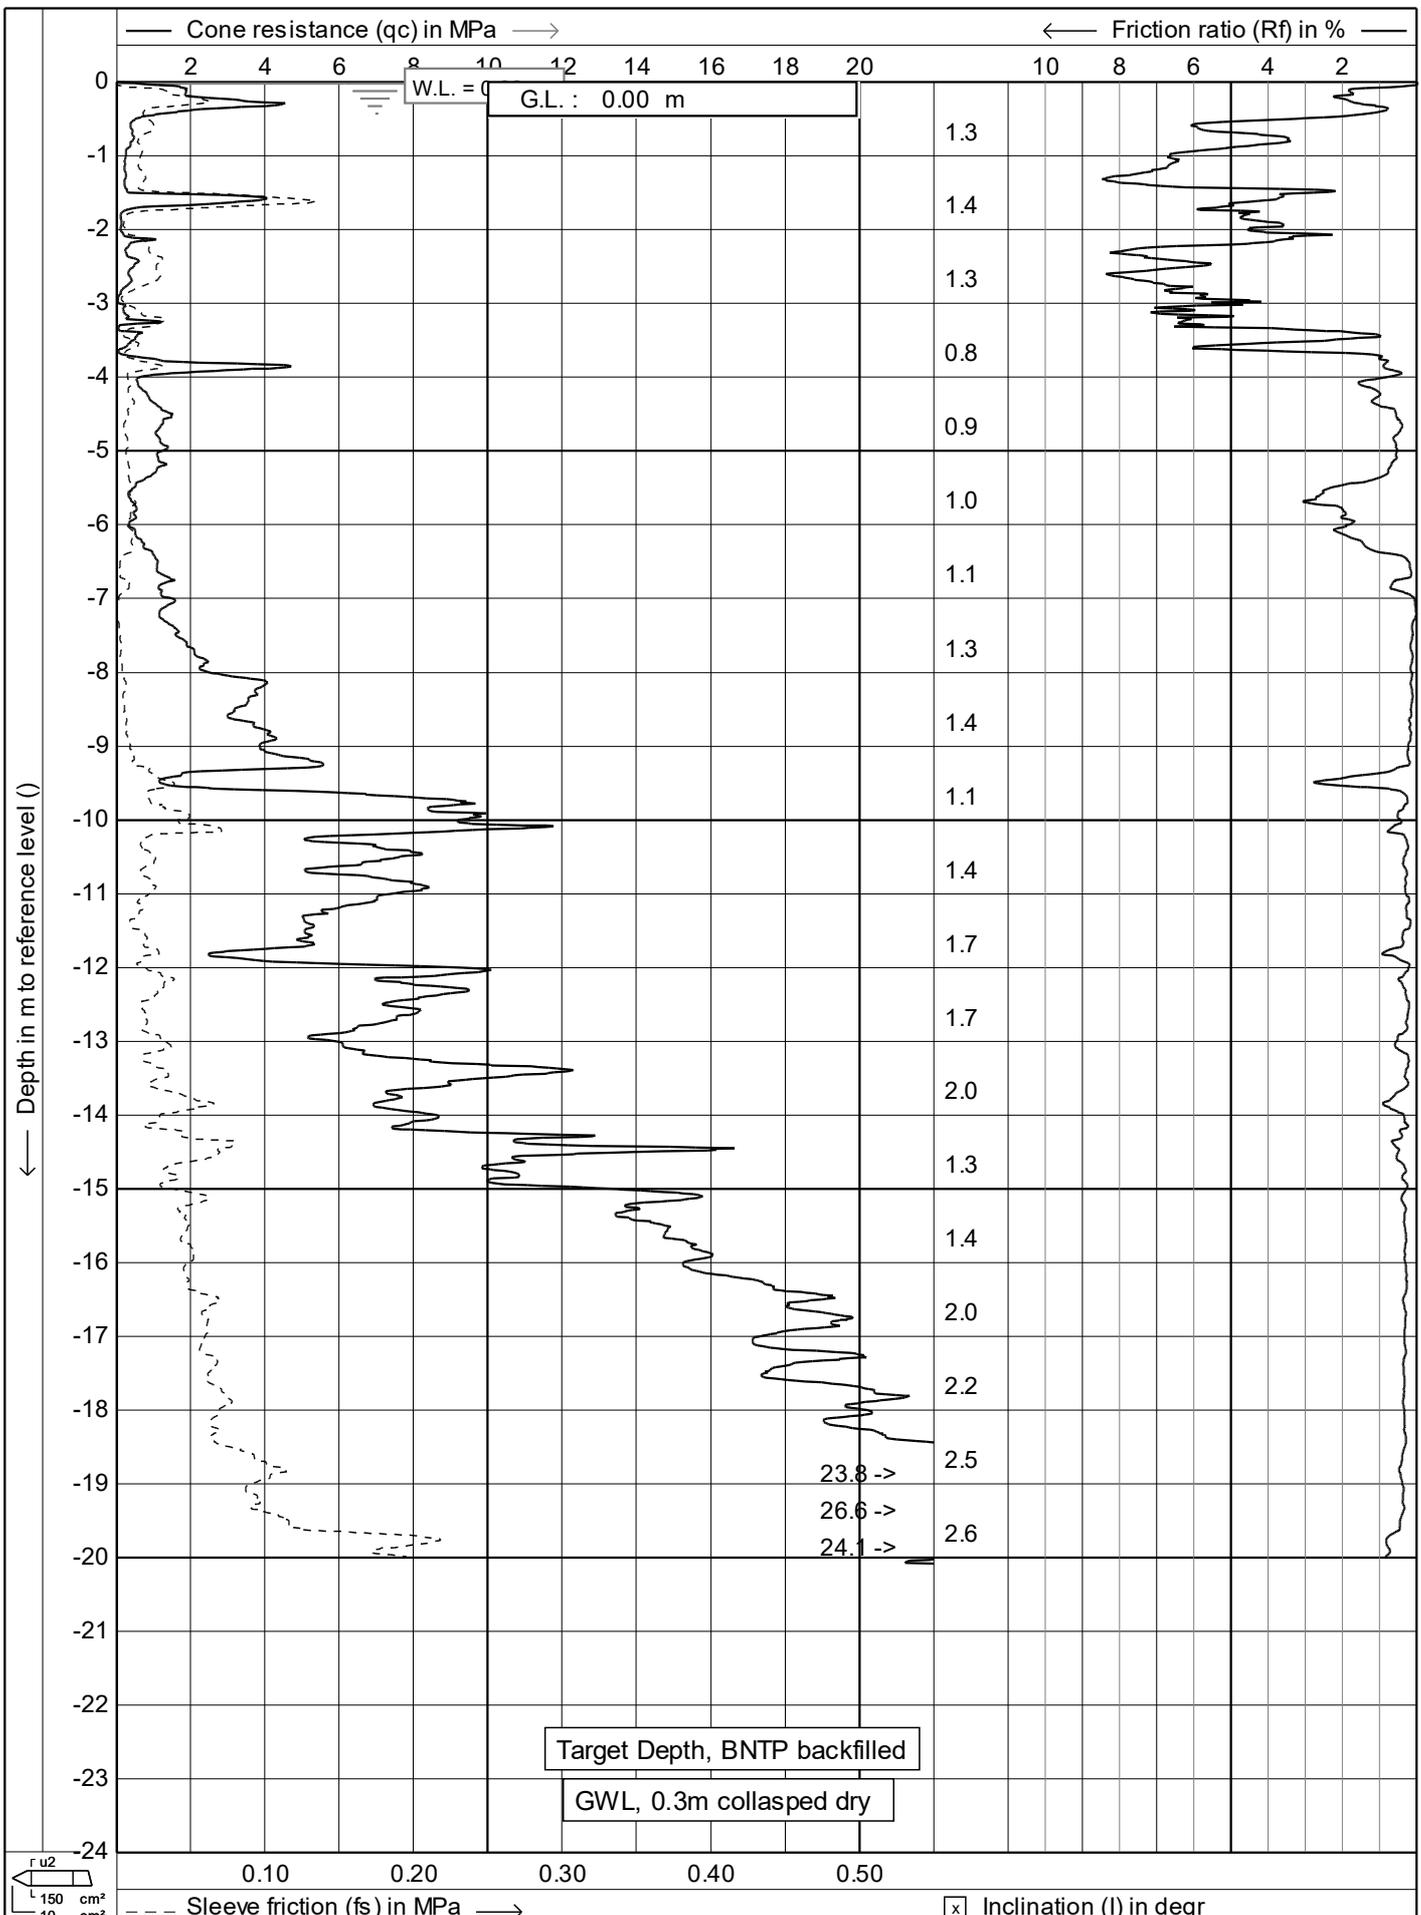
Date : **19/01/2022**  
 Cone no. : **C10CFIP.C17803**  
 Project no. : **05CMW099**  
 CPT no. : **02**

Test according A.S.T.M Standard D 5778-12  
 Project : **Site Investigations**  
 Location: **1491 Arawa Rd Pongakawa**  
 Position: **0, 0**

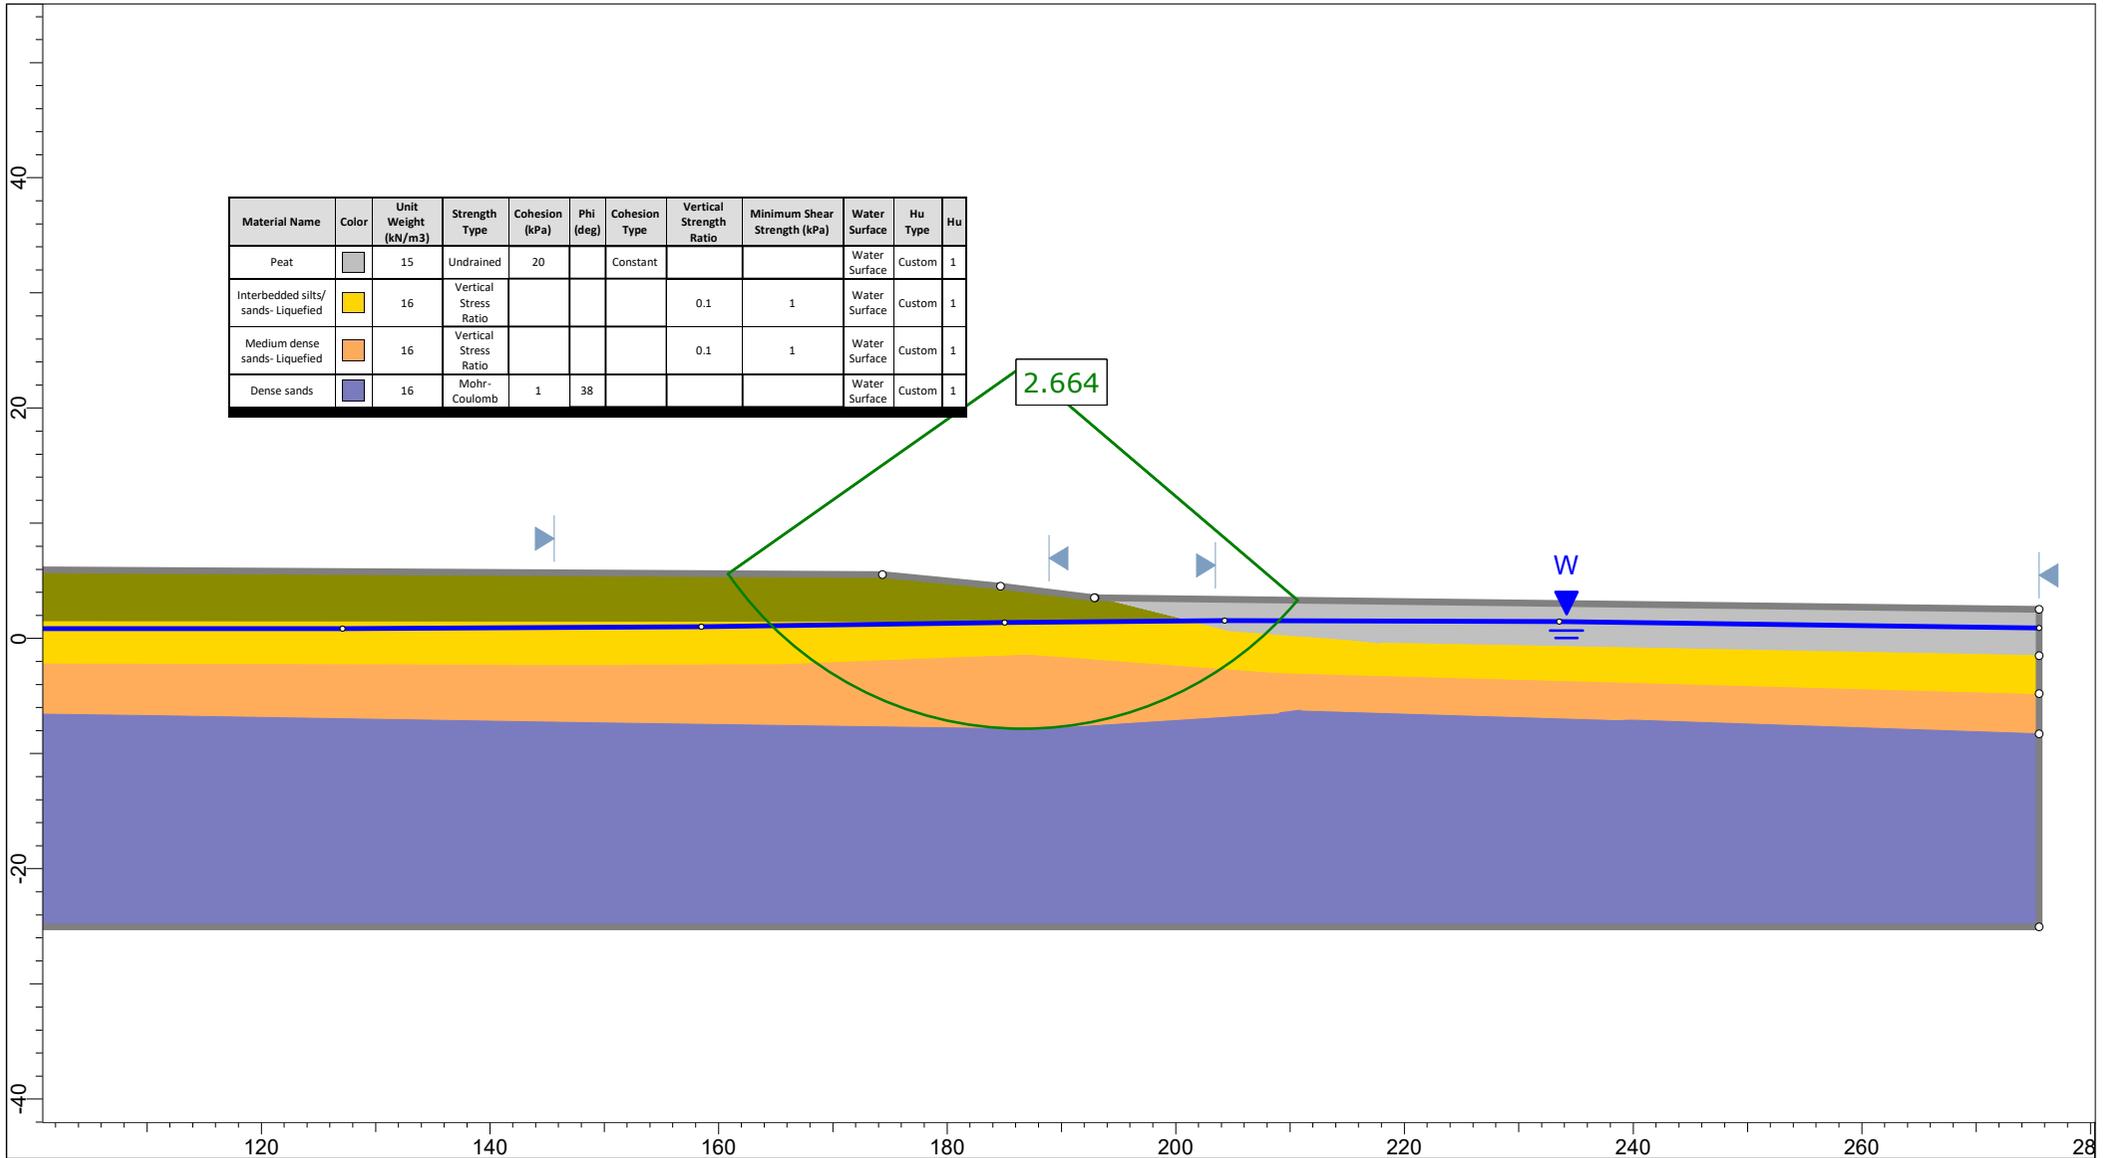
Project		Pencarrow Estate Section A - Flow Failure	
Group		Scenario	Lateral Spread
Drawn By	LGL	Client	Marsh
Date	01/02/22	File Name	A-A - test.slmd

Material Name	Color	Unit Weight (kN/m <sup>3</sup> )	Strength Type	Cohesion (kPa)	Phi (deg)	Cohesion Type	Vertical Strength Ratio	Minimum Shear Strength (kPa)	Water Surface	Hu Type	Hu
Peat	Grey	15	Undrained	20		Constant			Water Surface	Custom	1
Interbedded silts/sands- Liquefied	Yellow	16	Vertical Stress Ratio				0.1	1	Water Surface	Custom	1
Medium dense sands- Liquefied	Orange	16	Vertical Stress Ratio				0.1	1	Water Surface	Custom	1
Dense sands	Purple	16	Mohr-Coulomb	1	38				Water Surface	Custom	1

2.664

1. The stability of the slope assuming liquefied soil conditions under peak (ULS) ground acceleration to assess lateral spreading risk; and
2. The stability of the slope with liquefied soil parameters and zero ground acceleration to assess the risk of post-earthquake failure (termed 'flow failure').

The calculations to assess flow failure risk indicate that the northern slope has a factor of safety >1.0 in these conditions and the slope is therefore unlikely to be affected by post-earthquake flow failure.

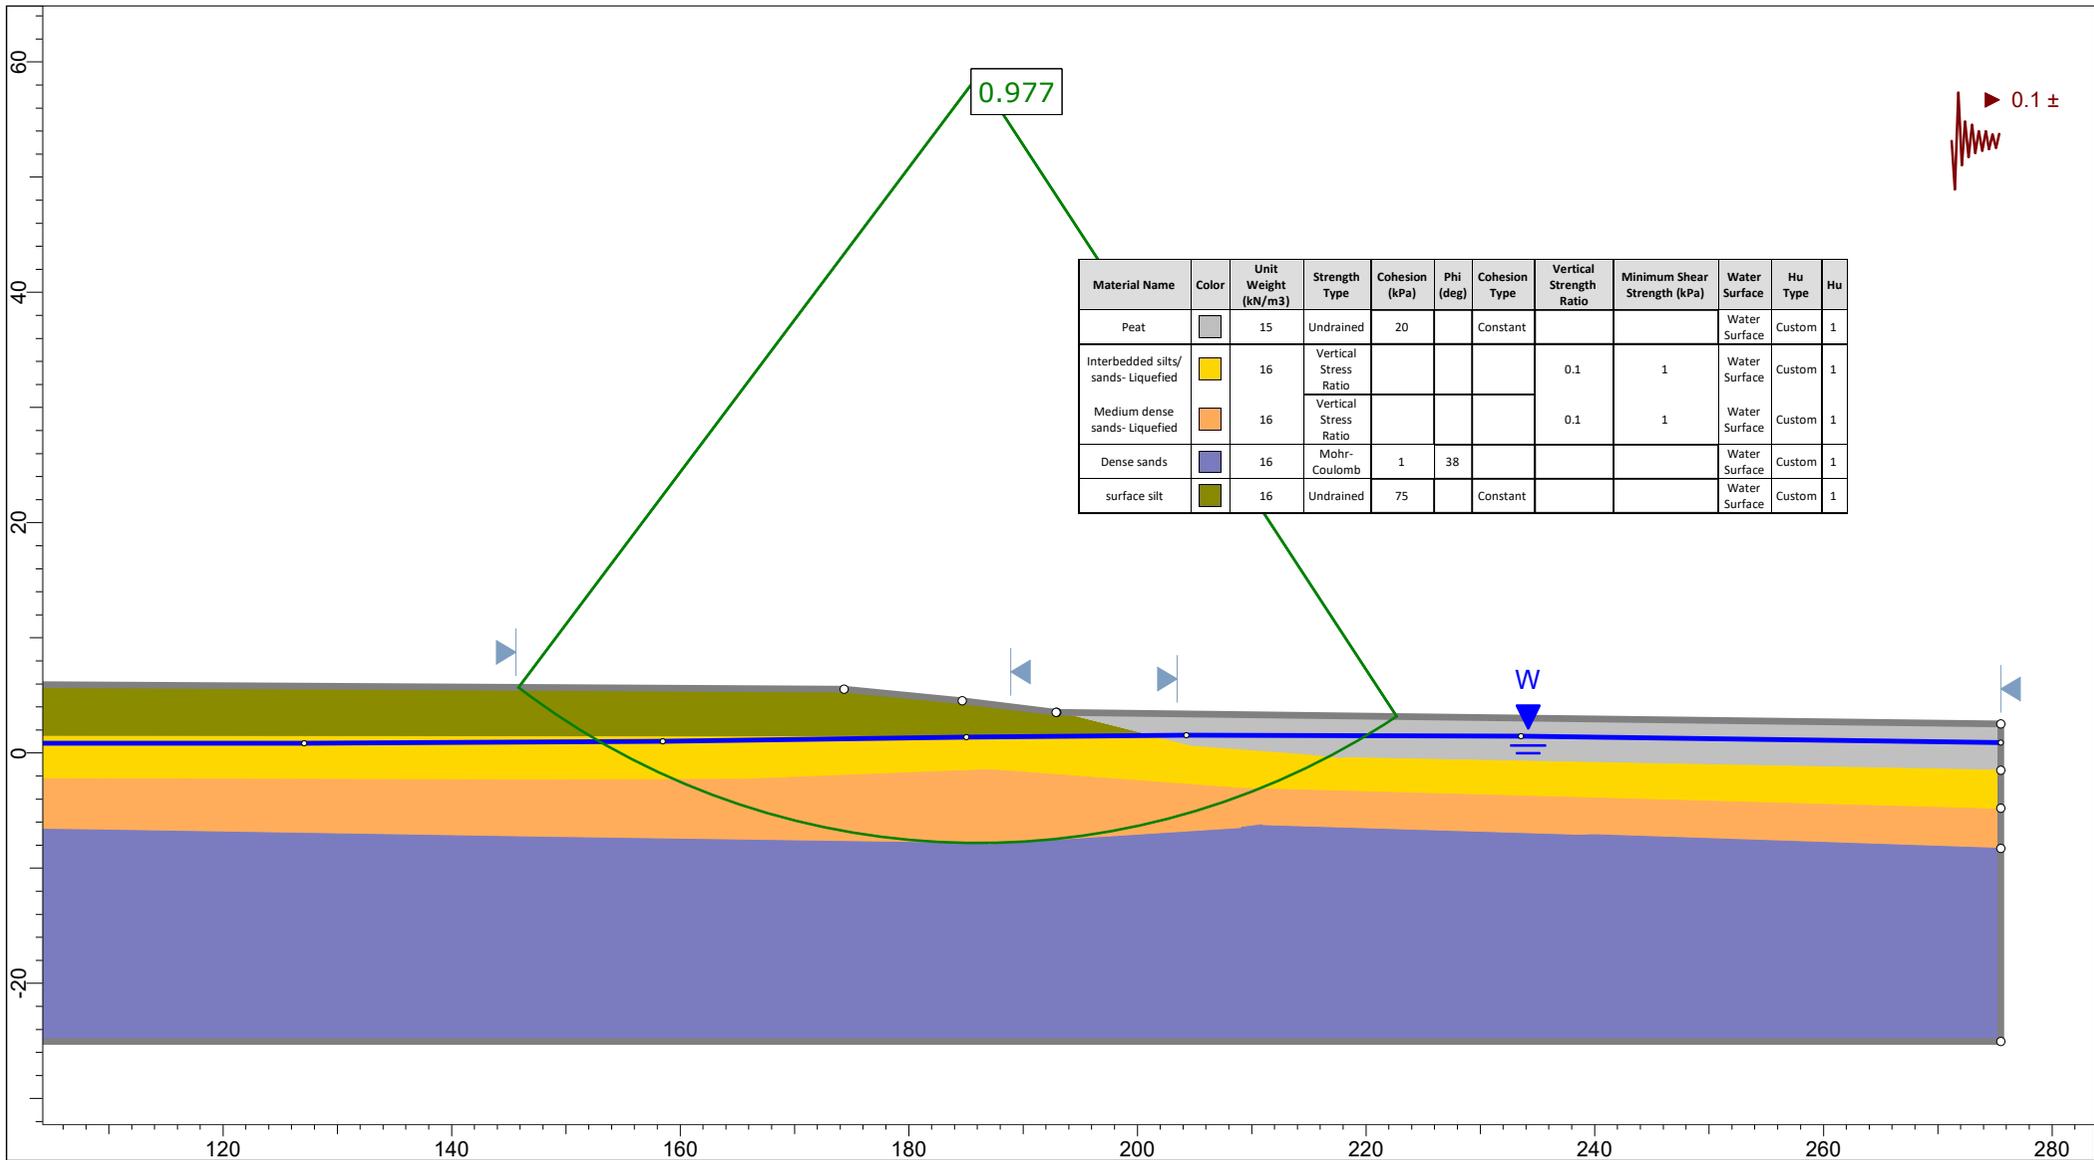
Material Name	Color	Unit Weight (kN/m <sup>3</sup> )	Strength Type	Cohesion (kPa)	Phi (deg)	Cohesion Type	Vertical Strength Ratio	Minimum Shear Strength (kPa)	Water Surface	Hu Type	Hu
Peat	Grey	15	Undrained	20		Constant			Water Surface	Custom	1
Interbedded silts/sands- Liquefied	Yellow	16	Vertical Stress Ratio				0.1	1	Water Surface	Custom	1
Medium dense sands- Liquefied	Orange	16	Vertical Stress Ratio				0.1	1	Water Surface	Custom	1
Dense sands	Blue	16	Mohr-Coulomb	1	38				Water Surface	Custom	1
surface silt	Green	16	Undrained	75		Constant			Water Surface	Custom	1
