Infrastructure, Transportation, Access & Soils

Client: Western Bay of Plenty District Council

Matakana Island Review

August 2011

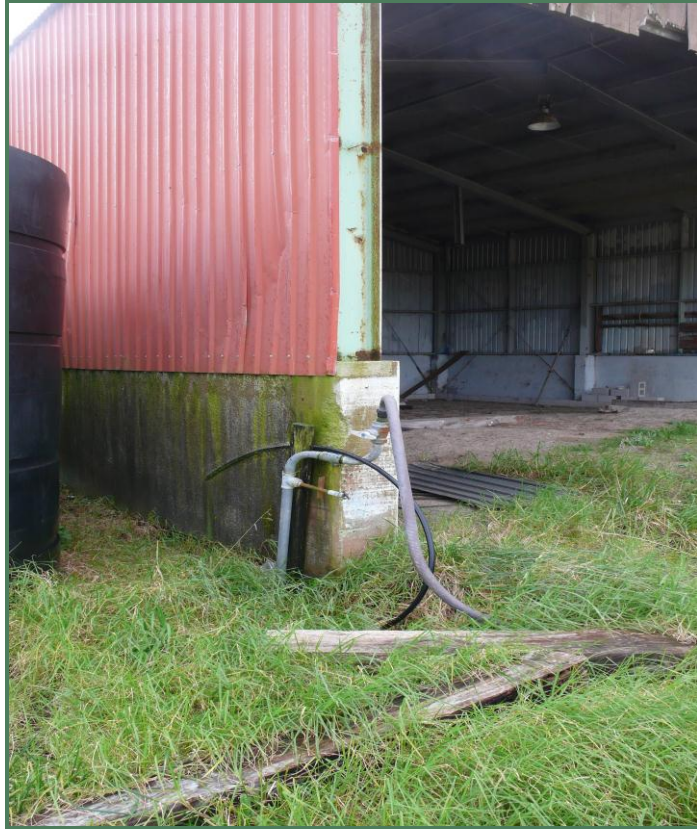
Photo 1: Water Bore at Hunters creek Mill on Barrier

From our observations and investigations potable water supply on Matakana Island is currently by way of either roof water collection and/or water bores (Refer photos 1 & 2 appendix 4). Generally, production forestry and farming blocks have water supplied by way of bores and individual dwellings have predominantly water supplied by roof water collection to tanks.

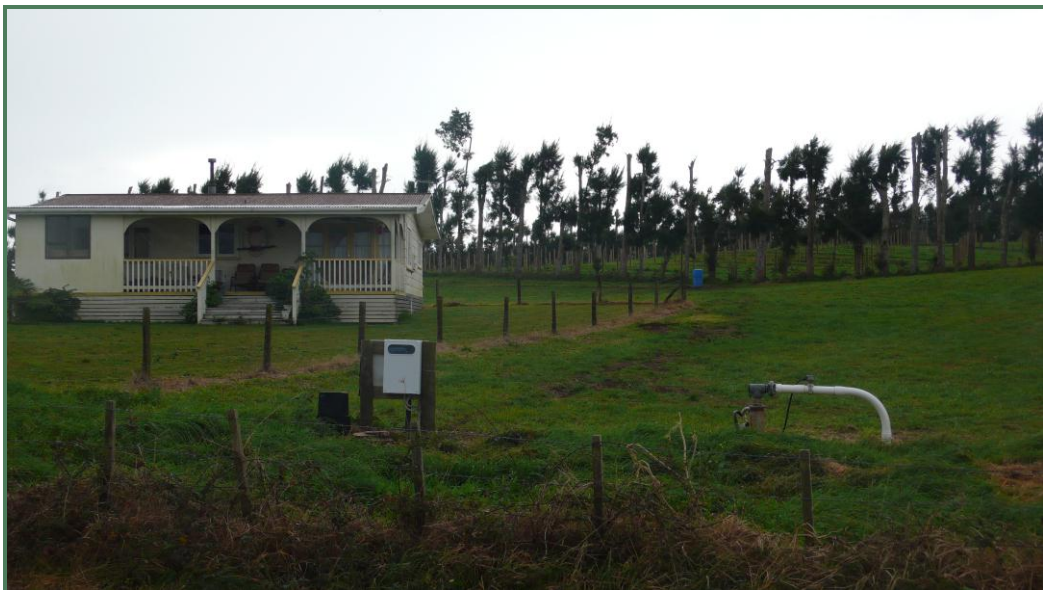
Photo 2: Water Bore on Core

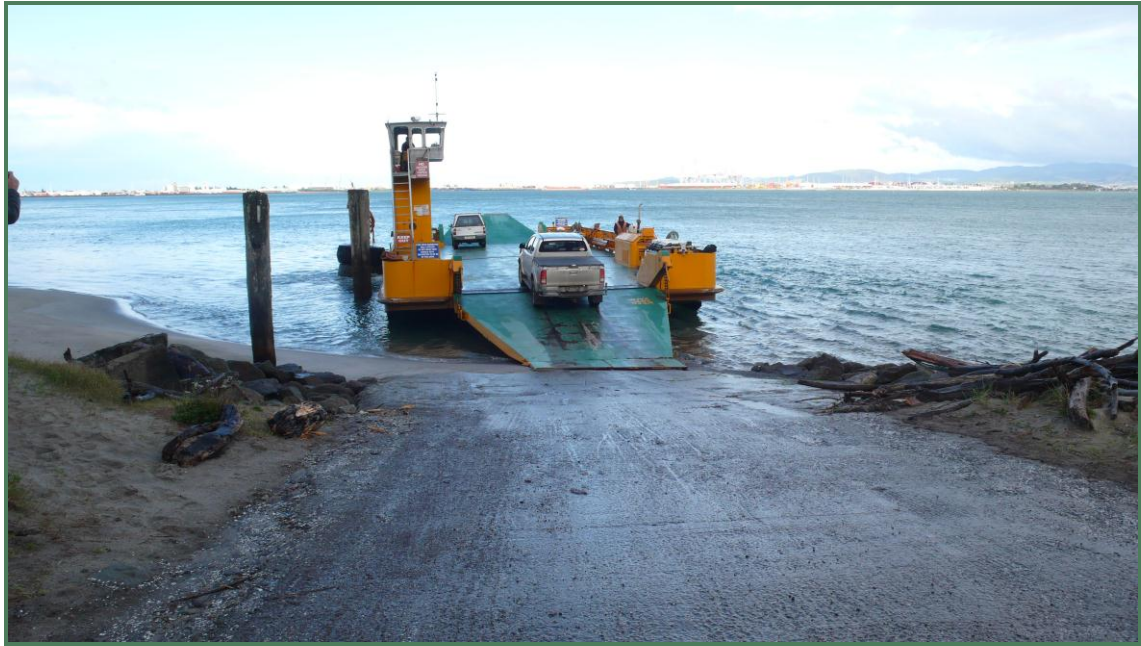
Photo 5: Pane Pane Ramp at South end of Island("Forest Lady" barge)

2. The "Forest Lady" Ferry, which is an 'on demand' service from the Cross Road ramp (Tauranga City-mainland) to Pane Pane ramp (Southern end of the Barrier-Matakana Island: refer photo 5 appendix 4). This ferry is owned and operated by a private company and is run as a commercial operation, and is licensed to dock in Tauranga City. This ferry carries vehicles, goods and passengers. As demand requires it also can dock at Rangiwaea Island ramp to cater for the transportation of goods and passengers to the Island, but particularly for the exporting of Island fruit crops.

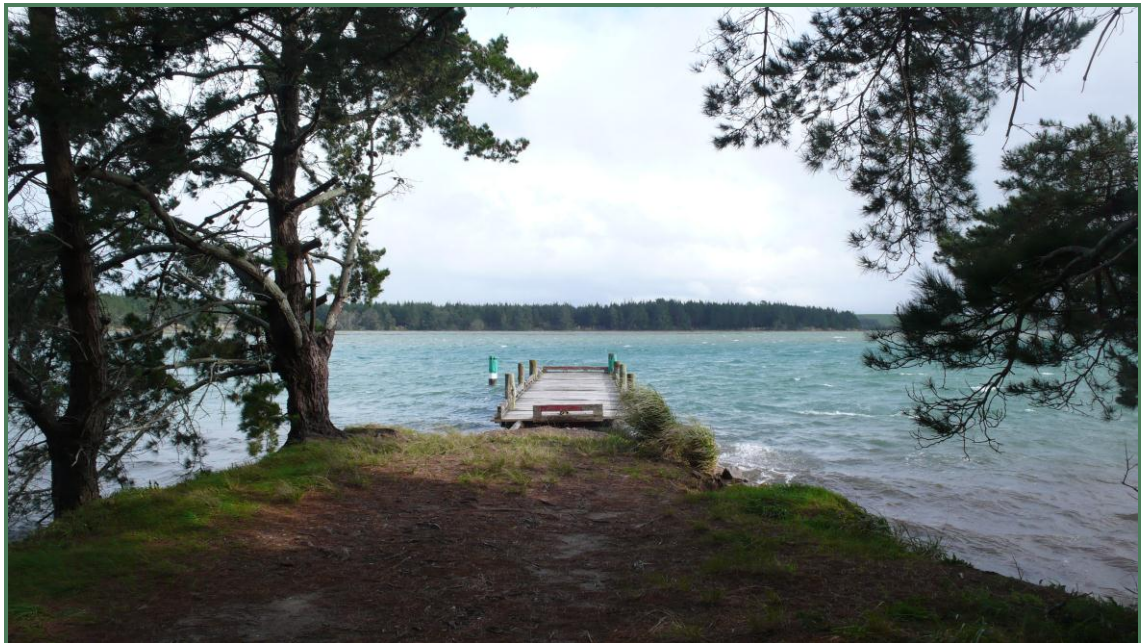
Photo 6: Hunters Creek Jetty looking West

Historically there were barges operating from the Port of Tauranga to Hunters Creek Mill/wharf which is located on the western side of the barrier (refer to photo 6 in appendix 4). Hunters Creek Mill/Wharf is now not operational.

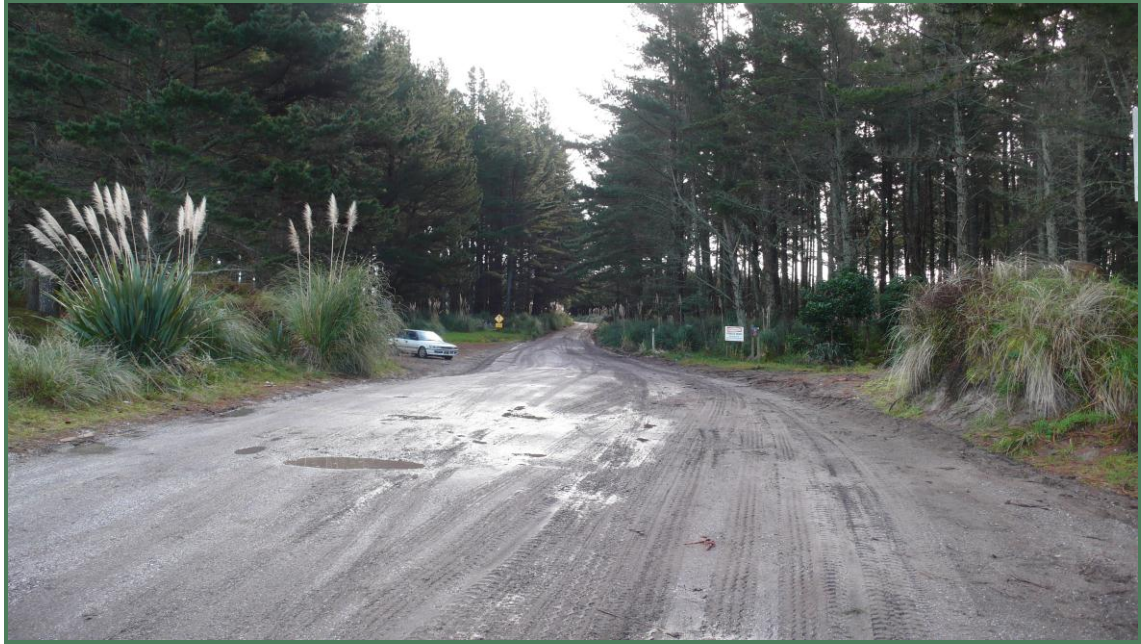
Photo 7: Right of Way formation looking North from Pane Pane Ramp

The only registered forms of roading within the barrier are Rights of Way. There is an extensive network of Rights of Way throughout the barrier, including one Right of Way that runs from the Pane Pane Ramp at the south end of the barrier to the northern end of the barrier. These Rights of Way mainly link and provide access to the large forestry holdings. All other access through the barrier is on an informal basis.

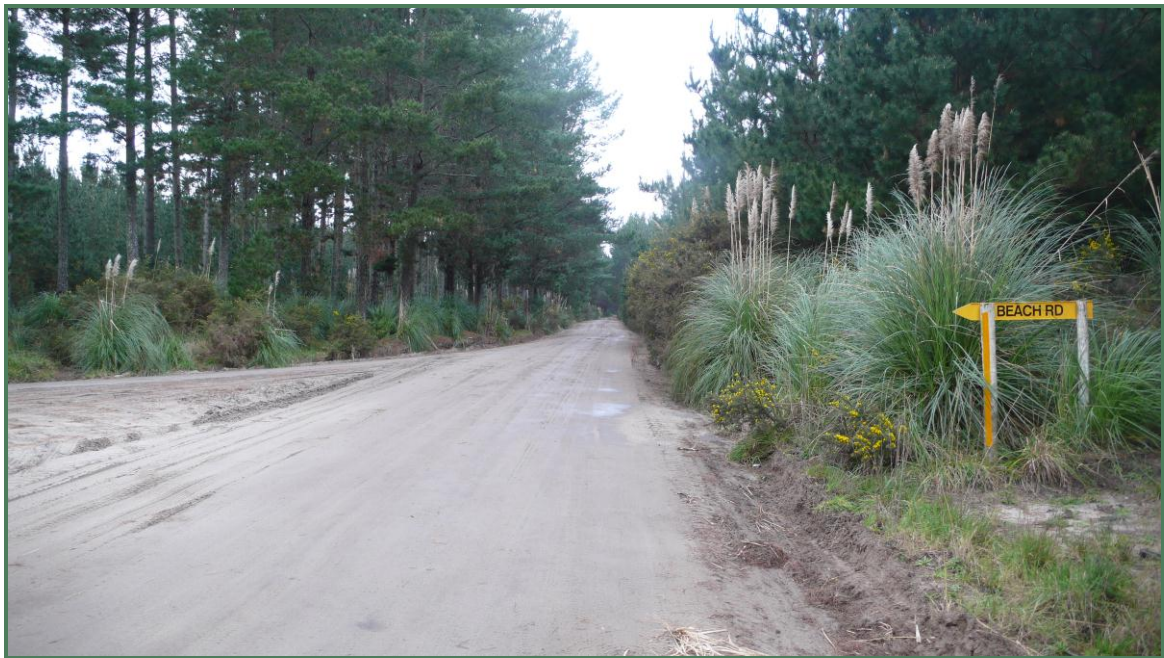
Photo 8: Main Right of Way (Hume Highway) unsealed formation on Barrier

The main Right of Way (Hume Highway) is unsealed. The unsealed rights of way have varying thicknesses of roading aggregate (graded) with layers of wind blown sand interspersed. Stormwater runoff from the rights of way on the barrier is generally channelled into soak holes or adjacent low areas.

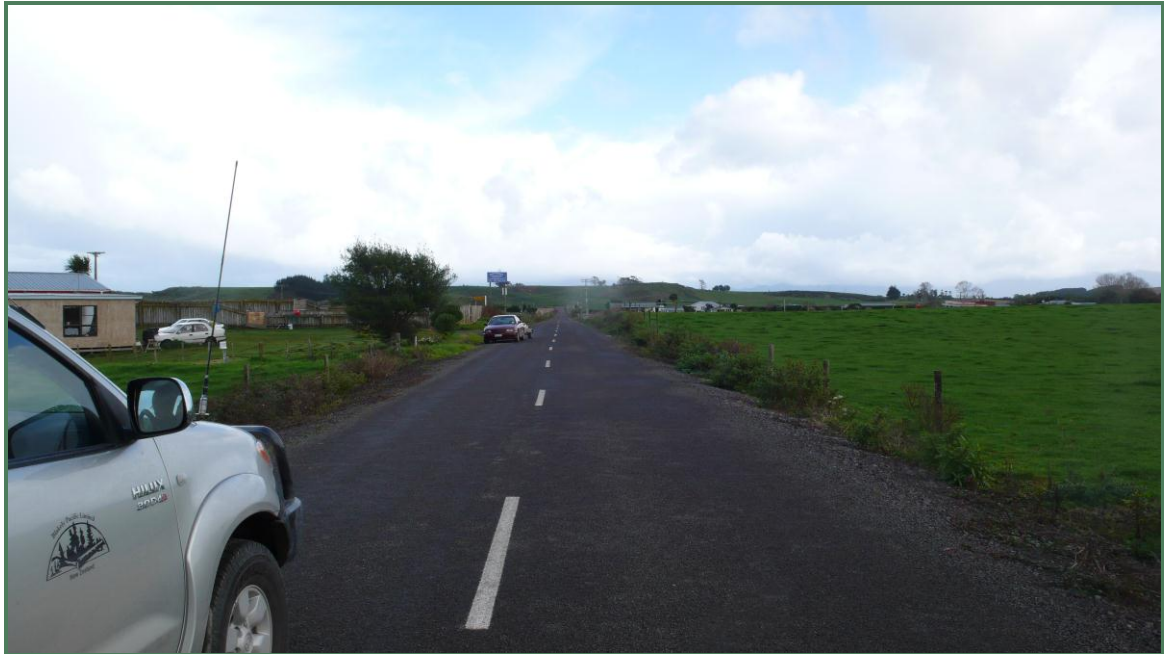
Photo 9: Waihirere Road sealed formation on Core

The standard of roading formation varies throughout the Island, with only a small percentage of the current roading, being chip sealed and/or culverted on the core. The balance of main roading/rights of way have varying thicknesses of roading aggregate (graded). The minor roads and tracks throughout the island are roughly formed and metalled and/or compacted sand/soil.

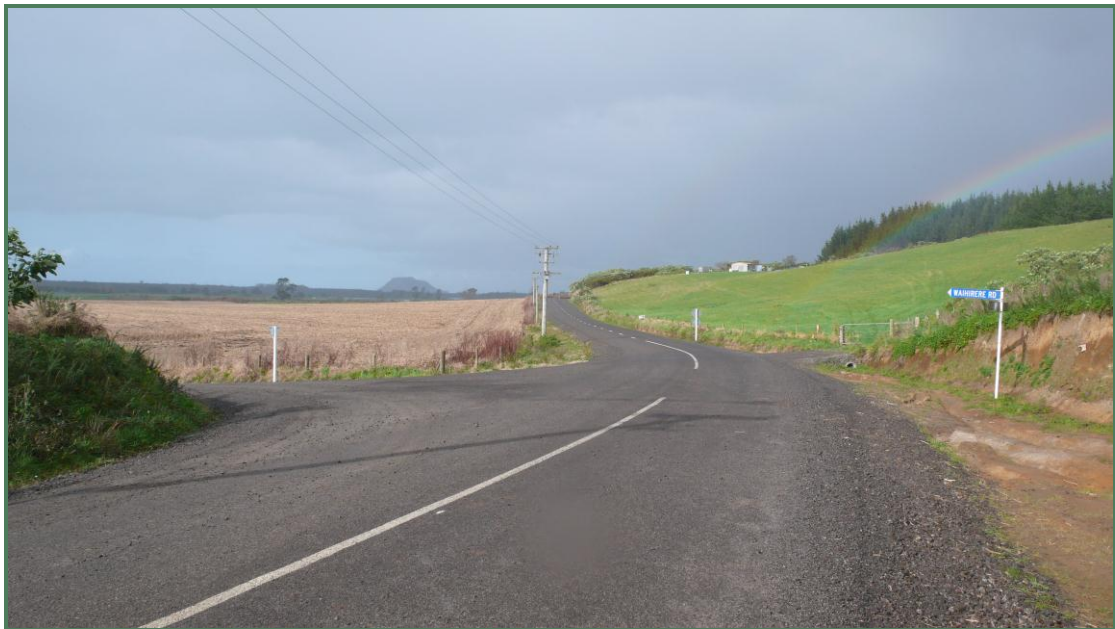
Photo 10: Matakana Road on core (sealed formation) looking South

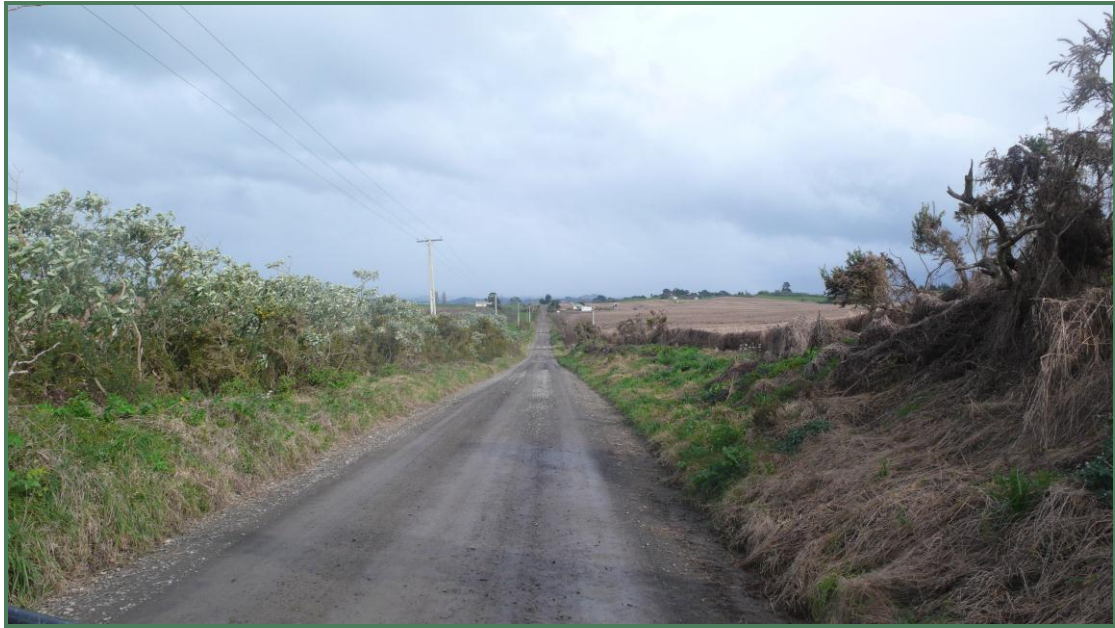
Photo 11: Matakana Point Road on Core (unsealed formation)

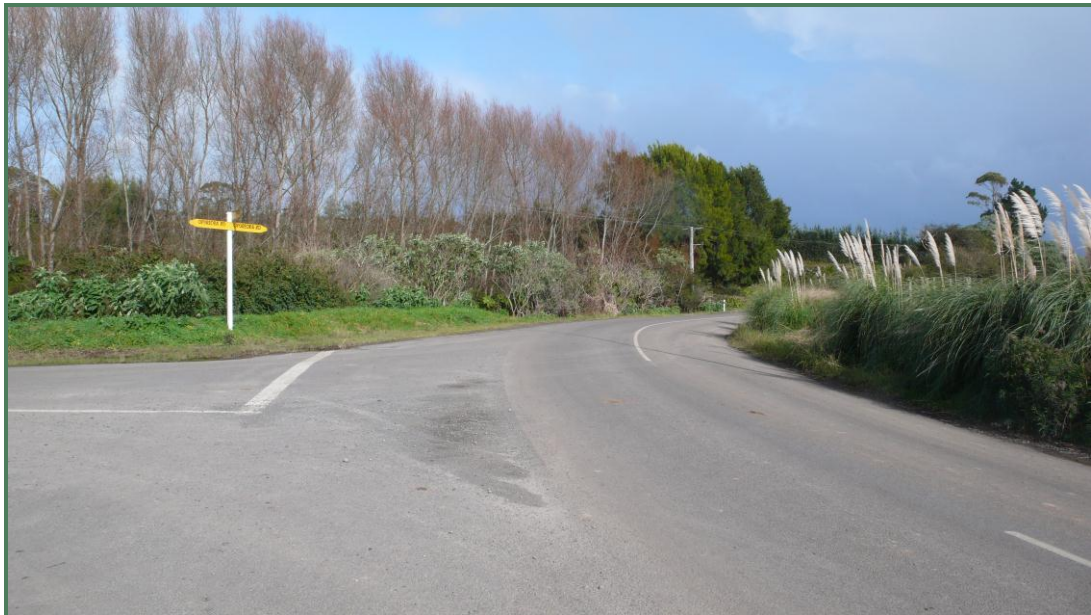
Photo 12: Oपुरeroa Road Intersection with Matakana Road (sealed formation)

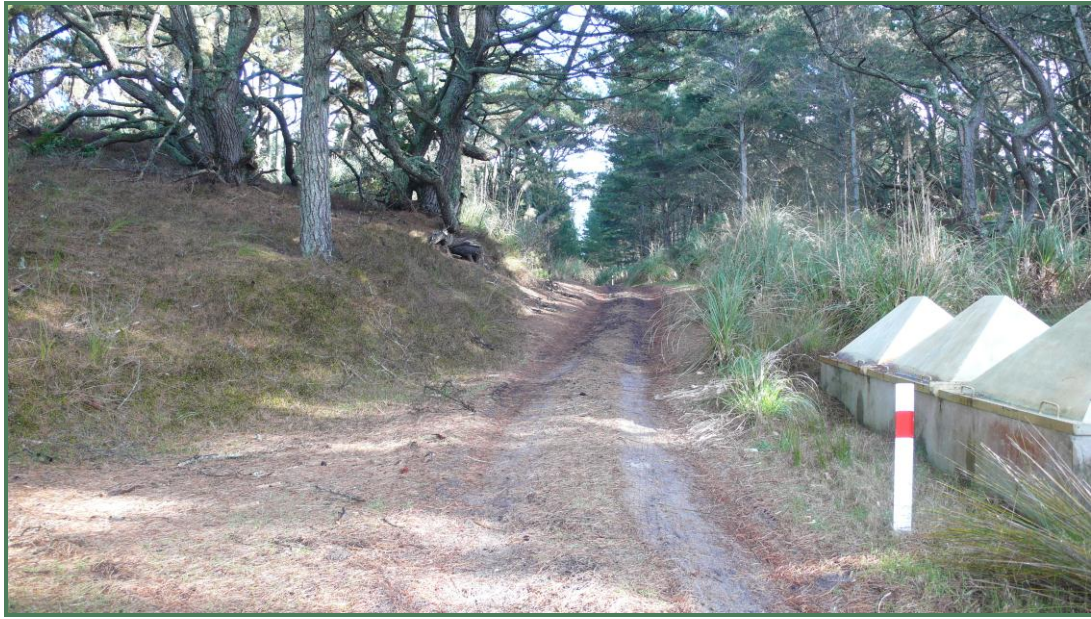
Photo 13: Pipeline Road (Right of Way) on Barrier (unsealed formation)
