# Tauranga Harbour Coastal Hazards Study

## Coastal Erosion Assessment

Prepared for  
Bay of Plenty Regional Council

Prepared by  
Tonkin & Taylor Ltd

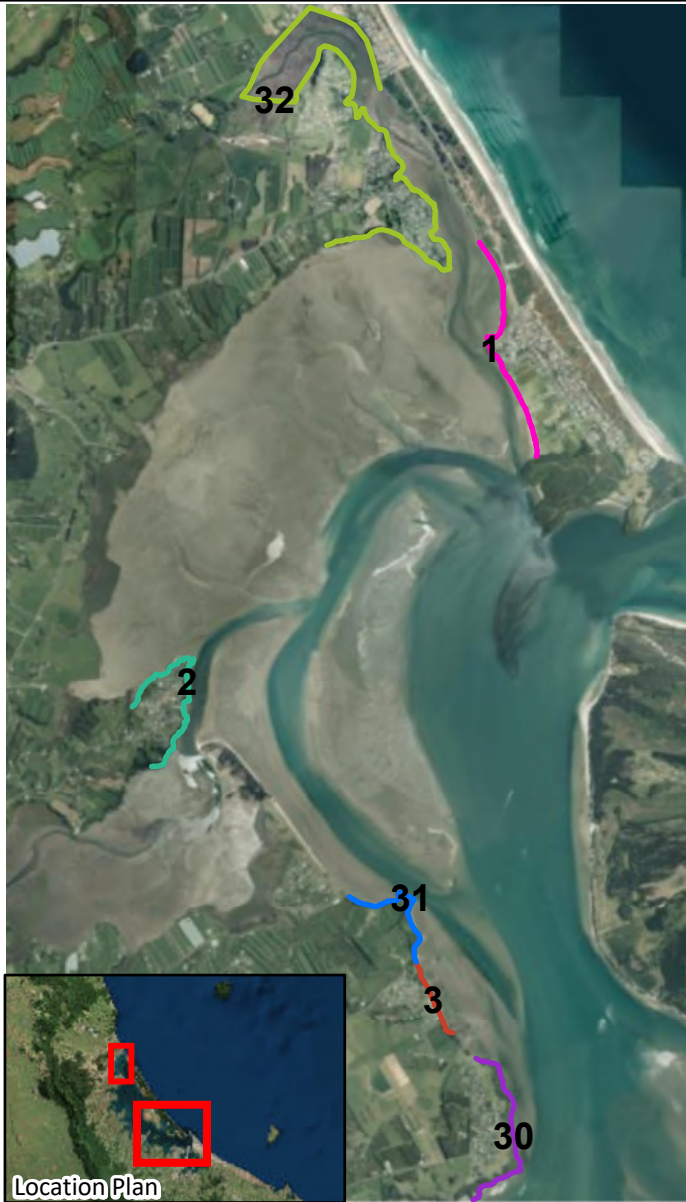
Location Plan

Site ID	Site Name
1	Bowentown
2	Tanners Point
3	Ongare
4	Omokoroa
5	Matakana Island
6	Motuhoa Island
7	Plummers Point
8	Te Puna West
9	Te Puna
10	Rangaiwaea Island
11	Bethlehem
12	Matua
13	Otumoetai
14	Waikareao
15	Tauranga West
16	Tauranga East
17	Waimapu
18	Maungatapu
19	Welcome Bay
20	Te Maunga
21	Matapihi
22	Whareroa
23	Pilot Bay
24	Waitao
25	Te Puna Estuary
26	Plummers Point West
27	Omokoroa South
28	Rangaiwaea North
29	Matakana North
30	Kauri Point
31	Ongare North
32	Athenree

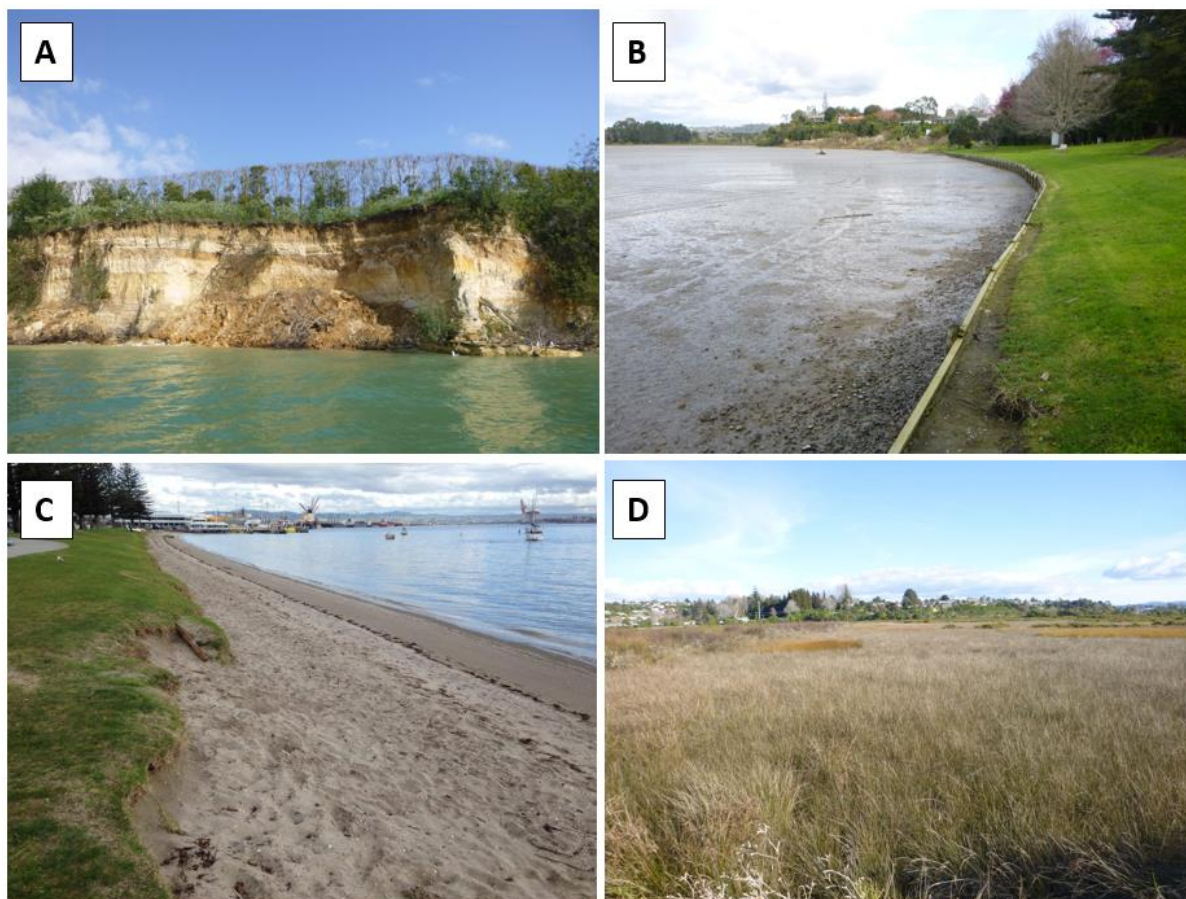
Figure 2-1 Examples of different shoreline morphology around Tauranga Harbour. (A) Consolidated cliffs, (B) consolidated bank, (C) unconsolidated beach ridge, (D) low-lying estuarine area.

Unlike the open coast, there are very few sand dune systems throughout the harbour. Most of the unconsolidated shorelines are characterised by beach ridges, backed by grass reserves. An example of an unconsolidated shoreline is Pilot Bay (Figure 2-1C).

The low-lying estuarine areas are characterised by non-eroding shorelines, typically fronted by salt marsh and mangroves. Such shorelines typically occur within the sheltered upper reaches of the harbour, for example, the Matua salt marsh (Figure 2-1D).

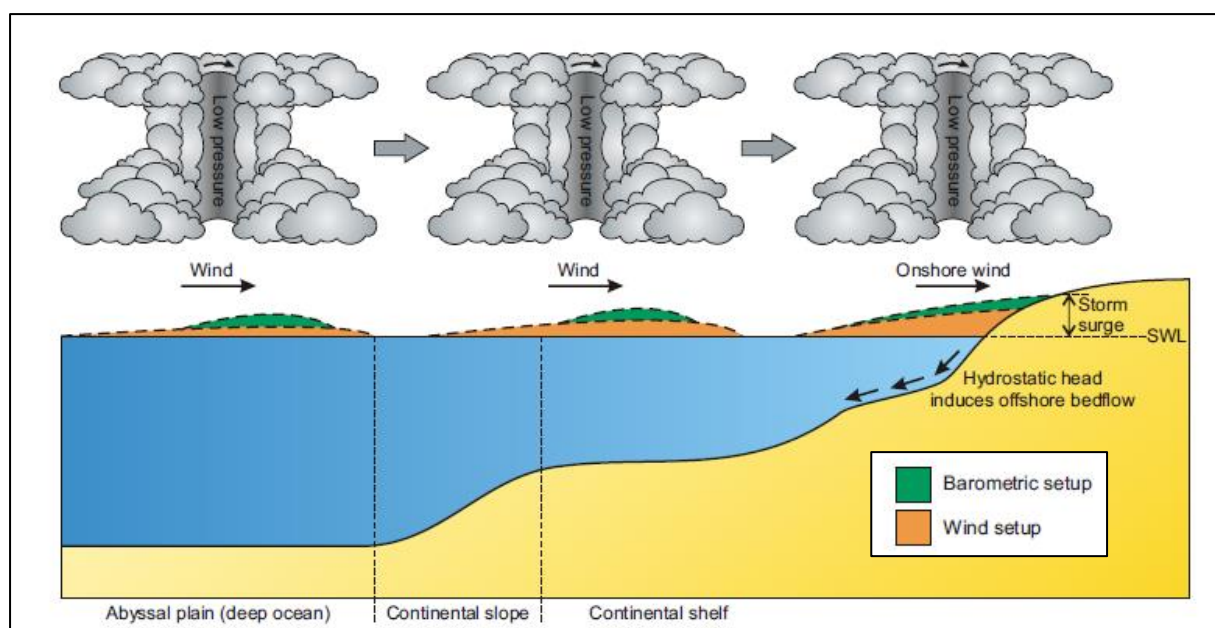
Figure 2-3 Processes causing storm surge (source: Shand, 2010).

Storm surge results from the combination of barometric setup from low atmospheric pressure and wind stress from winds blowing along or onshore which elevates the water level above the predicted tide (Figure 2-3). The combined elevation of the predicted tide and storm surge is known as the storm tide.

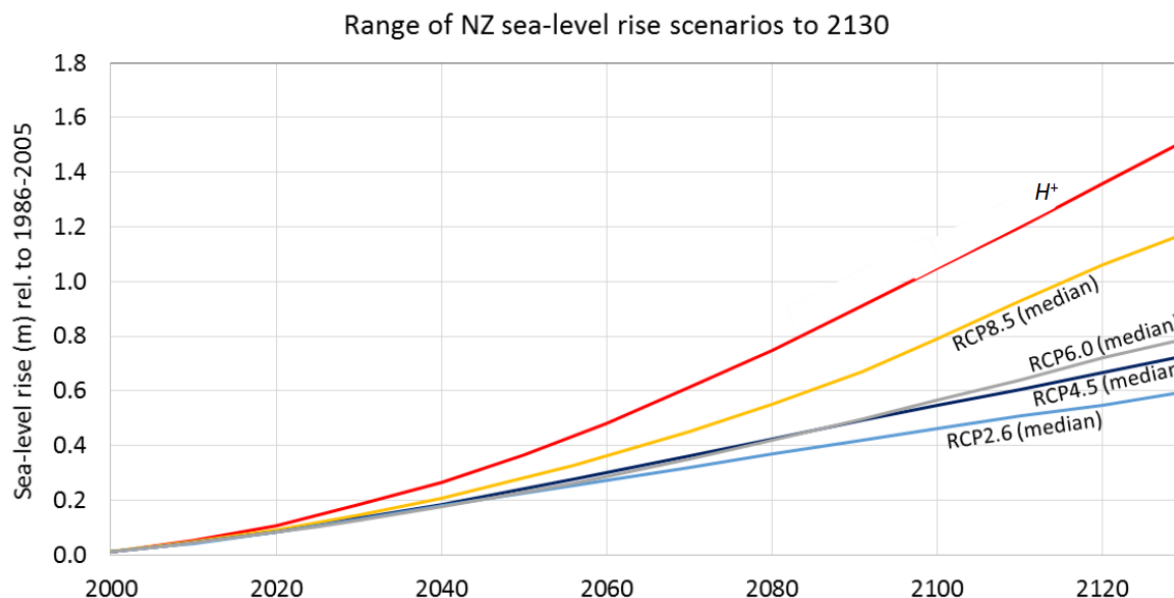
Figure 2-4 Range of sea level rise scenarios to 2130 (Stephens, 2017).

The Ministry for the Environment (2017) guideline recommends four sea level rise scenarios to cover a range of possible sea-level futures. The scenarios are based on the most recent IPCC report (IPCC, 2013) (Figure 2-4).

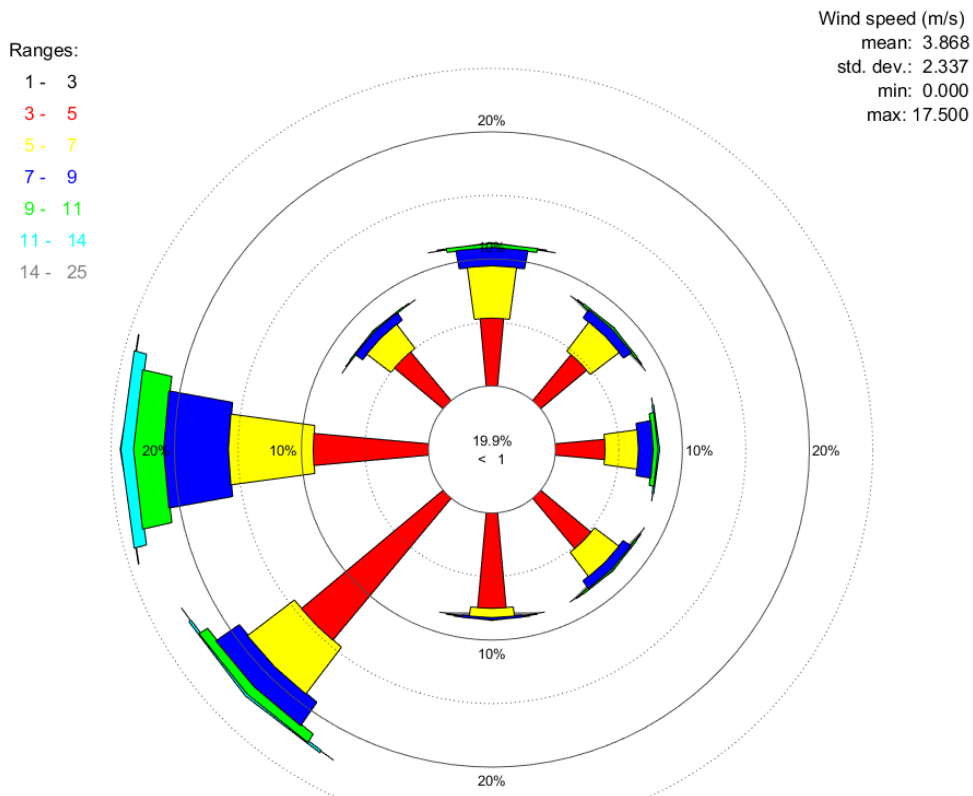
Figure 2-5 Wind rose for Tauranga Airport 1995 – 2016 (Source: MetService, 2018).

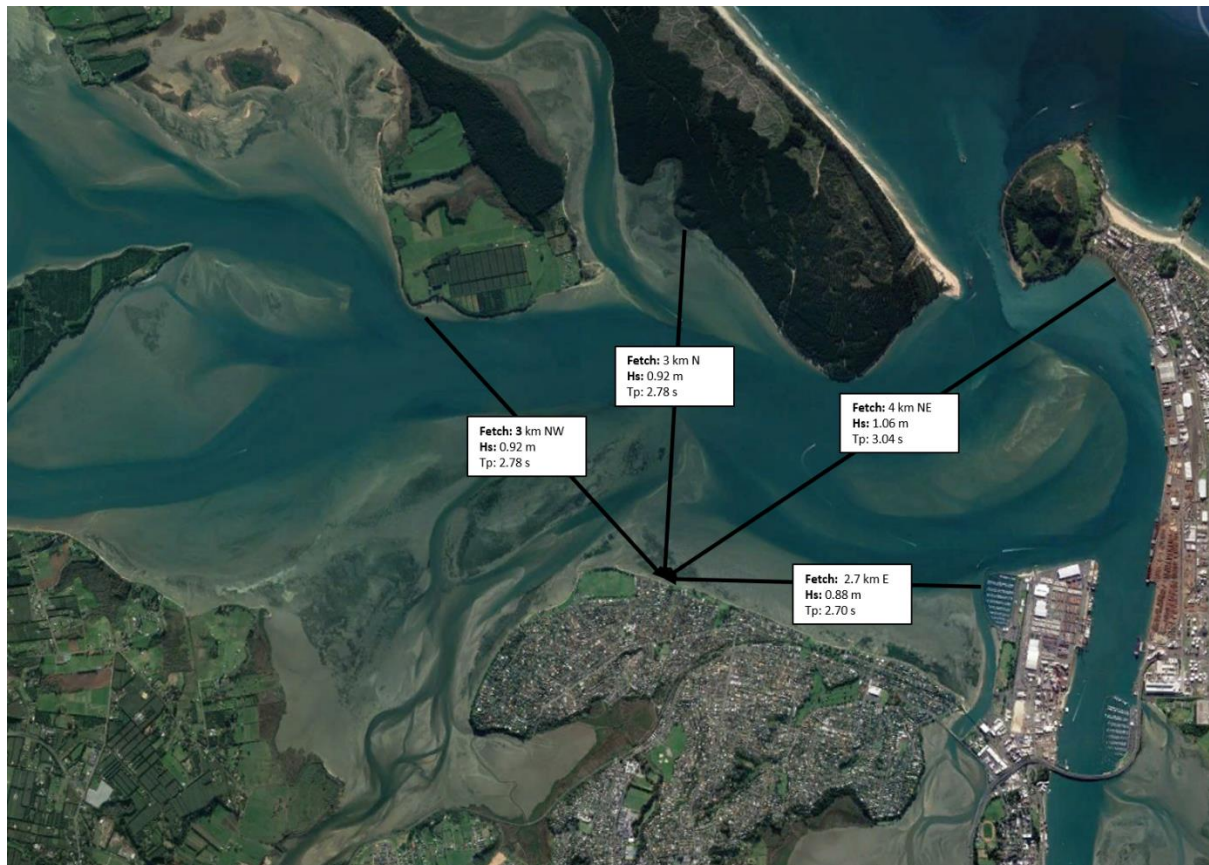
Figure 2-6 Example of fetch distances with corresponding fetch-limited wave heights for the western Otumoetai shoreline. Fetch-limited wave heights based on 23 m/s 1 hour duration wind speeds.

Figure 2-5 demonstrates the different fetch distances for the Otumoetai shoreline, where the maximum fetch-limited wave height at Otumoetai is 1.06 m, generated from the NE.

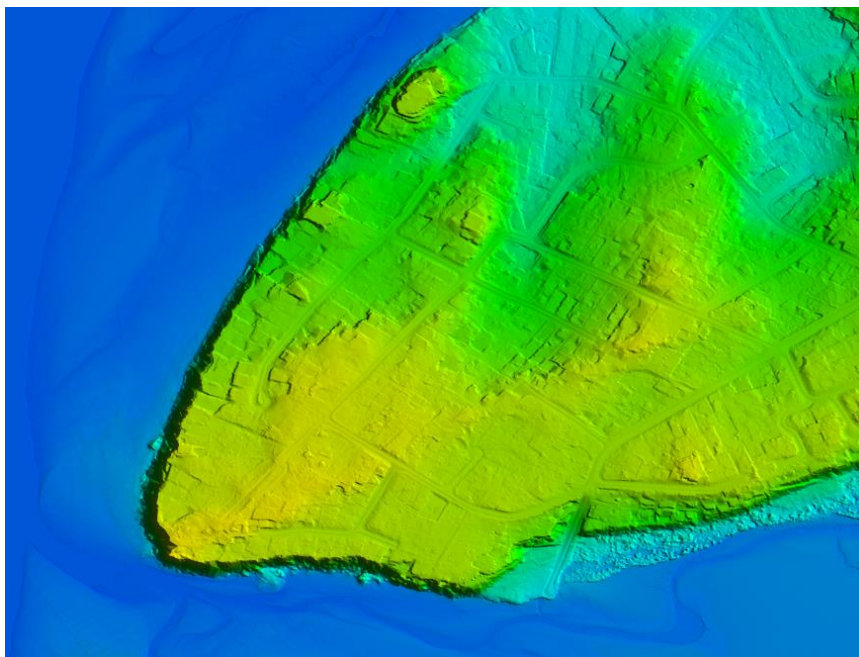
Figure 3-1 Example of 1 m by 1 m Digital Elevation Model used for topography around Tauranga Harbour.

Topography has been assessed using LiDAR (Light Detection and Ranging) data captured in 2015. The LiDAR was sourced from the LINZ Data Service as a 1 m by 1 m DEM (digital elevation model). The DEM was used for determining both location and elevation of the shoreline around Tauranga Harbour (Figure 3-1).

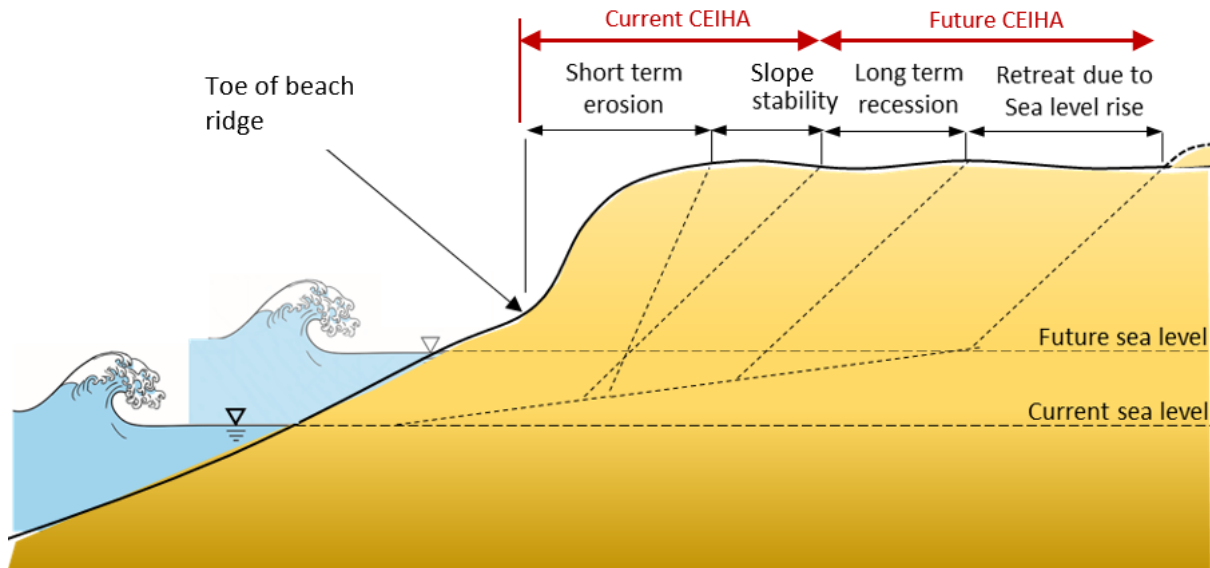
Figure 4-1 Definition sketch for the coastal erosion hazard area for an unconsolidated shoreline.

The CEIHA baseline to which values are referenced is the most recent beach ridge toe derived from site survey data or LiDAR. The cross over between the short term erosion and the slope stability represents the short term effect from talus material protecting the shoreline.

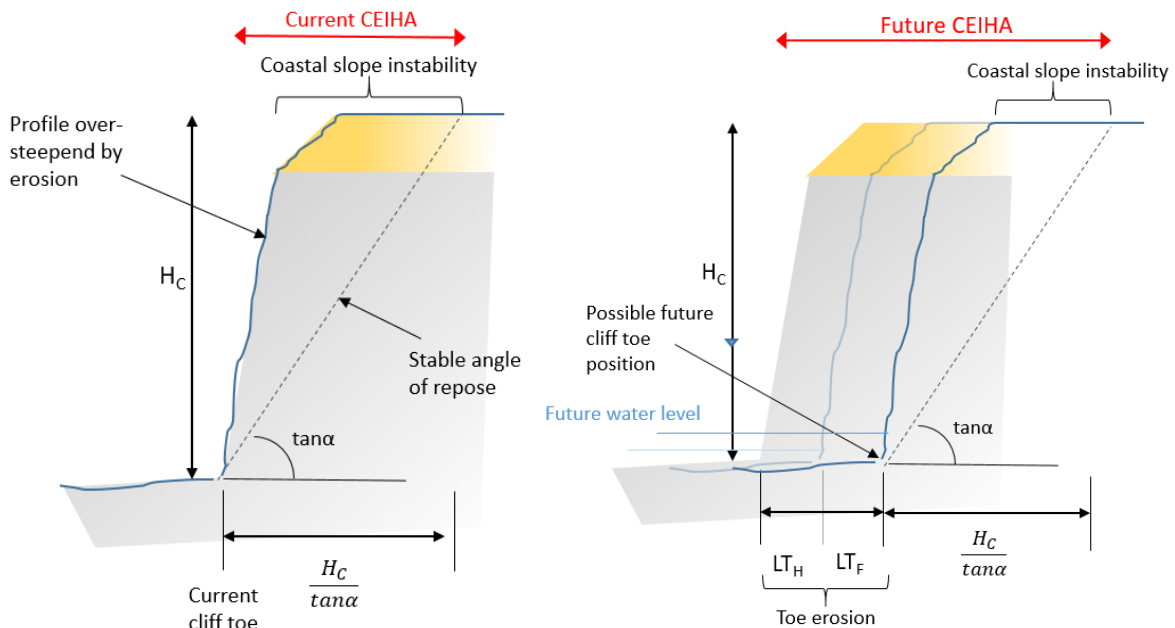
Figure 4-2 Definition sketch for consolidated shoreline.

Figure 4-2 shows that the current CEIHA distance is entirely dependent on the stable angle of repose. Therefore the current CEIHA for unconsolidated cliff and bank shorelines represents the land currently exposed to slope instability hazard.

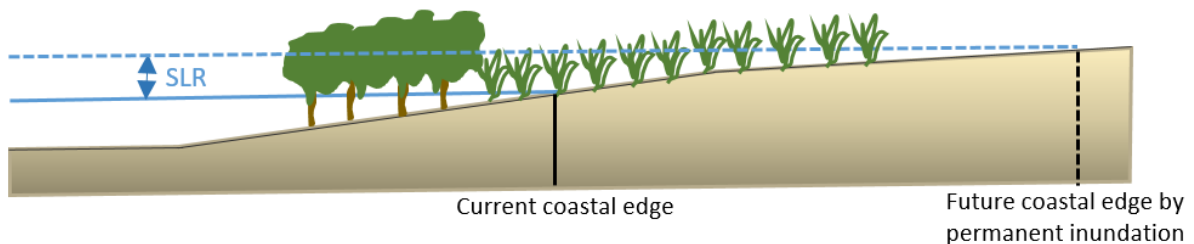
Figure 4-3 Effect of permanent inundation on coastal edge position in low-lying areas.

A shoreline is defined by the landward extent of typical marine processes such as tides and waves. In a sheltered estuarine environment this can be approximated by the mean high water spring (MHWS) position. The potential increase in future sea level may cause the shoreline to migrate landward as areas are permanently inundated by these processes (i.e. Figure 4-3). For the low-lying estuarine areas around Tauranga Harbour there is no evidence of shoreline erosion. However there is potential for the shoreline to migrate landward with permanent inundation from sea level rise assuming no change in morphology. For these shorelines we have used the future MHWS-7 output from Stephens (2019) to assess the permanent inundation hazard for low-lying estuarine areas.

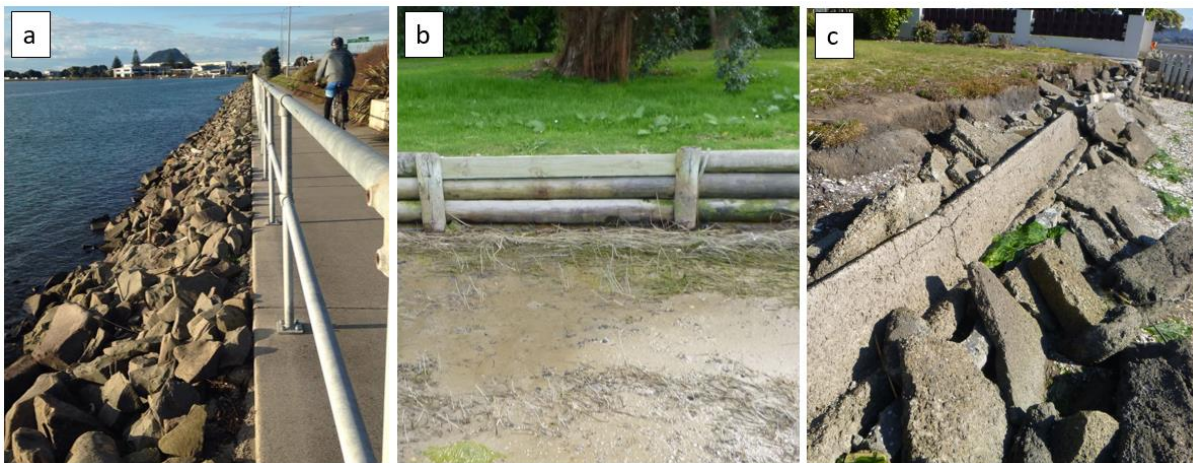
Figure 4-4 Example of the three types of protection structures around Tauranga Harbour (a) critical, (b) consented and (c) informal, non-consented structures.

- 1 Critical, consented structures (e.g. Figure 4-4A)
- 2 Non-critical, consented structures (e.g. Figure 4-4B)
- 3 Informal or non-consented structures (e.g. Figure 4-4C).

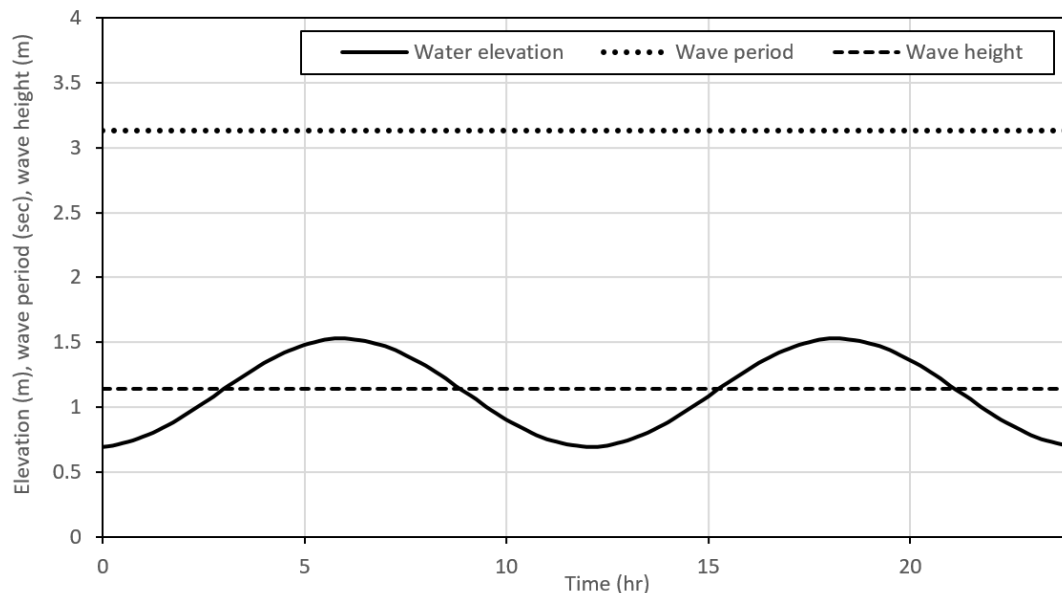
Figure 5-1 Example synthetic 100yr ARI design storm input for Pilot Bay.

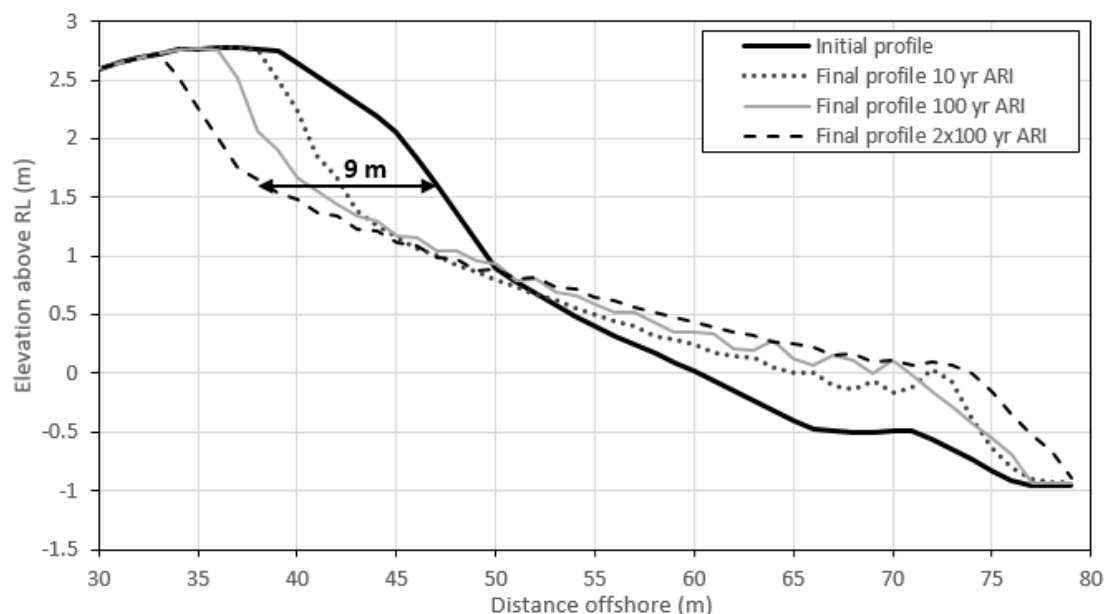
Figure 5-2 Example SBEACH results for Pilot Bay. The horizontal distance between the initial profile and the 2x100 yr ARI profile at the 1.5m CONTOUR is shown as 9 m.

SBEACH assumes an equilibrium profile concept which instantly responds to the present wave forcing conditions and calculates an equilibrium profile based on that forcing. Figure 5-2 shows the initial and equilibrium profiles formed due to 10, 100 and 2x100 year ARI storms for Pilot Bay. Changes in horizontal shoreline position at a predefined contour (i.e. 1.5 m) provide information on short term erosion distances. For Pilot Bay, these distances are 5, 7 and 9 m respectively.

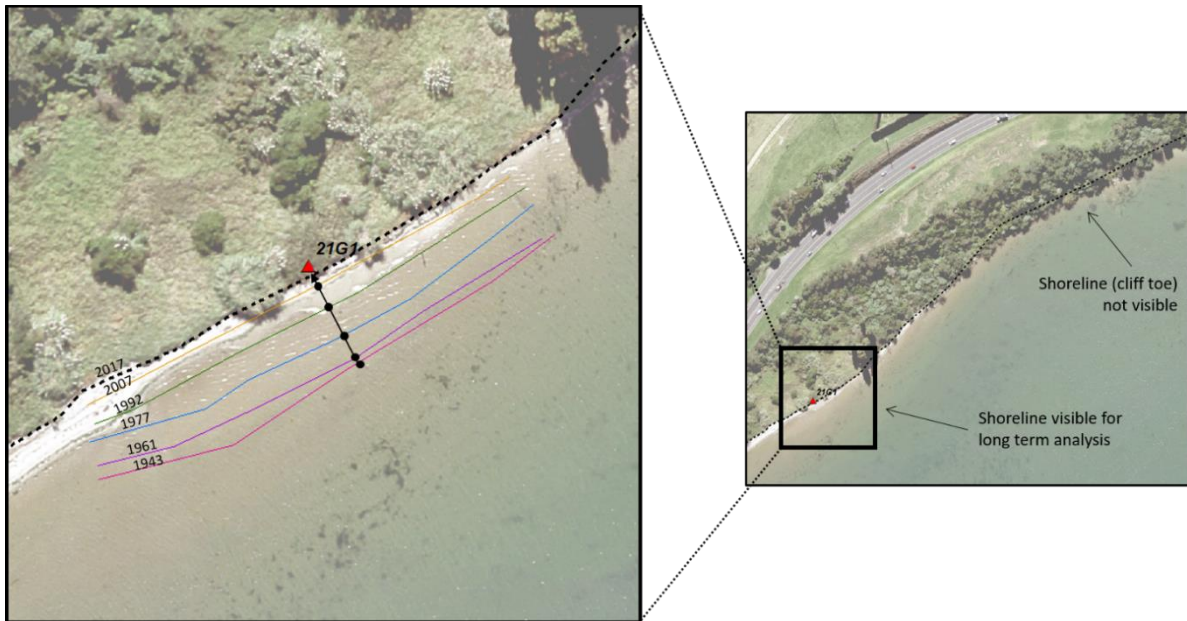
Figure 5-3 Example of single point shoreline position analysis for Cell 21G, Matapihi.

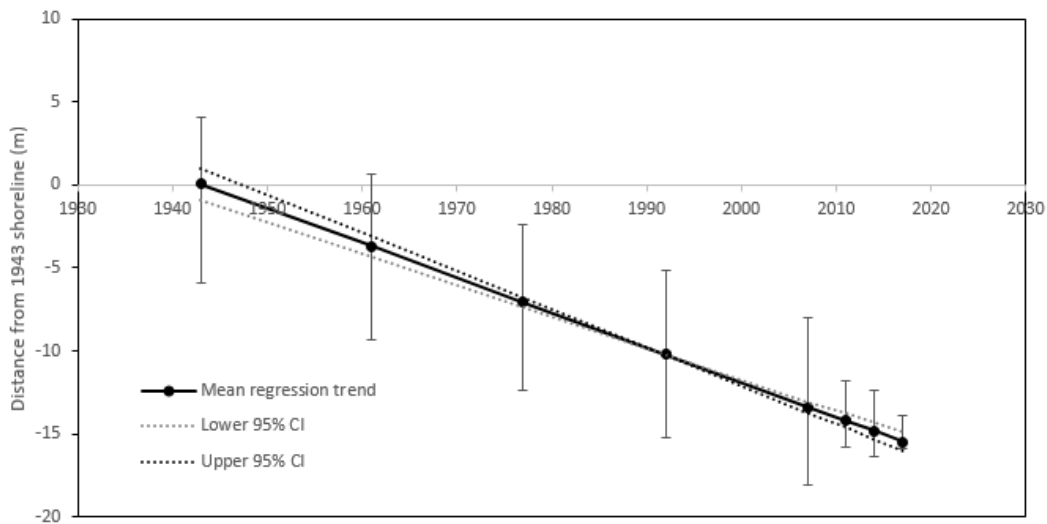
Figure 5-4 Example of linear regression analysis for the single point 21G (Matapihi) and upper and lower 95% confidence intervals. Error bars are based on estimated aerial photograph accuracy.

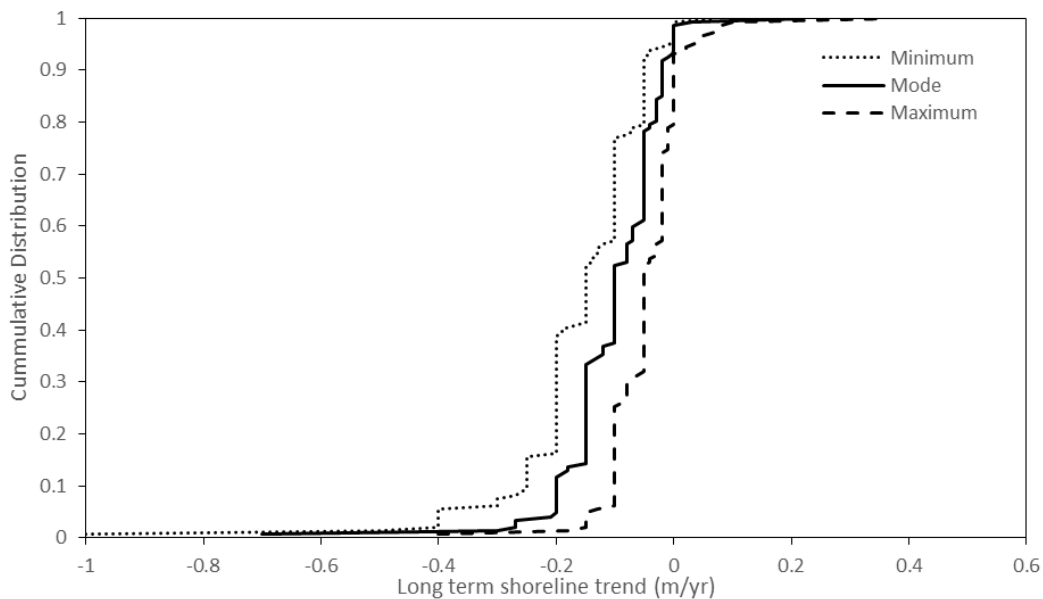
Figure 5-5 Cumulative distribution plot of the long term shoreline trends throughout Tauranga Harbour (negative values = erosion, positive values = accretion).

Long term shoreline trends throughout the Harbour range from -1 to +0.36 m/yr, with most shorelines showing a long term erosion rate of -0.1 m/yr (Figure 5-5). The majority of the sites have a measured long term erosion rate between -0.2 to -0.05 m/yr. This equates to -5 to -20 m of erosion over a 100 year timeframe.

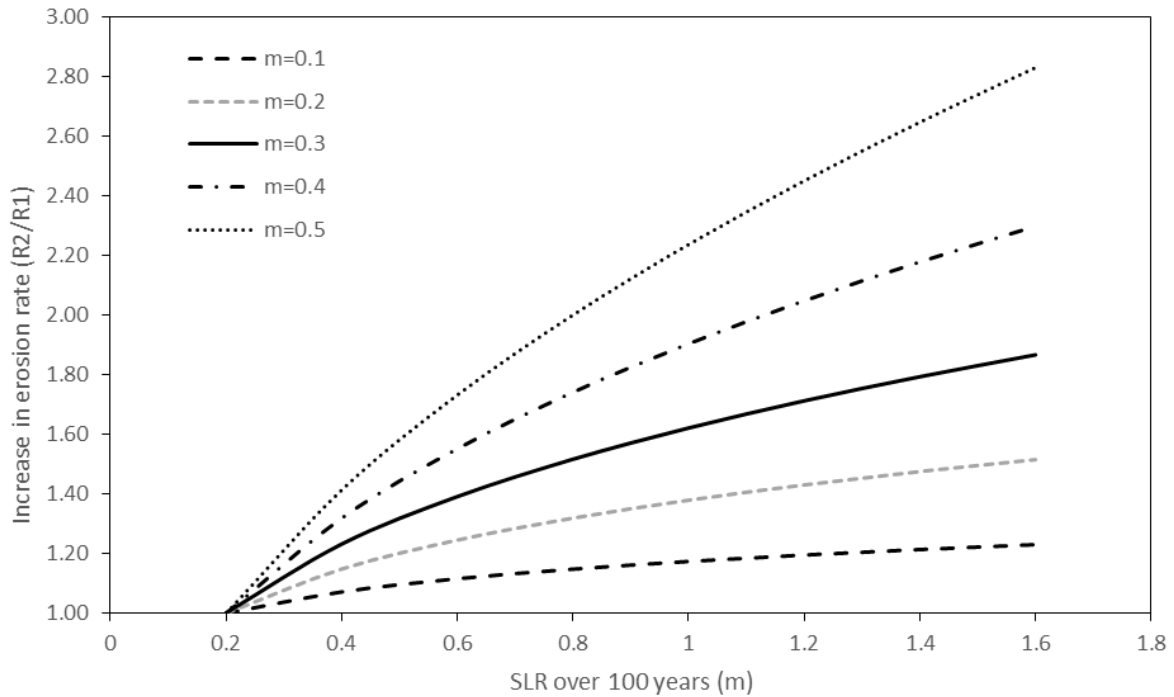
Figure 5-7 Increase in consolidated shoreline erosion rate with increasing SLR for different shoreline response factors.

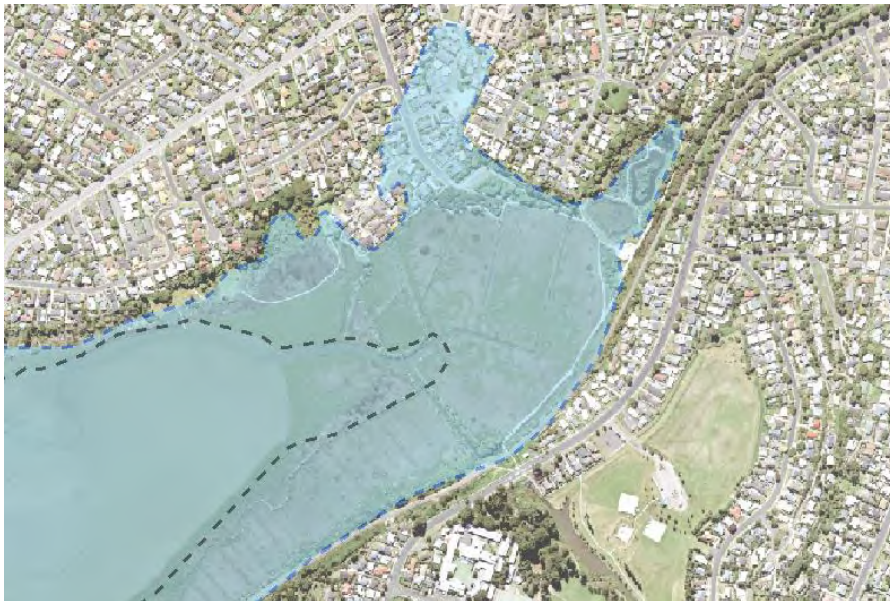
Figure 5-8 Example of how low-lying estuarine shorelines are likely to be translated landward with inundation from future SLR scenarios (black dashed line represents the current MHWS, blue shading represents future MHWS with 1.6 m SLR).

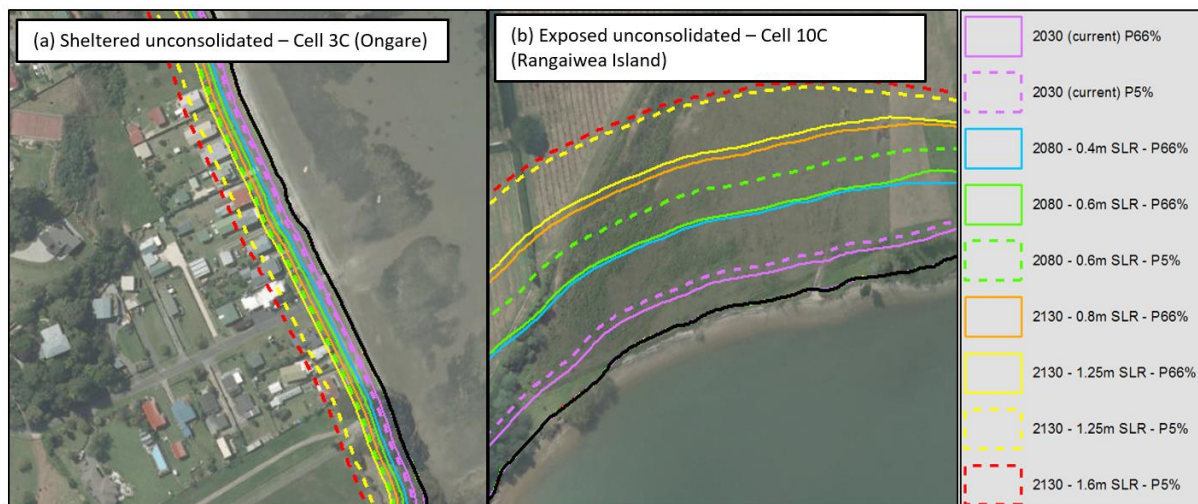
Figure 6-4 Comparison between (a) a sheltered unconsolidated shoreline (Cell 3C) and (b) an exposed unconsolidated shoreline (Cell 9D).
