30 Kauri Point

Tauranga Harbour Coastal Erosion Assessment
 Erosion Hazard Overview
 Site 30: Kauri Point

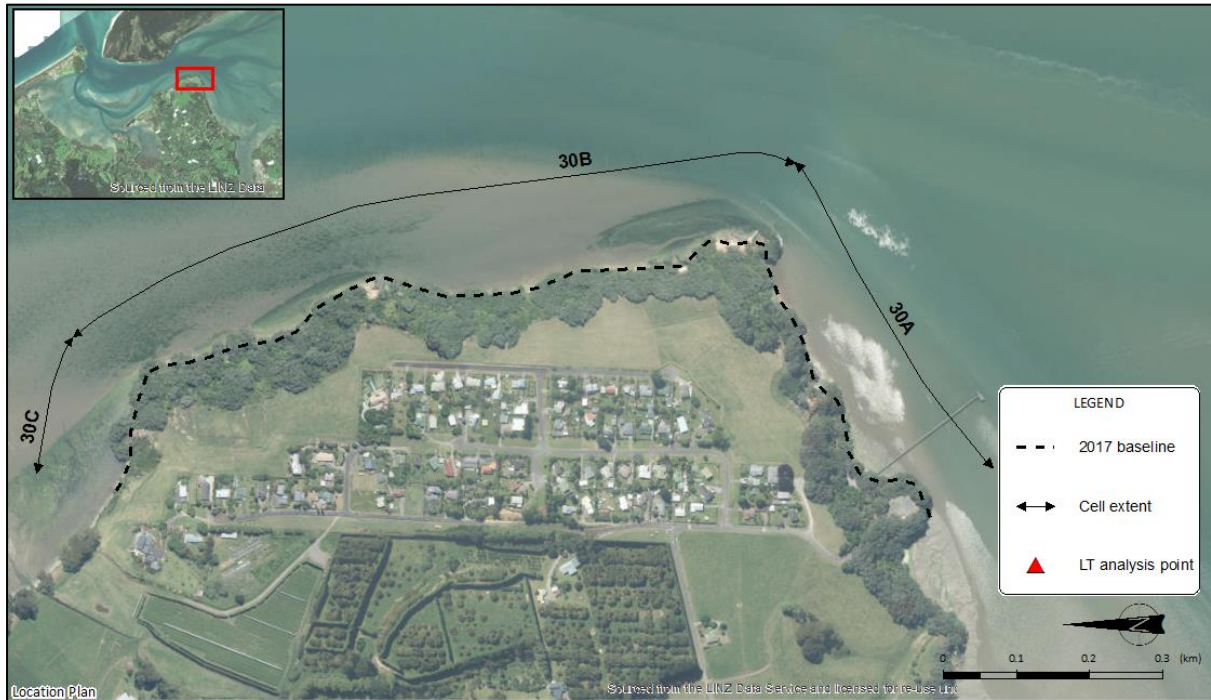
Kauri Point is located at the northern end of Tauranga Harbour, approximately 4 km south of the harbour entrance. The site consists of approximately 1.6 km of consolidated cliff. The site is split into 3 cells based on differences in exposure and shoreline elevation (Figure 30-1).

Figure 30-1 Location and cell extent around Kauri Point within Tauranga Harbour.

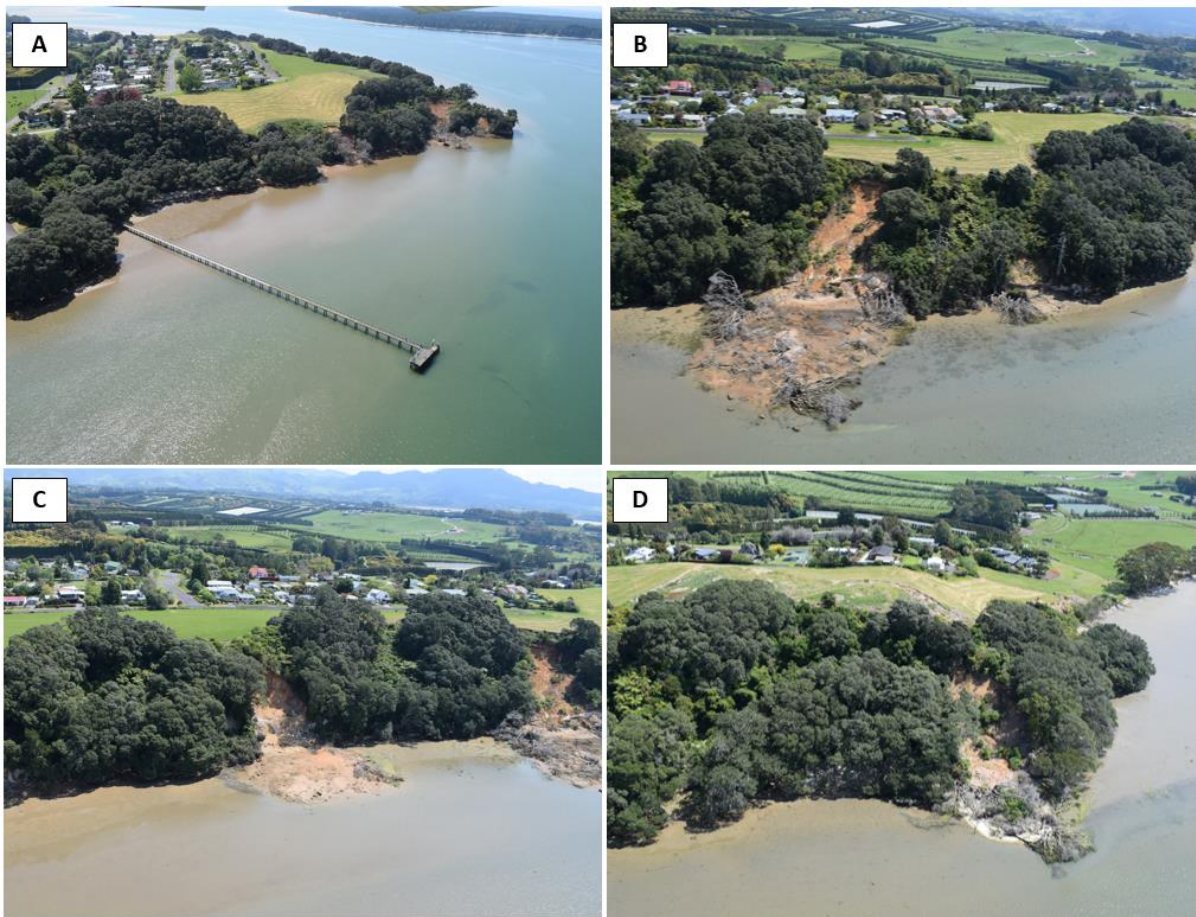
Figure 30-2 Site photos for Kauri Point. (A) South-facing cliffs (Cell 30A). (B) Large slip within Cell 30A). (C) East-facing cliffs (Cell 30B). (D) Northern end of Kauri Point (Cell 30B and 30C).

The cliffs at the southern end of Kauri Point range in elevation from RL 25 to 33 m (Cell 30A). The cliffs face south and are exposed to a maximum fetch of 14 km from southeast. Large pohutukawa trees overhang most of the cliffs and there is evidence of large slips.

Further north the cliffs wrap around to an east-facing orientation (Cell 30B). The cliffs are also densely vegetated with large overhanging pohutukawa trees and there is evidence of some slips occurring.

At the northern end of the shoreline the cliffs face northeast and are slightly reduced in elevation, ranging from RL 7 to 24 m (Cell 30C).
