7 Plummers Point

Tauranga Harbour Coastal Erosion Assessment
 Erosion Hazard Overview
 Site 7: Plummers Point

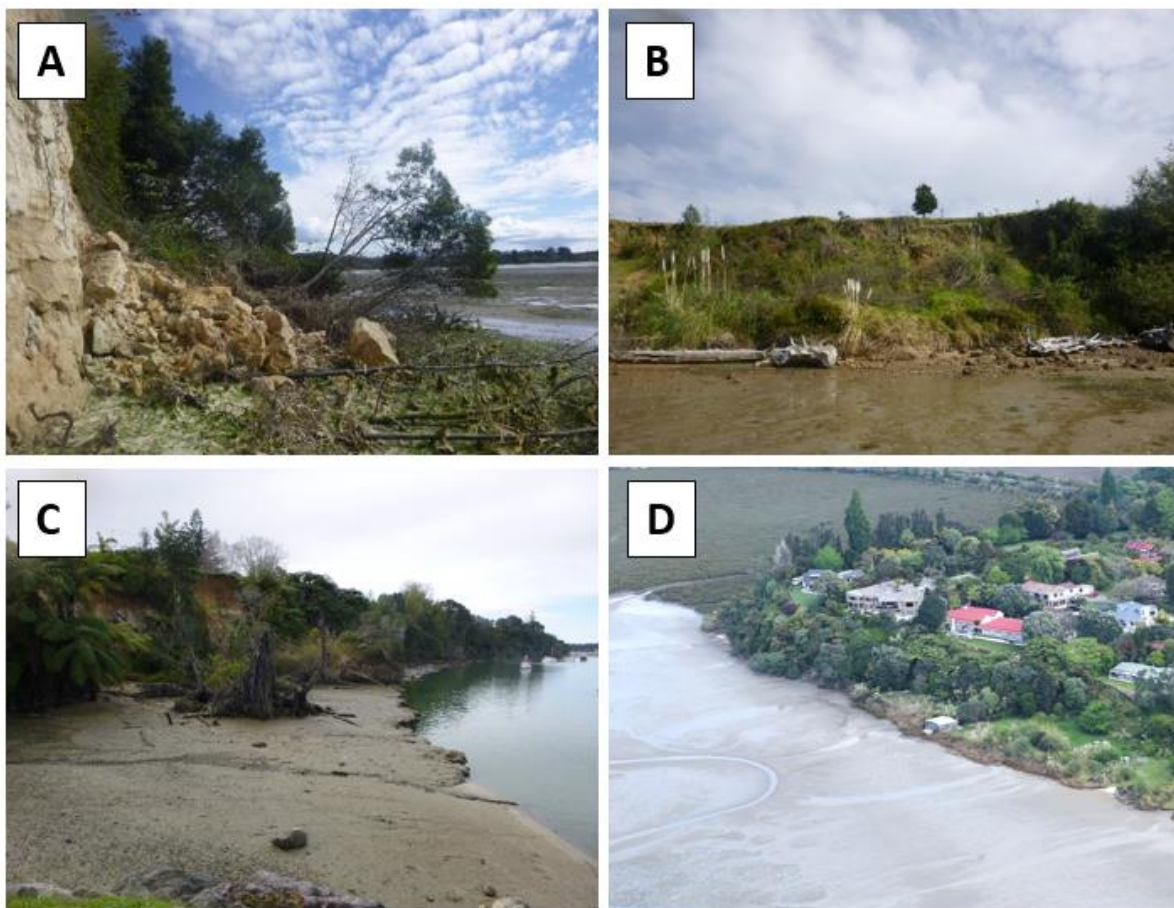
Figure 7-2 Site photos for Plummer's Point. (A) North-facing cliff (Cell 7A), (B) east-facing cliff (Cell 7C), (C) south-facing cliff (Cell 7E), (D) consolidated shoreline (Cells Cell 7F & 7G).

At the northern end, below Ongarahu Pa, there are north-facing cliffs, elevated approximately RL 14 m (Cell 7A). The cliffs are mostly vegetated although there are sections where slips have occurred leaving bare cliff face (Figure 7-2A). The cliffs wrap around to a northeast-facing aspect where they are exposed to an average fetch of 4 km (Cell 7B). Cliff elevations range from RL 12 to 15 m.

South of Cell 7B the cliffs change to a direct easterly orientation and are exposed to an average fetch of 9 km (Cell 7C). Along the east-facing cliffs the vegetation is less dense and in many sections a grass covered talus slope has formed (Figure 7-2B). Along the base of the cliffs are small patches of sandy beach and accumulated rock debris.

Further around the point are southeast-facing cliffs that are situated close to the tidal channel (Cell 7D) (Figure 7-2C). Vegetation is typically dense, however there are sections of bare cliff face where recent slips have occurred.

Along Kotuku Reserve there is approximately 0.2 km of protected, consolidated shoreline, including rock revetment around the boat ramp and pontoon and a seawall along the grass bank (Cell 7E). South of Kotuku Reserve is a section of approximately 0.3 km of low consolidated shoreline (Cell 7F) (Figure 7-2D). At the southernmost end of the site is a short section of well-vegetated, east-facing, cliffs, ranging in elevation from RL 16 to 18 m (Cell 7G) (Figure 7-2D).

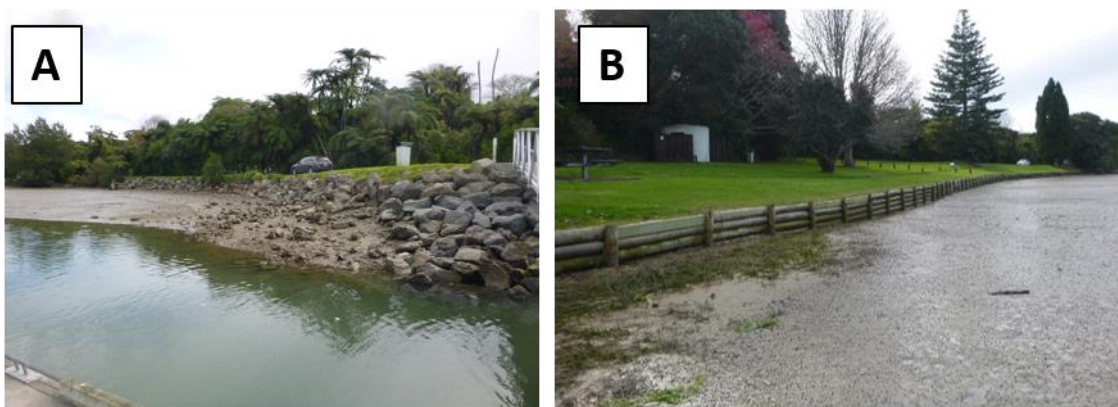
Figure 7-3 Protection structures at Plummer's Point. (A) Rock revetment, (B) timber seawall.

At the northern end of Kotuku Reserve is a section of rock revetment and rip rap extends from the pontoon to the boat ramp (Figure 7-3A). The revetment is approximately 1 m to 1.5 m high. South of the boat ramp is a small section of revetment followed by approximately 100 m of timber wall (approximately 0.5 m to 1 m high) (Figure 7-3B). The wall is in good condition however there is evidence of slight wave overtopping at the northern end. At the southern edge of the seawall an unprotected section of grass bank shows wave undercutting, indicating that without the seawall the grass reserve would be subject to erosion.
