28 Rangaiwaea North

Tauranga Harbour Coastal Erosion Assessment
 Erosion Hazard Overview
 Site 28: Rangaiwaea North

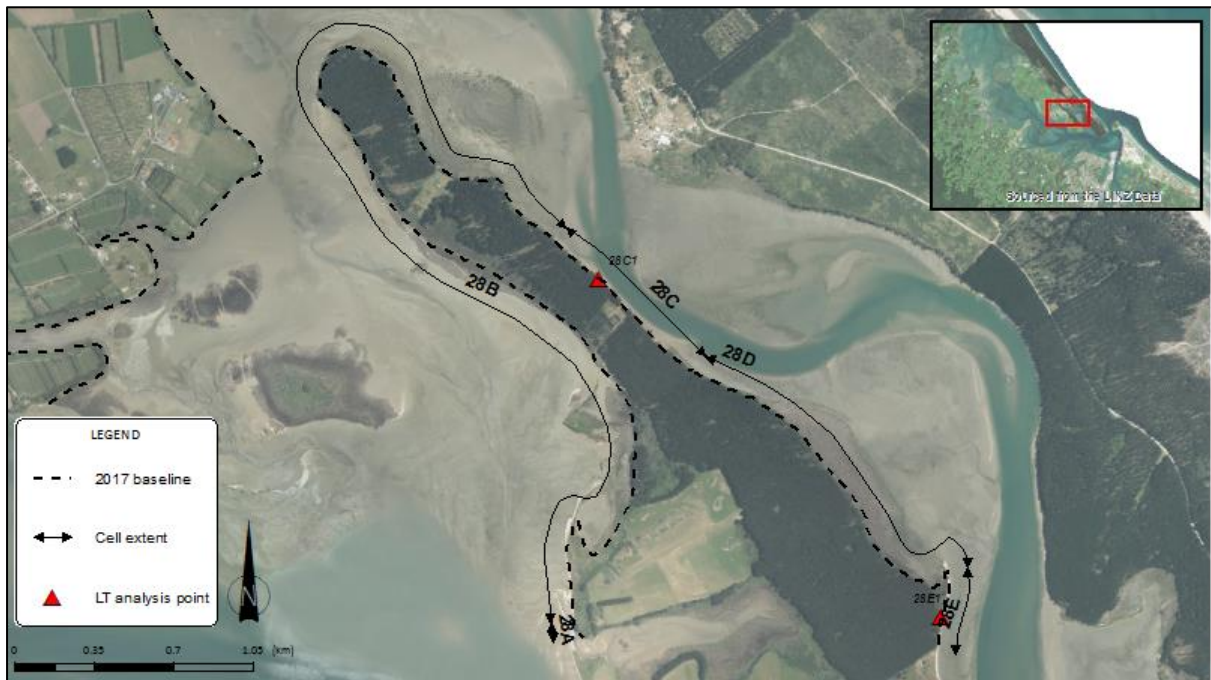
Figure 28-1 Location and cell extent of the Rangaiwaea North shoreline within Tauranga Harbour.

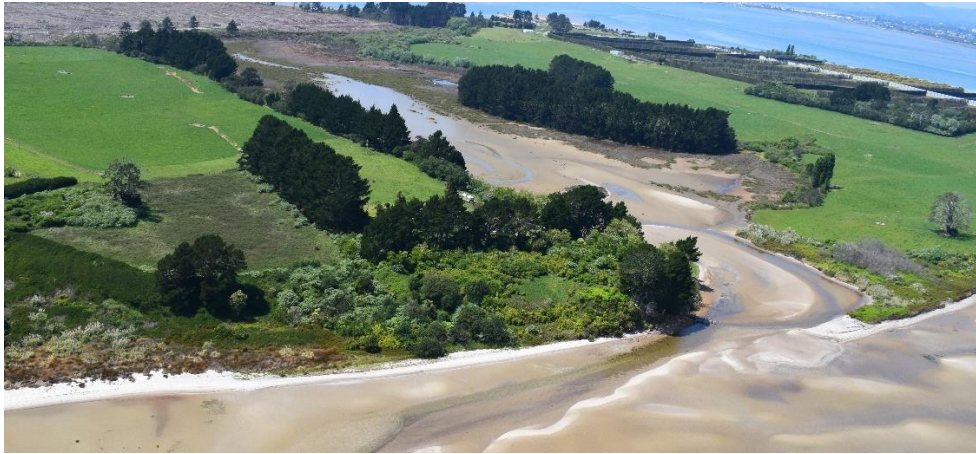
Figure 28-2 Site photo of Rangaiwaea North. Consolidated shoreline with sandy high tide beach within Cell 28A.

At the south-western extent of the shoreline there is small section approximately 100 m long of west-facing cliffs which range in elevation from RL 12 to 15 m (Cell 28A) (Figure 28-2). Towards north the shoreline elevation drops to a low-lying estuarine shoreline which is fronted by shallow intertidal flats (Cell 28B). The low-lying estuarine shoreline continues around to the eastern side of Rangaiwaea Island.
