## 10 Rangaiwaea Island

**Tauranga Harbour Coastal Erosion Assessment**  
 Erosion Hazard Overview  
 Site 10: Rangaiwaea Island

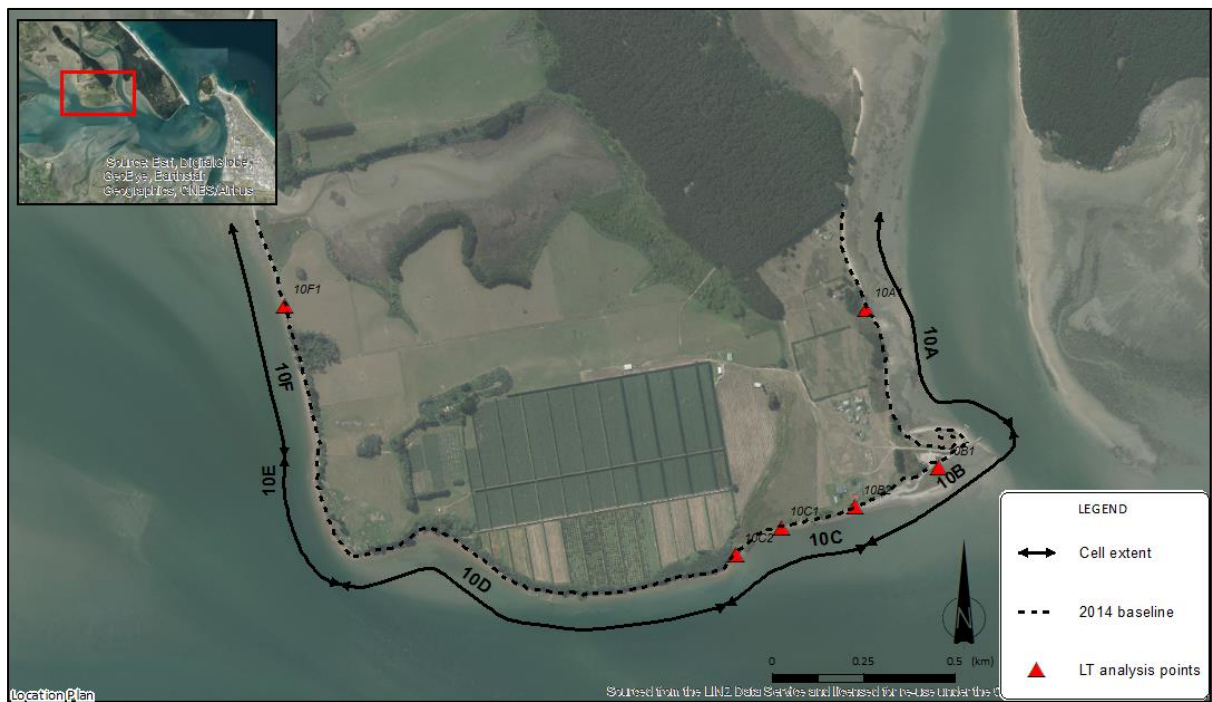
Rangaiwaea Island is located in the southern section of Tauranga Harbour, close to the south-western end of Matakana Island. The study site is located at the southern end of the Rangaiwaea Island and consists of approximately 2 km of cliffs and 1.5 km of low-lying, unconsolidated shoreline. The site is split into 6 cells based on differences in morphology, exposure and shoreline elevation (Figure 10-1).

Figure 10-1 Location and cell extent for Rangaiwaea Island within Tauranga Harbour.

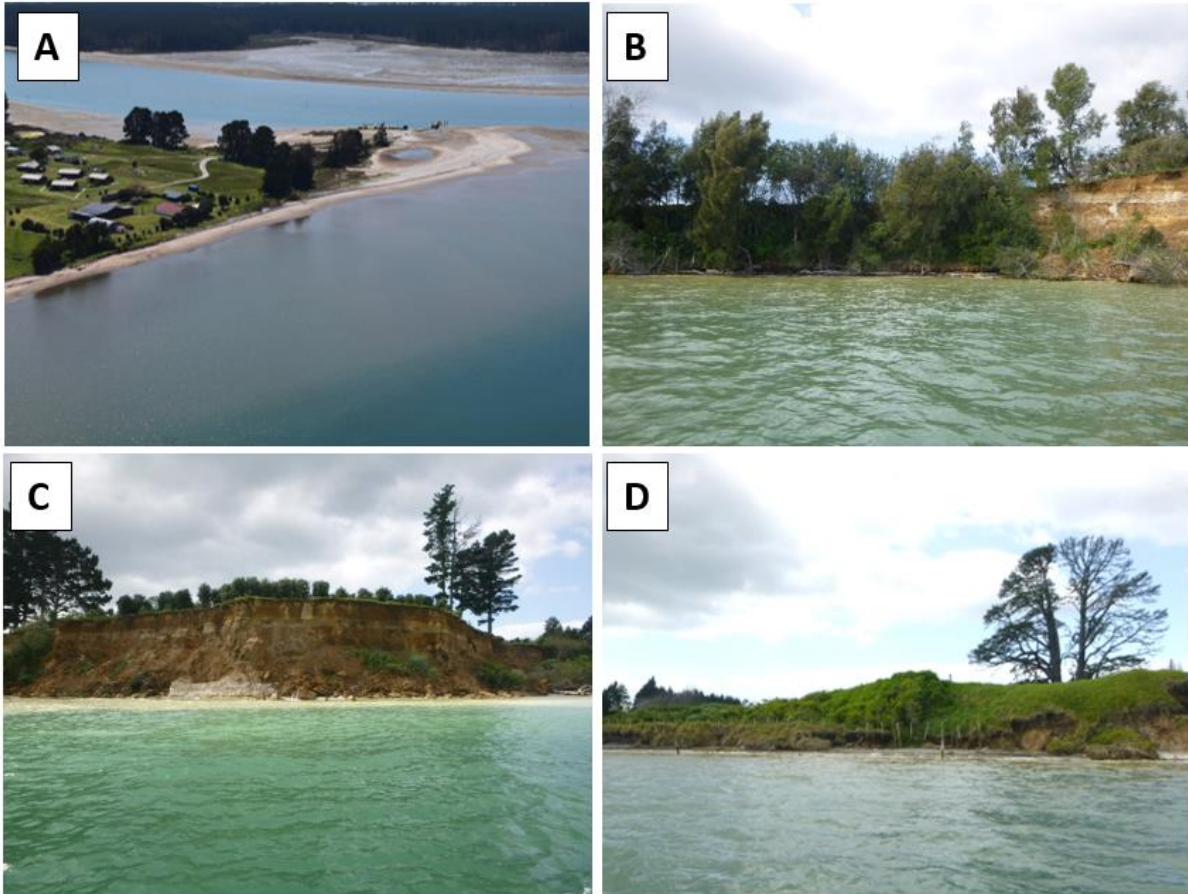
On the eastern corner of the island there is a sand spit feature, which indicates an accreting environment (Cell 10B) (Figure 10-2A). Along the south-facing shoreline there is another section of unconsolidated shoreline with a backshore characterised by a grass bank, approximately 1.8 m high (Cell 10C). Further towards the east is a section of south-facing cliffs that range from 10 m to 12 m high (Cell 10D) (Figure 10-2B). Most of the cliff is vegetated with small trees, however some slips have occurred, leaving a bare cliff face. On the western corner of the island, there is bare cliff face, approximately 12 m high (Cell 10E) (Figure 10-2C). Along the western side the topography gradually decreases from steep, exposed cliff to a low bank vegetated with grass and shrubs (Cell 10F) (Figure 10-2D).

Figure 10-2 Site photos for Rangaiwaea Island. (A) Unconsolidated shoreline and spit (Cell 10B), (B) south-facing cliffs (Cell 10D), (C) west-facing cliffs (Cell 10E), (D) low, west-facing cliff (Cell 10F).

Wave undercutting is evident along the grass bank within Cell 10C. The regression analysis indicates that the erosion rate at this site is high (up to -1 m/yr). The exposed cliffs at the western end of the shoreline (Cell 10D) also show evidence of recent erosion. The cliffs are closely situated to the Western Channel and there is a relatively large fetch from the south (approximately 4.5 km). Therefore, wind waves and tidal currents are likely to continually remove slip debris and contribute to the shoreline erosion. Long term erosion rates are estimated to be between -0.15 to -0.4 m/yr for Cell 10C.

The west-facing shoreline is also an exposed site, with the maximum fetch approximately 14 km towards the northwest. Field observations indicate that coastal processes are actively eroding the bank. The regression analysis shows long term erosion rates ranging from -0.15 to -0.4 m/yr within Cell 10F. Due to the similar exposure and field observations it is assumed that long term erosion rates are similar for Cells 10D and 10E (Table 10-1).

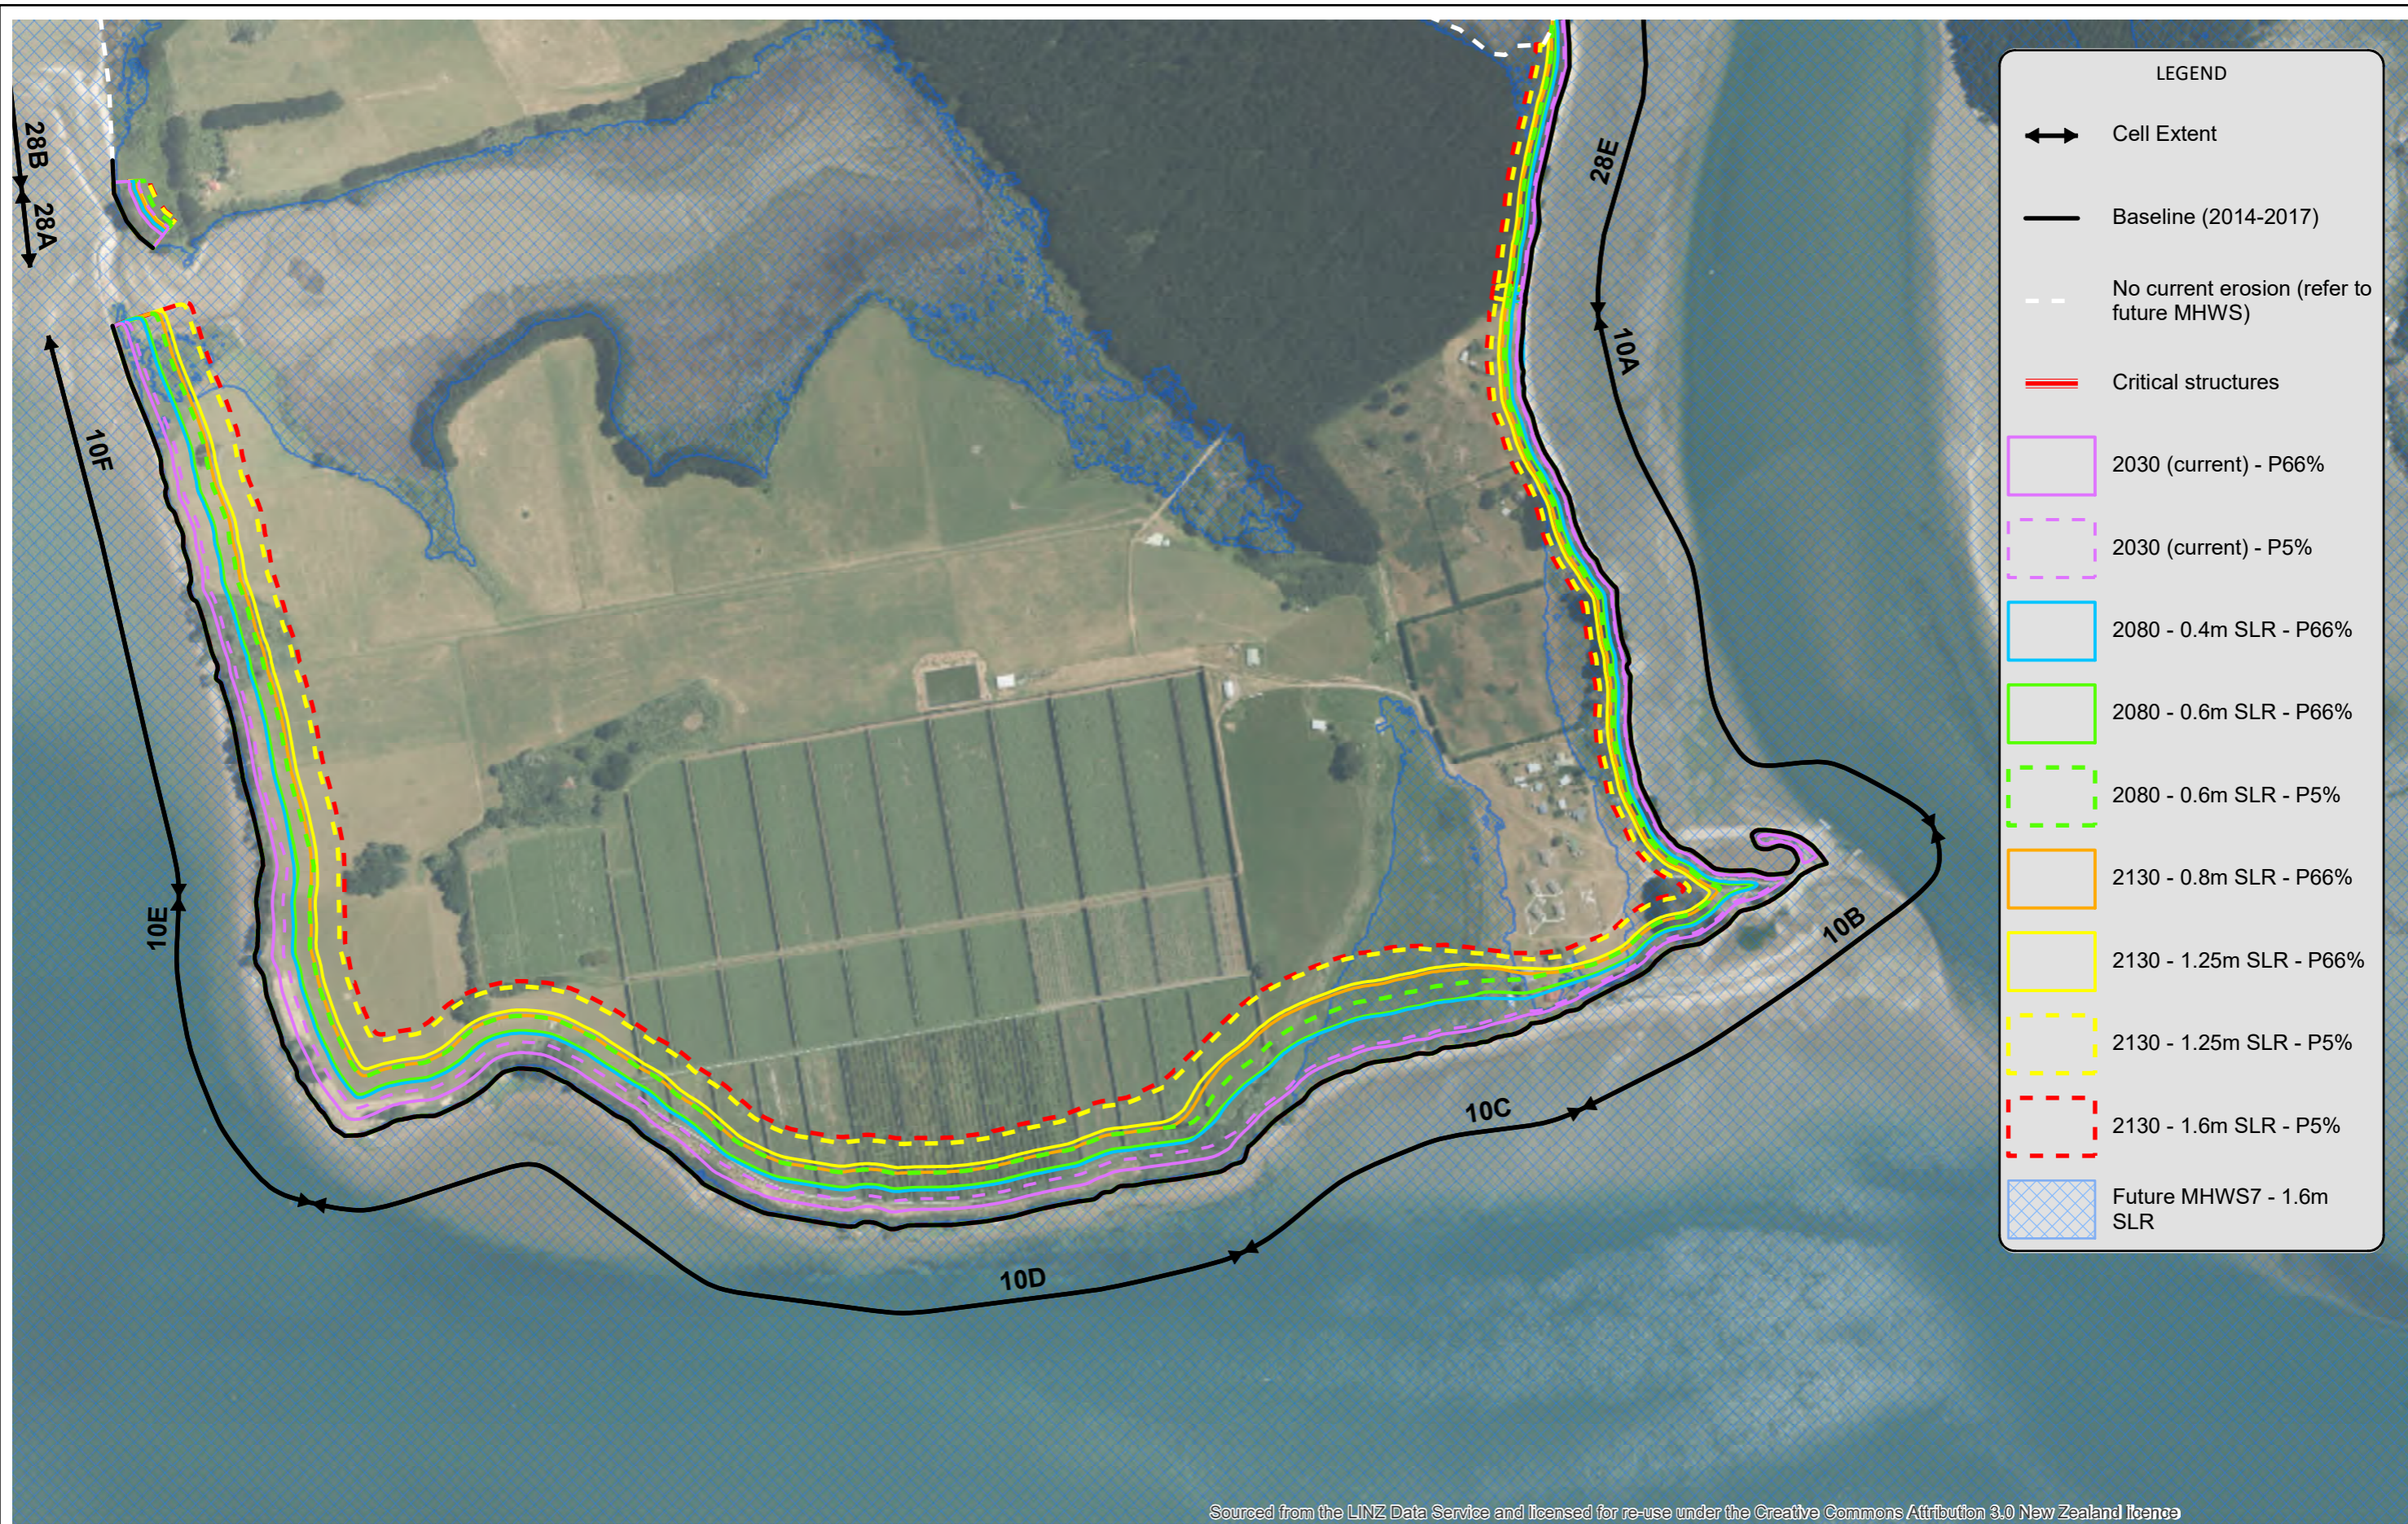
FIGURE No. Figure 10-4

Coastal erosion hazard distances for Rangaiwea Island are presented within Table 10-2 and an overview map in Figure 10-4. Histograms of individual components and resultant erosion hazard distances using a Monte Carlo technique are shown in Appendix B. For the purpose of this assessment all coastal erosion protection structures have been ignored (refer to main report Section 4.5.4).

The current P<sub>66%</sub> erosion hazard for the unconsolidated shoreline around Rangaiwea ranges from -5 m on the east-facing shoreline to -16 m on the south-facing shoreline.

Due to the large historic erosion rates within Cell 10C, the future P<sub>5%</sub> for 1.6 m SLR in 2130 is -125 m, representing the largest potential erosion value across all of the harbour sites.

Although the cliffs are not retreating as rapidly as the unconsolidated shoreline within Cell 10C, the erosion values are still relatively high, with the current P<sub>66%</sub> erosion hazard ranging from -14 m to -18 m, and the future P<sub>5%</sub> erosion hazard for 1.6 m SLR in 2130 ranging from -89 m to -96 m.
