## 8 Te Puna West

**Tauranga Harbour Coastal Erosion Assessment**  
 Erosion Hazard Overview  
 Site 8: Te Puna West

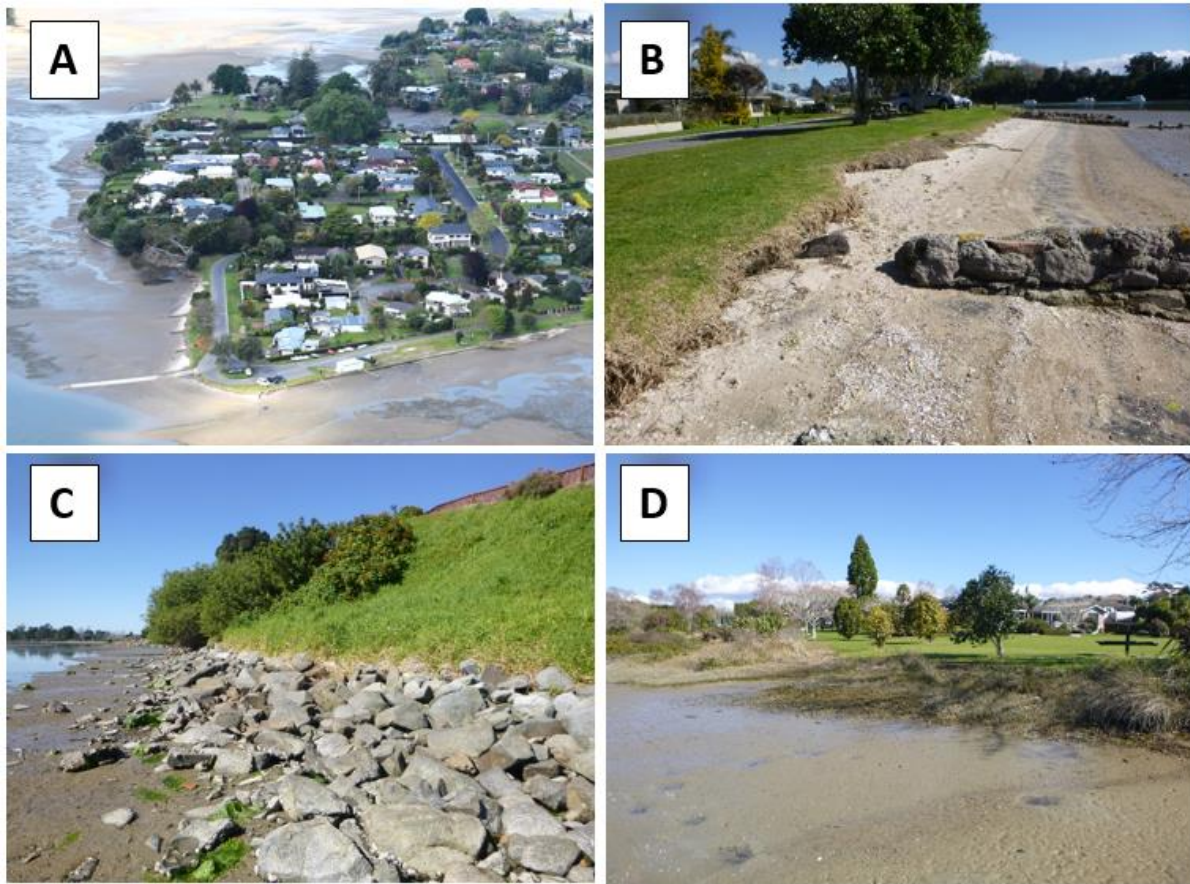
Figure 8-2 Site photos for Te Puna West. (A) Aerial shot of Te Puna West shoreline (Cells 8A & 8B), (B) groynes along the unconsolidated shoreline (Cell 8B), (C) revetment at the base of the cliffs (Cell 8C), (D) unconsolidated shoreline around Te Kopa O Te Hotu Reserve (Cell 8H).

Around Waitui Reserve the shoreline is low elevation with a combination of protection structures, including seawalls, groynes and rock revetment (Figure 8-2A). The west-facing side of Waitui Reserve is relatively sheltered with an average fetch of 0.5 km (Cell 8A). The north-facing section of Waitui Reserve is slightly more exposed with an average fetch of 4 km from the northeast (Cell 8B). The shoreline is characterised by a small unconsolidated sandy beach in between a groyne field (Figure 8-2B).

East of Waitui Reserve is a section of north-facing coastal cliffs that ranges in elevation from RL 7 to 9 m and are mostly vegetated with grass and shrubs (Cell 8C). Along most of the cliff toe is an engineered rock revetment ranging in height from 1 to 3 m RL (Figure 8-2C).

Further south-east around Te Kopa O Te Hotu Reserve, the shoreline comprises unconsolidated sediment with patches of salt marsh and mangroves along the fringe (Cell 8H) (Figure 8-2D).

Due to the extensive structures around Te Puna West it is difficult to determine long term shoreline trends. However, the presence of structures suggests that coastal erosion is an issue. Around Waitui Reserve the shoreline is relatively sheltered with regression analysis indicating an average long term erosion rate of -0.08 m/yr within Cell 8B. Cell 8A is exposed to smaller fetches than Cell 8B, hence the average long term erosion rate is assumed to be -0.05 m/yr. Sediment accumulation along the eastern side of the groynes indicates there is some westward sediment transport (Figure 8-2A).
