# Memorandum

Message Ref: Evaluation of existing on site Light Reflectance Values and potential mitigation

Project No: BM211084

This memorandum is as an addendum to the “Te Puna Station Road – Landscape Effects Assessment<sup>1</sup>” (LEA) and assesses the potential visual amenity effects in relation to Light Reflectance Values. The Western Bay of Plenty District Plan outlines the activity performance standards for Industrial zoned land and includes the following standard for the Te Puna Business Park.

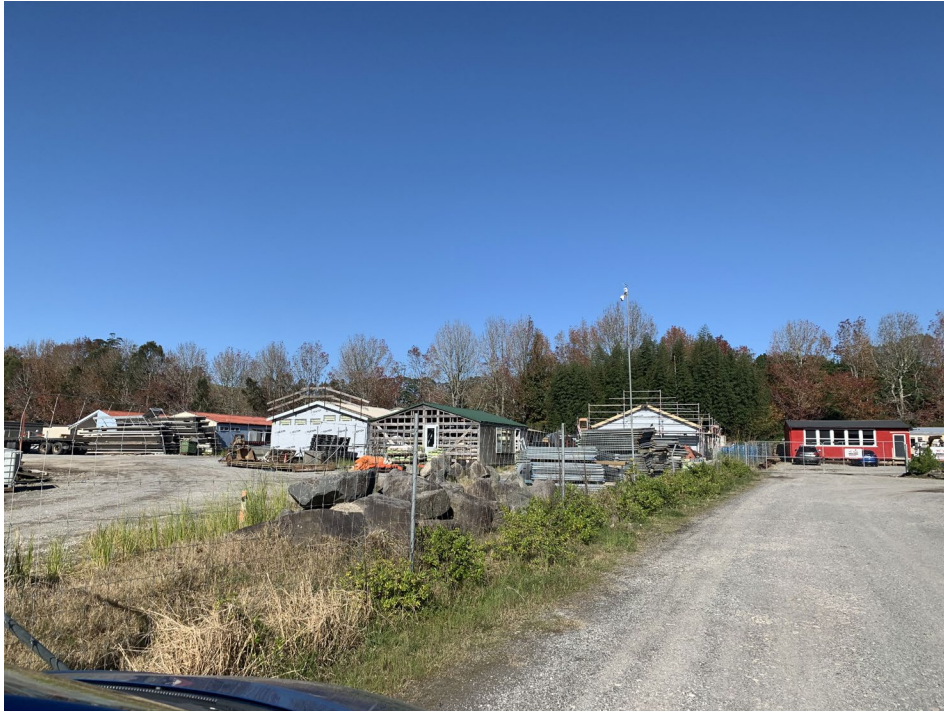
The house/building material storage operations typically contain a range of transportable dwellings on temporary basis. The materials and colour of these transportable dwellings vary and will ultimately change as dwellings are removed and replaced. Currently, the colours and finishes of the structures include:

- dark and light coloured corrugated steel roofs
- weatherboard clad buildings with natural wood, light and dark colouration
- light coloured temporary building wrap

The lot also contains a range of building materials including temporary metal fencing, wooden palettes, prefabricated concrete and boulders.

Photo 1: House and building material storage operations

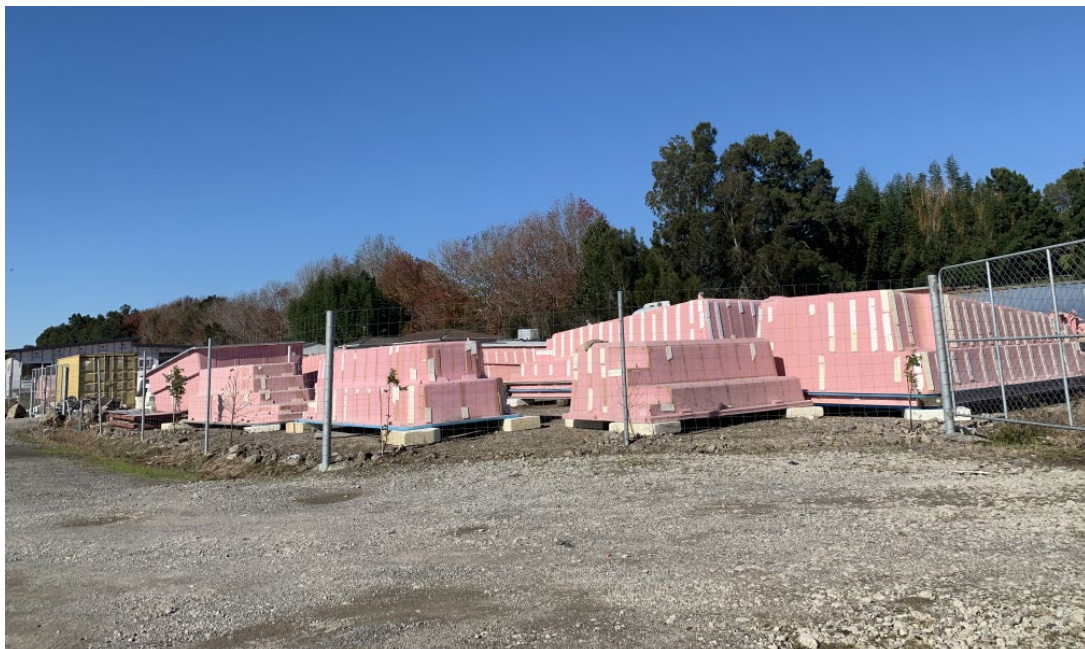
The swimming pool shell storage yard contains a collection of prefabricated pools in a range of sizes and three shipping containers are also present and have a matte yellow, blue and brown coloured finishes. The height of the pools are low lying in the landscape and range from approximately 1.5m to 2.5m above the ground. Compass Pools are finished with a pink colouration in support of the Breast Cancer Foundation NZ<sup>2</sup>. The specific shade of pink used is Pantone ® 7606 U<sup>3</sup>, when cross referenced through the Resene colour range this most closely matches “Resene Petite Orchid”, which has an LRV rating of 49%.

Photo 2: Compass Pools shell storage area

The pools, as viewed from the residential property at 110 Te Puna Station Road, will be a small element within the context of panoramic easterly views. Adverse amenity effects related to the reflective colour of the pools are able to be mitigated by either;

- erecting a shade screen approximately 4.5m in height along the western edge of the swimming pool storage area adjoining internal boundary planting (refer Figure 1 below), until internal boundary planting has established to a height of 4.5m; or;
- covering pools with a low reflectivity tarpaulin or similar matt covering (when stored for longer than one week).

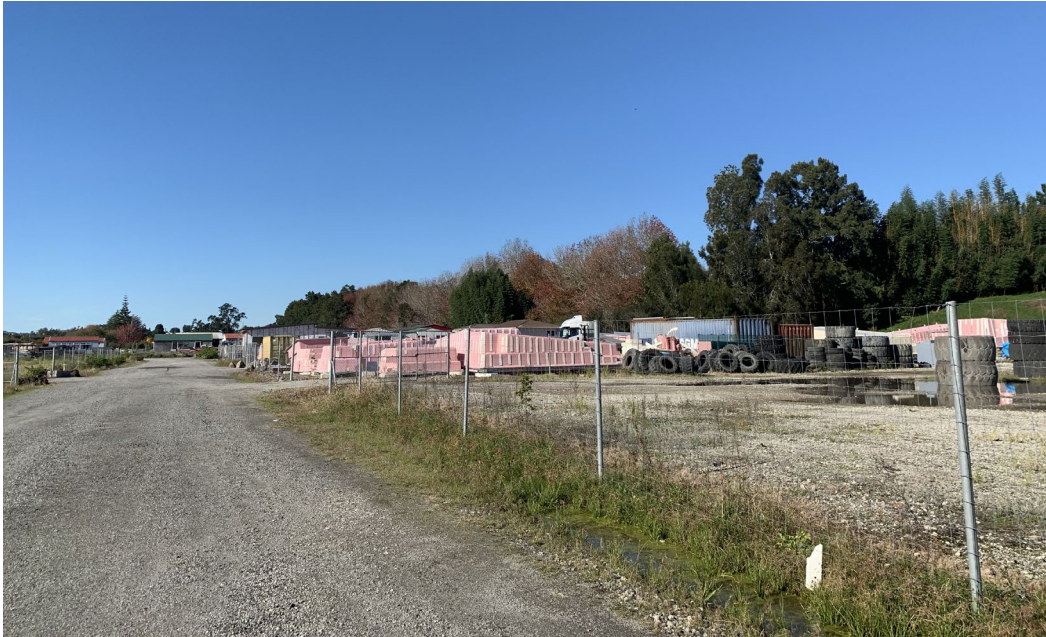
The tyre storage yard contains a range of different sized used tyres that are predominantly black which is a recessive non-reflective colour. The yard is only partially used. Currently tyres are stacked along the eastern site boundary adjacent to the pool storage area.

Photo 3: Tyre storage yard viewed against the backdrop of the pool storage area

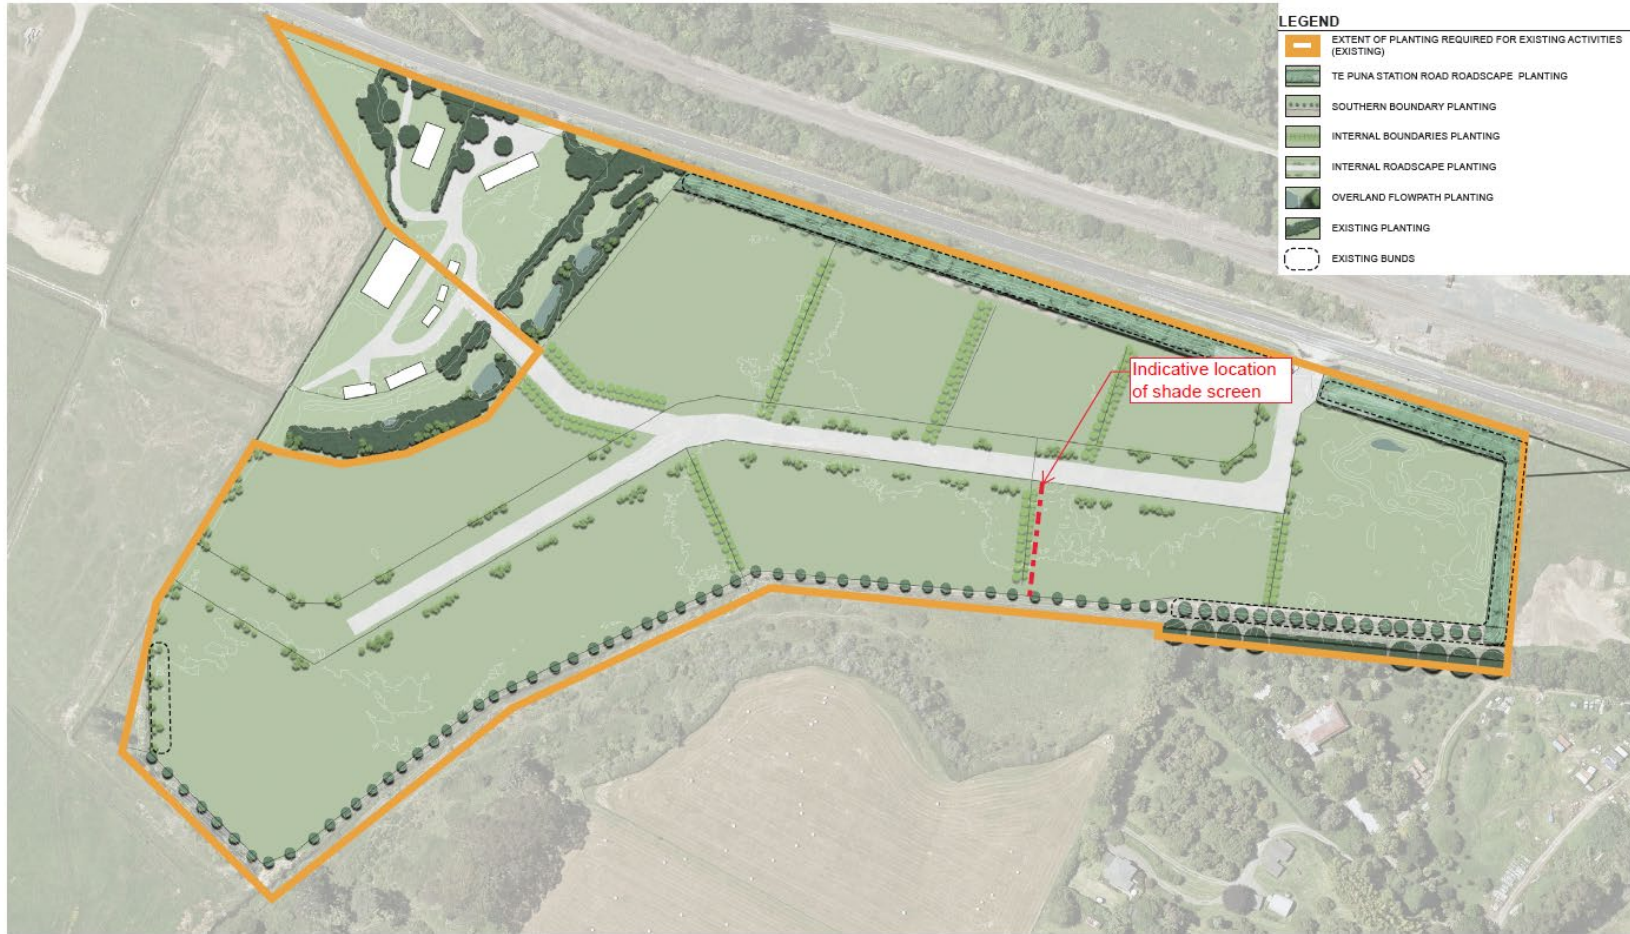
LANDSCAPE MITIGATION PLANTING PLAN | TE PUNA STATION ROAD BUSINESS PARK | 01 JUNE 2023  
REVISION: A | DRAWING NUMBER: BM211084\_200

EXTENT OF PLANTING REQUIRED FOR THE MITIGATION OF EXISTING ON-SITE ACTIVITIES

NOTE:  
THE EXTENT OF PLANTING BOUNDED WITHIN THE ORANGE LINE IS THE EXTENT OF PLANTING CONSIDERED TO BE REQUIRED TO HAVE BEEN INSTALLED IN ORDER FOR EXISTING ACTIVITIES TO BE ABLE TO CONTINUE ON-SITE, BEING THE SUBJECT OF THE RESOURCE CONSENT APPLICATION THAT THIS PLAN IS INTENDED TO SUPPORT.

Figure 1: Indicative location of shade screen to mitigate visual amenity effects related to stored pool shells.
