**From:** Jewel Zhu – Fire Engineer

**Date:** 23 June 2022

**Action:** 19 Derrimore Heights Residential House Fire

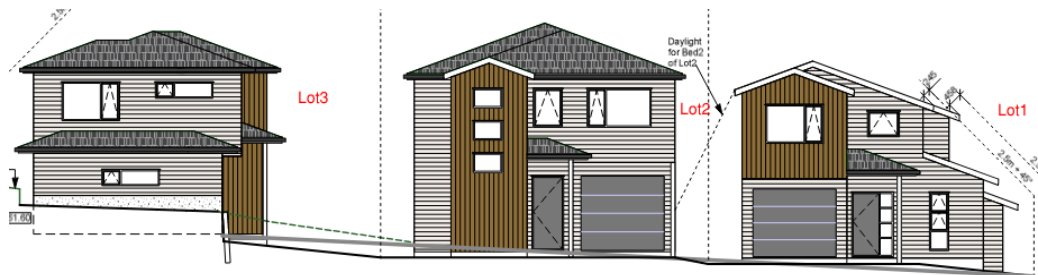
Figure 2: Proposed three new standalone two storey dwellings at the same site – elevation view from the east

At the time of the incident, the three two-storey dwellings were under construction and were considered weathertight, however, it is noted that the internal wall framing was not lined yet and no electrical services were installed.

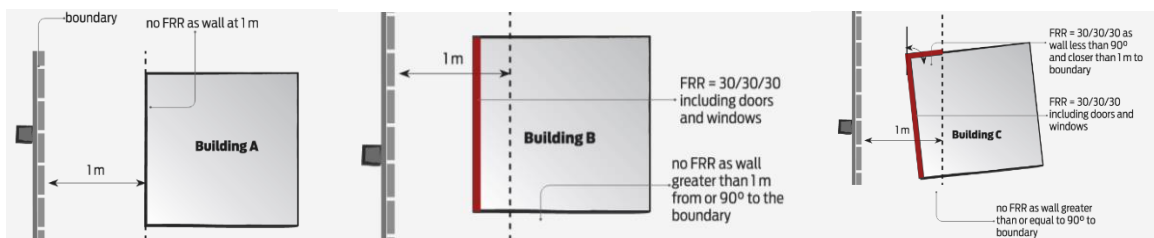
Figure 12: External fire resistance rating requirement for single household

- Ensuring that the wall is at least 1m away from the boundary;
- designing the wall to achieve a fire resistance rating

This is illustrated in Building A, B C in Figure 12 below.

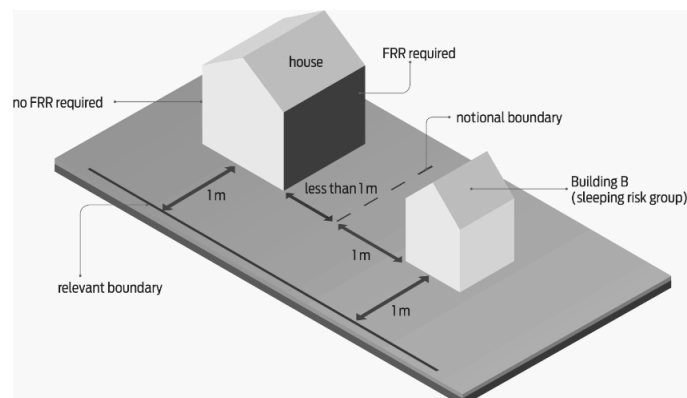
Figure 13: Fire resistance ratings for various sleeping risk group buildings under the same title

If the buildings considered includes sleeping use, those requirements also apply to buildings on the same section under one title or same ownership. Under this circumstance, a notional boundary should be used between the two buildings instead of relevant boundary; for instance, between the main house and sleepout.

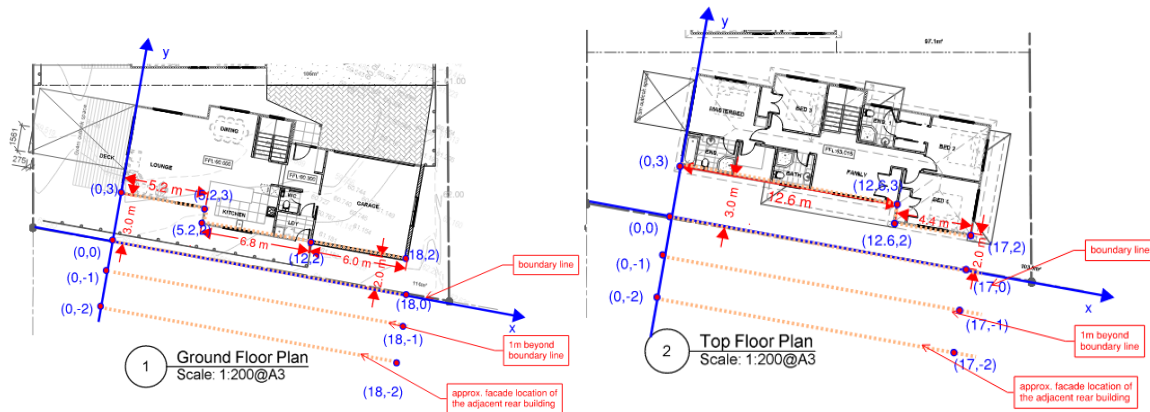
Figure 14: TRA input emitter and receiver panels in plan view – x, y coordinates

TRA simulates incident heat flux on a receiver from an emitter. For residential settings including stand-alone houses, an emissive flux of 84kW/m<sup>2</sup> is usually assumed. It is in line with the parameters used for “all spaces where occupants sleep” as described in *C/VM2 Verification Method: Framework for Fire Safety Design*. It is noted that the dwelling of concern was not occupied at the time of the fire, with no furniture or personal belongings, so the live fuel loads would be reduced. On the other hand, as the internal wall framing was not lined (with plasterboard typically), all the exposed combustible structure members and insulation material could increase the severity and provide considerable amount of fuel to sustain the fire once it became established. Though the accelerant used might have contributed during the early stages of fire development, its impact at later (e.g. post flashover) stage can be neglected.

The detailed geometry of the entire dwelling 3 south elevation and receiver panels used in TRA simulation is illustrated Figure 14 below. Refer to Appendix A for three-dimensional coordinates included in the simulation.

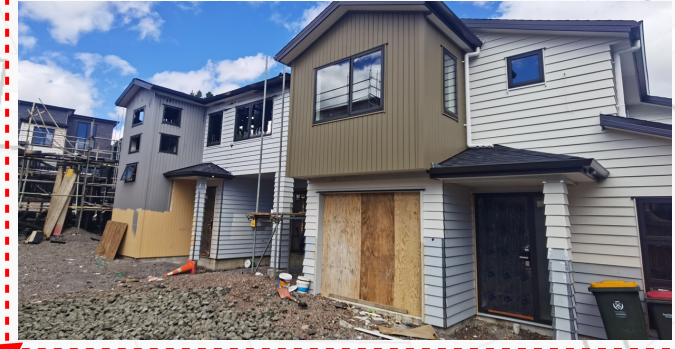
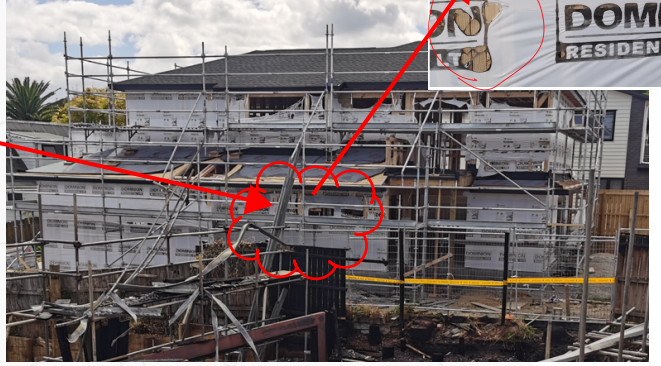
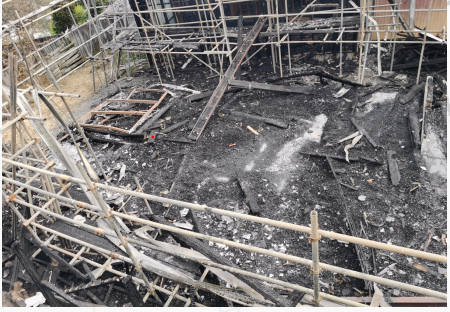
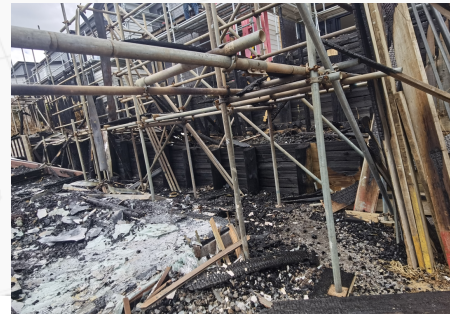
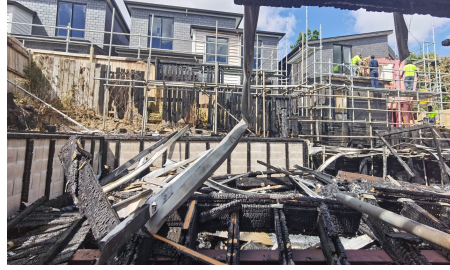
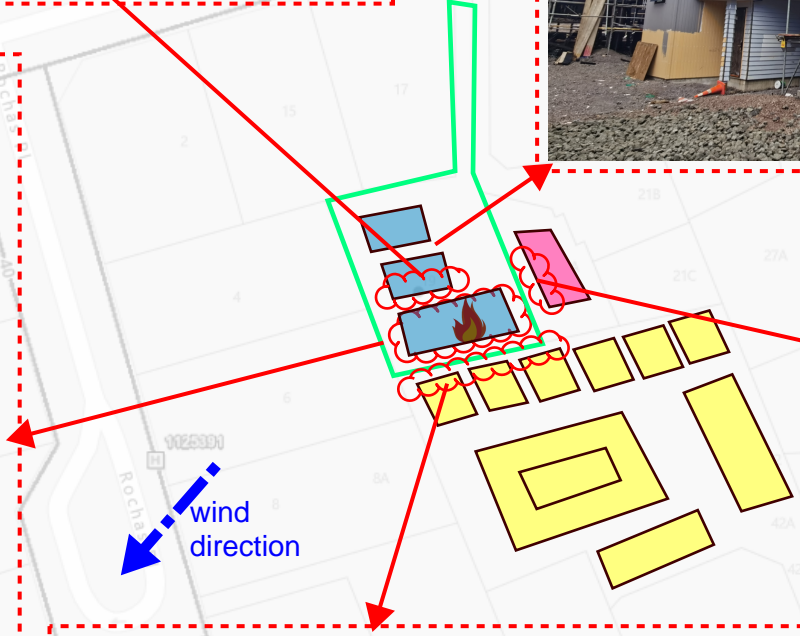
access via other residential property

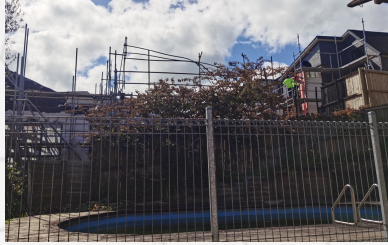
view from property

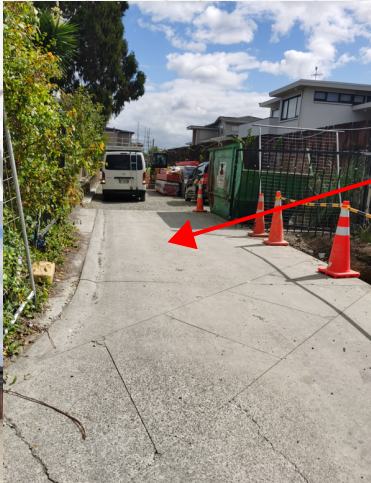
Drawing Title: Firefitting access

access via other development (under construction) from Redoubt Rd
