# **Western Bay of Plenty District Council**

### **Plan Change 71 Changes to District Plan Map U64, Lynley Park, Omokoroa**

#### **Section 32 Report**

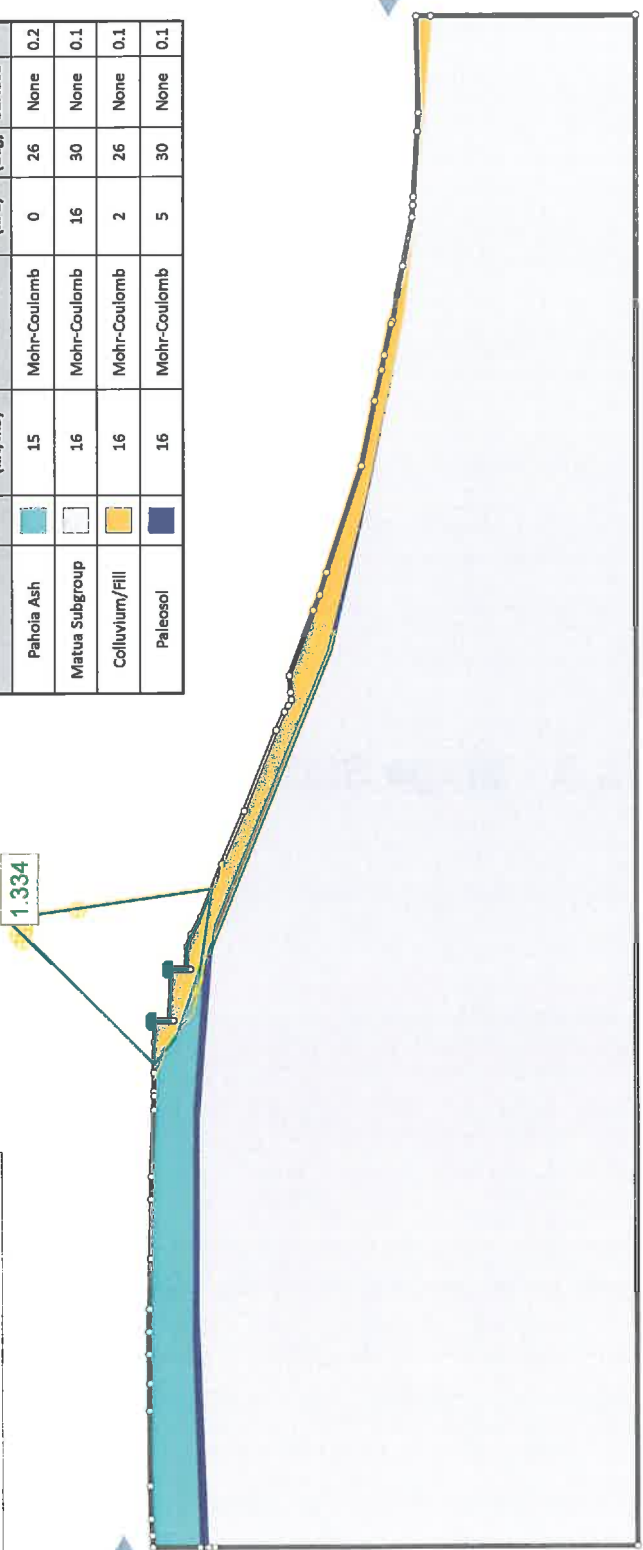
Failure surfaces with FoS < 1.5 shown

| Project | | Stage 3, Lynley Park, Omokoroa | | Section B-B | |
| Analysis Description | | Prevailing groundwater conditions | | Project Number GENZTAUC15909AB | |
| Analysis Method Used | Morgenstern-Price | Scale | 1:750 | Search Method | Path Search |
