# Western Bay of Plenty District Council

Plan Change 68
Deletion of Built Heritage Feature 31
(Former Union Bank Building)

**Section 32 Report**

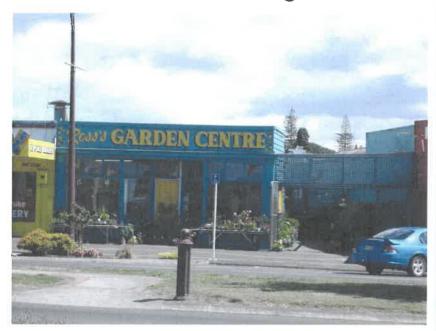
#### Former Union Bank building

Location: 2 Boucher Ave, Te Puke

**Physical Description:** Symmetrical timber weatherboard clad building. Shopfront windows and centrally positioned recessed entrance extend along the entire façade. Timber weatherboard interior, in poor condition.

The building is in a notably poor condition, with the ceiling sagging, the walls bowing out and the floor undulating and some of the timber floor members sagging with degradation of the timber itself. This is particularly due to water damage as the building has been a garden centre for a significant period and on-going watering of the plants has affects a number of the building elements.
