**Glen Isla Reserve Coastal Protection Structure**  
**Landscape and Visual Effects – Peer Review Summary and Expert Re-Evaluation**

This document provides a summary of findings from the original review of the *Assessment of Landscape and Visual Effects* (the Assessment) for the Glen Isla Reserve Coastal Protection Structure (the Proposal), as well as the initial Section 92 request for further information (S92).

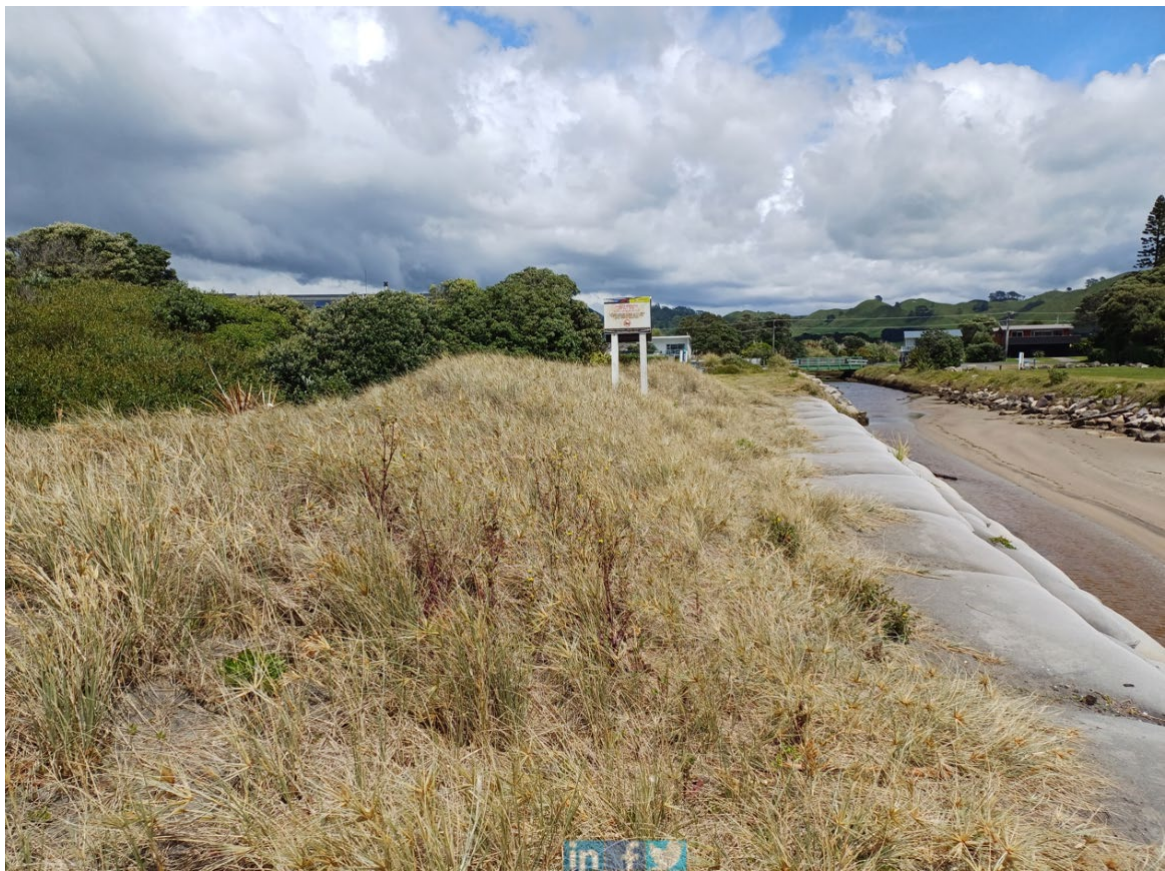
9. **Vegetation removal** describes the extent of vegetation required to be removed for construction of the structure. During the site visit it was observed that there is a crest in the existing dune at the northwest end of the proposed sea wall, adjoining the existing sandbags along the edge of Three Mile Creek (see Figure 1 below). Figure 5.0a from the Construction Methodology Statement<sup>4</sup> indicated that this would be removed as part of the works.

Figure 1: Photo of the dune crest at the north end of the site

- **Sand Crest Protection:** A sand crest at the northwest end of the seawall was confirmed to remain outside the construction footprint. However, the absence of fencing raises questions about potential disturbance during construction.

It is clear in the written response that the intention is to retain and protect the sand crest, and it is noted that such a fence could be installed during the construction phase. The sand crest fence alignment has not appeared on any of the plans seen to date.

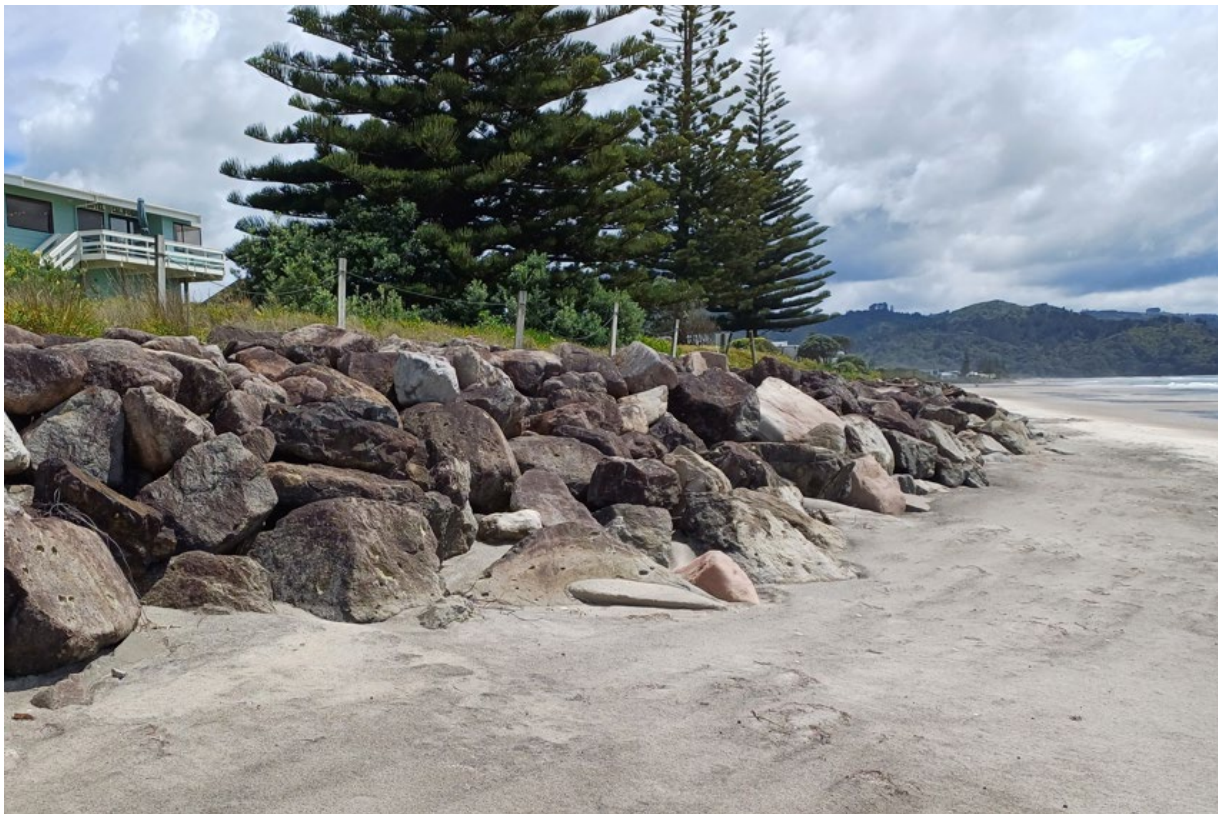
24. Clarification was also sought on the potential cumulative effects of the proposal and the existing, fully exposed seawall/ rock revetment approximately 200 meters north (see photo below). This example appears to be a fair representation of the anticipated 20-30 year scenario referred in the Assessment.

Figure 2: Example of a fully exposed seawall approximately 200 metres north of the site
