| <b>To:</b> | Luke Faithfull<br>Partner – Mitchell Daysh | <b>Date:</b> | Thursday, May 15, 2025 |
| <b>From:</b> | Brad Coombs, Isthmus Group Ltd (IGL) | <b>Job No:</b> | 5034 |
| <b>Subject:</b> | <b>Glen Isla Place Society (GIPS) Coastal Protection Structure second s92 Draft Response</b> | | |

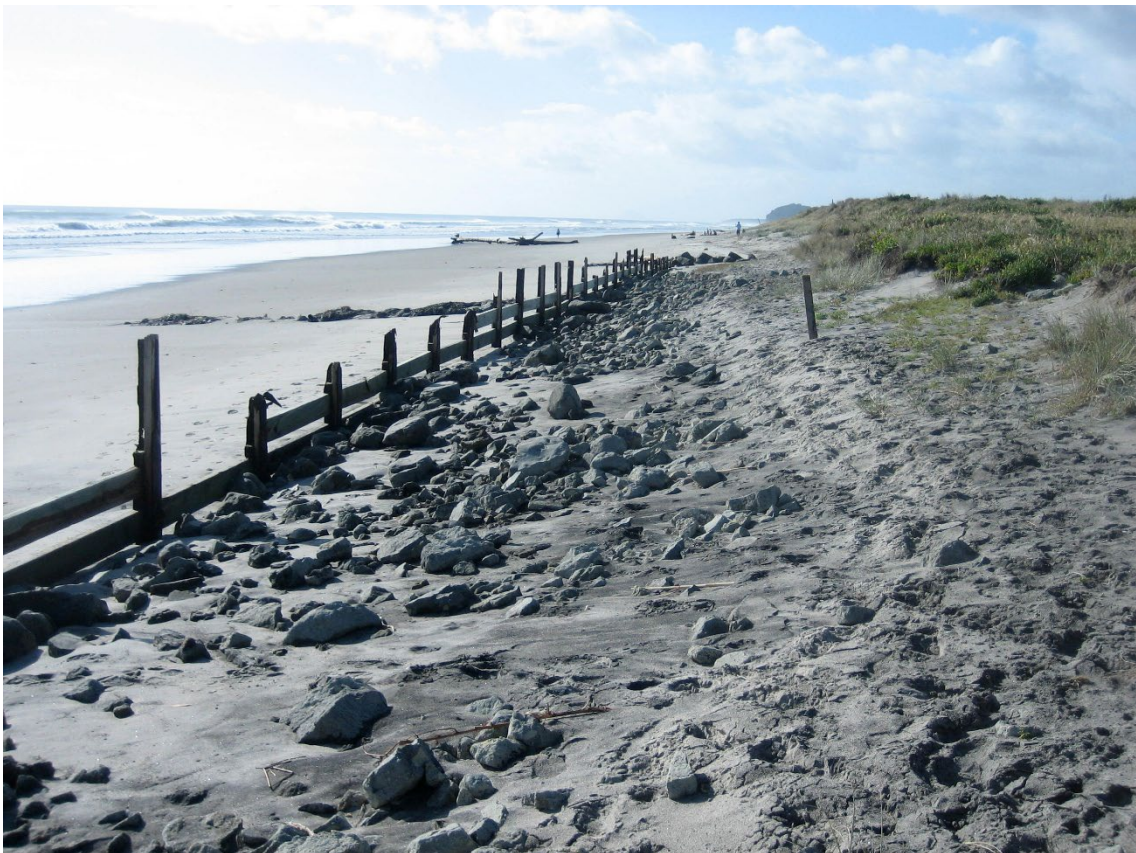
Figure 1: Remnant seawall prior to the 2010/2011 coastal protection works.

centres perpendicular to the wall. By 2010 these barriers (shown below in Figure 1 and 2) which were located approximately 20m from the GIPS property boundaries, had fallen into a state of disrepair, however, these barriers protected the dune with the dune having extended out since these barriers were installed in the early 1980's. Since the removal of these barriers and the implementation of the unsuccessful 2010/2011 dune enhancement works, several metres of dune have been lost from the depth of the sand covered dunes adjacent to Glen Isla Place, with the narrowest dune area down to a minimum of 4.5m from the private property boundary. The history of coastal protection structures on the site and the effects of Three Mile Creek, climate change and sea level rise indicates ongoing erosion and the need for a coastal protection structure as proposed in this application.

23. The steel posts and rocks underlying the sand covered dune that were exposed by Cyclone Gabrielle in 2023 were likely remnants of previous protection barriers from prior to the Ohinemuri barriers and these remain a part of the post-storm existing environment.

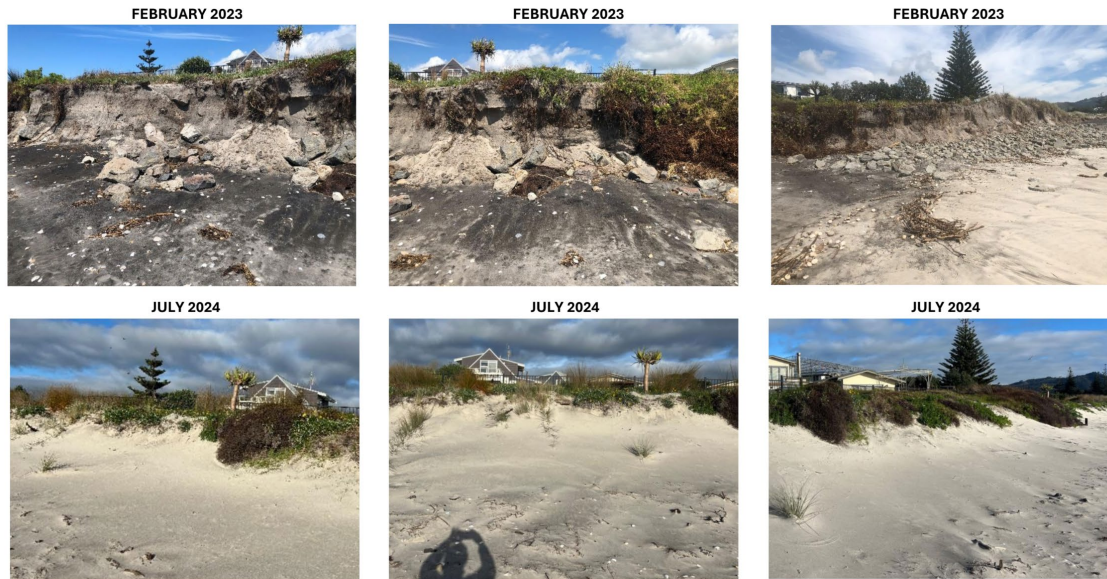
Figure 3: Examples of Glen Isla Place post-storm dune scouring and natural dune accretion

33. The GIPS coastal protection structure is 200m long and is comparatively subtle and sympathetic in its' design, providing sufficient room for future public access, should it be required and includes the burying of the structure, dune recontouring and planting. The dog leg arrangement of the wall which steps back away from the sea at the north end ensures that most of the wall will remain buried and only a portion (less than 100m) could be intermittently exposed.
